ADA Self-Evaluation and Transition Plan

January 2020

Opera House
RESTAURANT

Prepared by:

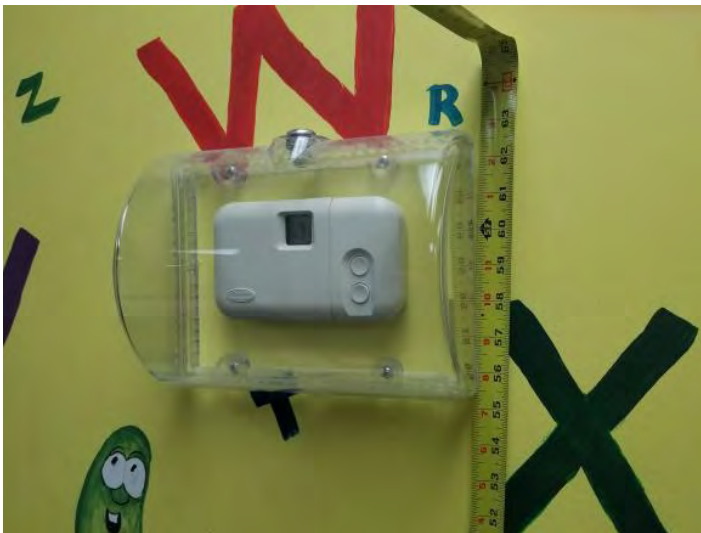
The thermostat is not positioned correctly for either a side or front approach. The thermostat is at 59".

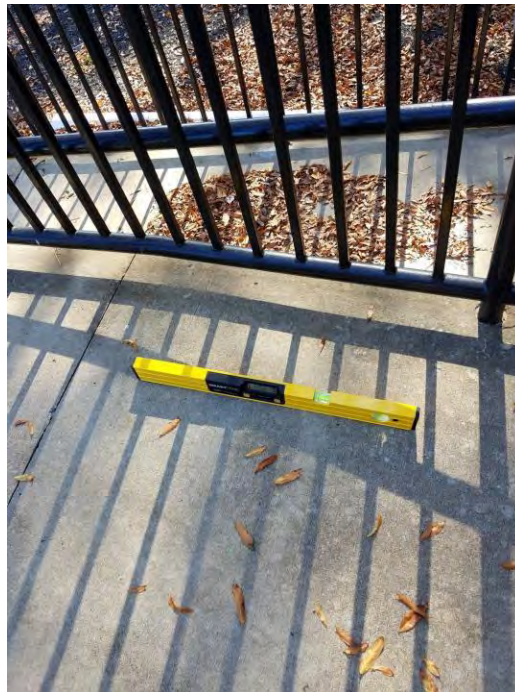
The ramp varies up to 10.2%

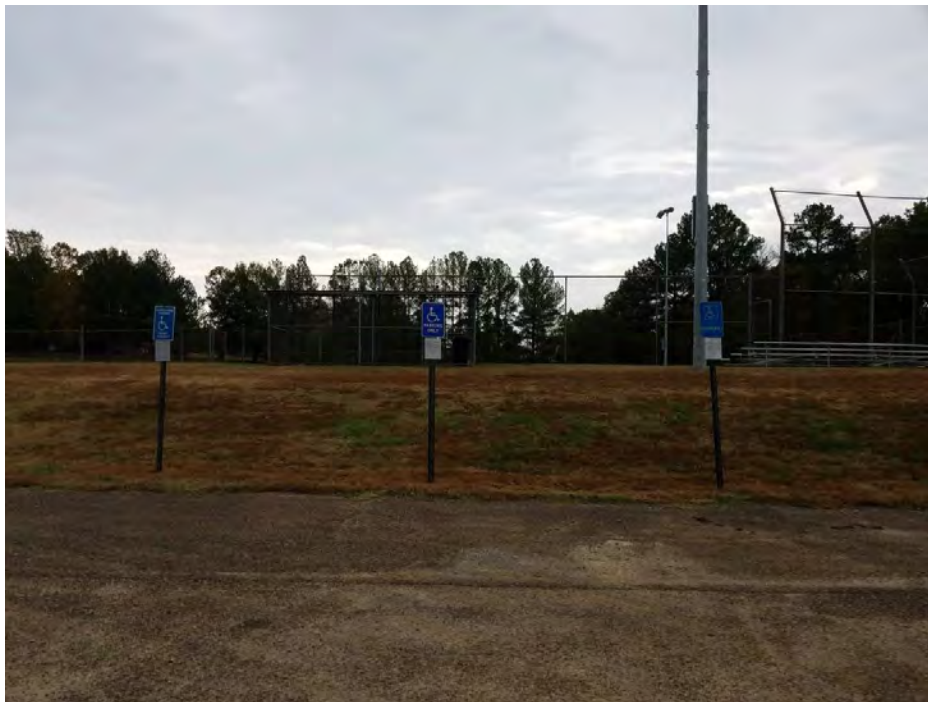
No striping, no access aisles, no van sign.
