ADA Self-Evaluation and Transition Plan

January 2020

Opera House
RESTAURANT

Prepared by:

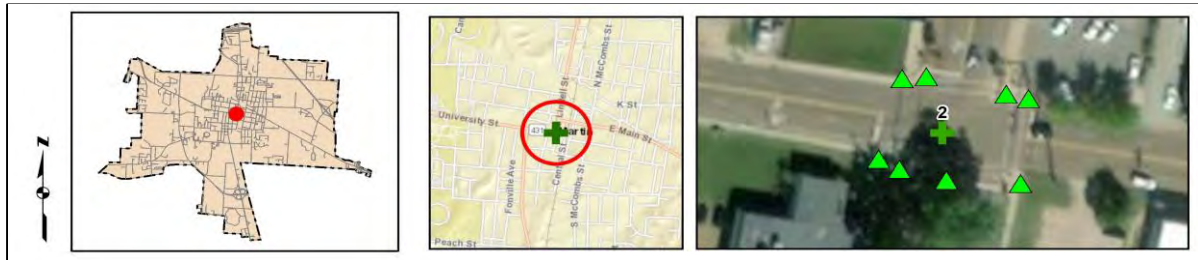
Project Location

Intersection Issues	Crosswalk				Possible Solutions
	N	E	S	W	
Path of travel pavement condition	Good	Poor	Dangerous	Poor	Repave roadway and install crosswalk pavement markings
Path of travel running slope is greater than 5%					
Path of travel cross slope is greater than 5%					
Crosswalk width is less than 6'					
Crosswalk striping condition	Good	Worn	Worn	Good	Remove and replace crosswalk pavement markings

Curb Ramp Issues	Curb Ramp ID ('Z', 'I', or 'CN' in ramp label indicates no existing ramp)								Possible Solutions
	SF	1A	1B	2A	2B	3A	4A	4B	
Curb ramp does not exist and is needed									Remove and replace crosswalk pavement markings
Curb ramp does not land in crosswalk									
No 4' x 4' clear space at base of curb ramp						X			
Curbed side is not 90° or has traversable adjacent surface									Remove and replace curb ramp
Flare cross slope is greater than 10%									
Curb ramp running slope is greater than 8.3%									
Blended transition running slope is greater than 5%									Remove temporary obstruction For intersection, commercial driveway, and park ramps, install color truncated domes
Cut-thru ramp running slope is greater than 5%									
Curb ramp cross slope is greater than 2%									
Cut-thru ramp cross slope is greater than 5%									Remove and replace landing area
Curb ramp width is less than 48"

Cut-thru ramp width is less than 60"									
Permanent obstruction (>0.25') in curb ramp/landing/flares					X				Remove and replace landing area
Temporary obstruction (>0.25') in curb ramp/landing/flares					X		X	X	
No textured surface at base of curb ramp	X								
No color contrast at base of curb ramp	X				X	X	X	X	Remove and replace landing area
Landing area does not exist and is needed									
Landing area is less than 5' x 5' or slopes greater than 2%		X	X	X	X				
Missing or no pedestrian push buttons									Install push button pole and relocate pedestrian push buttons
Pedestrian push button is offset more than 5' from the nearest crosswalk edge									
Pedestrian push button offset more than 10' from curb face					X				
Pedestrian push button is not parallel to crosswalk		X	X						Relocate pedestrian push buttons
Pedestrian push button height is greater than 48"									
Pedestrian push button diameter is not 2"

Pedestrian push button sign does not exist	X								Install pedestrian push button sign
Pedestrian push button sign is not MUTCD approved		X	X	X	X	X	X	X	
Clear floor space does not exist and is needed	X						X	X	
Clear floor space for pedestrian push button is less than 30' x 48' or has a slope greater than 2%		X	X		X	X			Remove and replace clear floor space
Missing or no pedestrian signal heads									
Curb ramp transition onto roadway is greater than 0.25"		X							
Counter slope of the gutter or street at the foot of the curb ramp is greater than 5%					X			X	Fix curb ramp counter slope
Ponding occurs at base of curb ramp		X			X		X	X

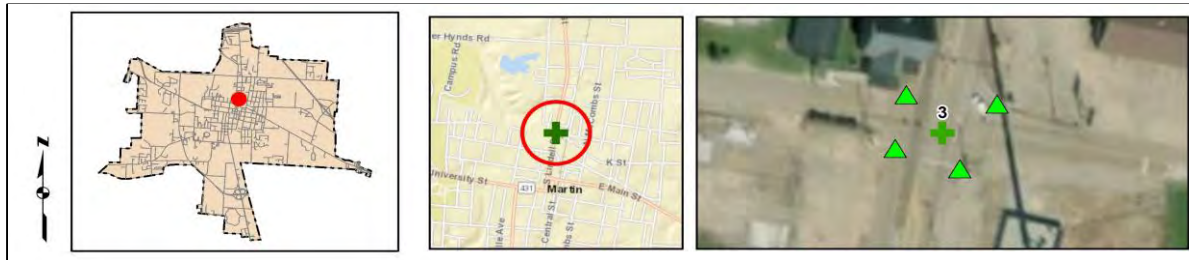
Project Location

Intersection Issues	Crosswalk				Possible Solutions
	N	E	S	W	
Path of travel pavement condition	Good	Good	Good	Good	
Path of travel running slope is greater than 5%					
Path of travel cross slope is greater than 5%					
Crosswalk width is less than 6'					
Crosswalk striping condition	Good	Good	Good	Good

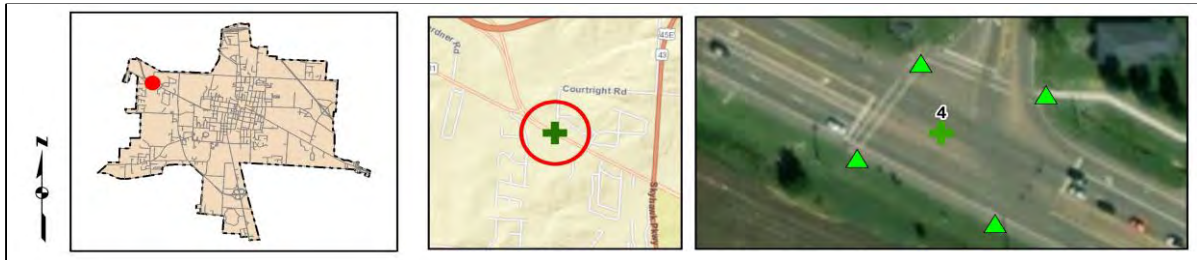
Project Location

Intersection Issues	Crosswalk				Possible Solutions
	N	E	S	W	
Path of travel pavement condition	Poor	N/A	N/A	Poor	Repave roadway and install crosswalk pavement markings
Path of travel running slope is greater than 5%		N/A	N/A		
Path of travel cross slope is greater than 5%		N/A	N/A		
Crosswalk width is less than 6'		N/A	N/A		
Crosswalk striping condition	Worn	N/A	N/A	Worn	Remove and replace crosswalk pavement markings

No color contrast at base of curb ramp	X	X			
Landing area does not exist and is needed					
Landing area is less than 5' x 5' or slopes greater than 2%					
Missing or no pedestrian push buttons					
Pedestrian push button is offset more than 5' from the nearest crosswalk edge	X				Install push button pole and relocate pedestrian push buttons
Pedestrian push button offset more than 10' from curb face					
Pedestrian push button is not parallel to crosswalk					
Pedestrian push button height is greater than 48"					
Pedestrian push button diameter is not 2"					
Pedestrian push button sign does not exist					
Pedestrian push button sign is not MUTCD approved	X	X		X	Remove and replace pedestrian push button sign
Clear floor space does not exist and is needed				X	Install clear floor space
Clear floor space for pedestrian push button is less than 30" x 48" or has a slope greater than 2%					
Missing or no pedestrian signal heads

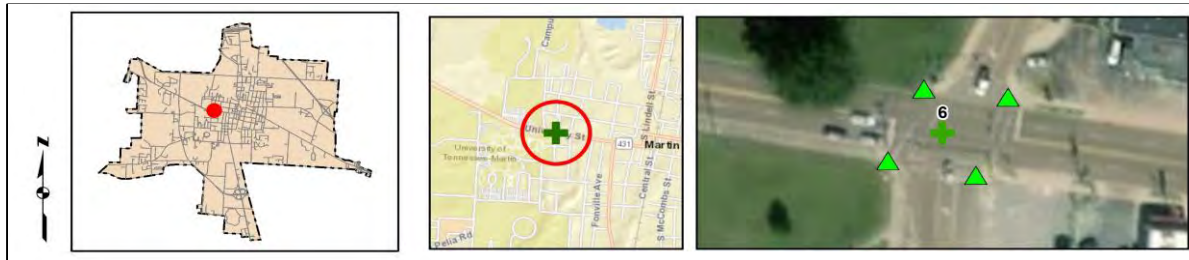
Project Location

Intersection Issues	Crosswalk				Possible Solutions
	N	E	S	W	
Path of travel pavement condition	Poor	Poor	Poor	Dangerous	Repave roadway and install crosswalk pavement markings
Path of travel running slope is greater than 5%					
Path of travel cross slope is greater than 5%					
Crosswalk width is less than 6'					
Crosswalk striping condition	Worn	Worn	Worn	Worn	Remove and replace crosswalk pavement markings

Curb Ramp Issues	Curb Ramp ID ('z', 'i', or 'CN' in ramp label indicates no existing ramp)				Possible Solutions
	1z	2z	3A	4A	
Curb ramp does not exist and is needed	X	X			Install curb ramp; if median improvement, see shapefile
Curb ramp does not land in crosswalk					
No 4' x 4' clear space at base of curb ramp			X	X	Remove and replace crosswalk pavement markings
Curbed side is not 90° or has traversable adjacent surface				X	
Flare cross slope is greater than 10%			X		
Curb ramp running slope is greater than 8.3%			X		
Blended transition running slope is greater than 5%					
Cut-thru ramp running slope is greater than 5%			X		Remove and replace curb ramp
Curb ramp cross slope is greater than 2%					
Cut-thru ramp cross slope is greater than 5%					
Curb ramp width is less than 48"					
Cut-thru ramp width is less than 60"					
Permanent obstruction (>0.25') in curb ramp/landing/flares			X		
Temporary obstruction (>0.25') in curb ramp/landing/flares

No textured surface at base of curb ramp				X	
No color contrast at base of curb ramp				X	For intersection, commercial driveway, and park ramps, install color truncated domes
Landing area does not exist and is needed				X	Install landing area
Landing area is less than 5' x 5' or slopes greater than 2%			X		Remove and replace landing area
Missing or no pedestrian push buttons					
Pedestrian push button is offset more than 5' from the nearest crosswalk edge					Install push button pole and relocate pedestrian push buttons
Pedestrian push button offset more than 10' from curb face			X		
Pedestrian push button is not parallel to crosswalk					
Pedestrian push button height is greater than 48"					
Pedestrian push button diameter is not 2"		X		X	Remove PBs and replace with APS push buttons
Pedestrian push button sign does not exist					
Pedestrian push button sign is not MUTCD approved	X	X	X	X	Remove and replace pedestrian push button sign

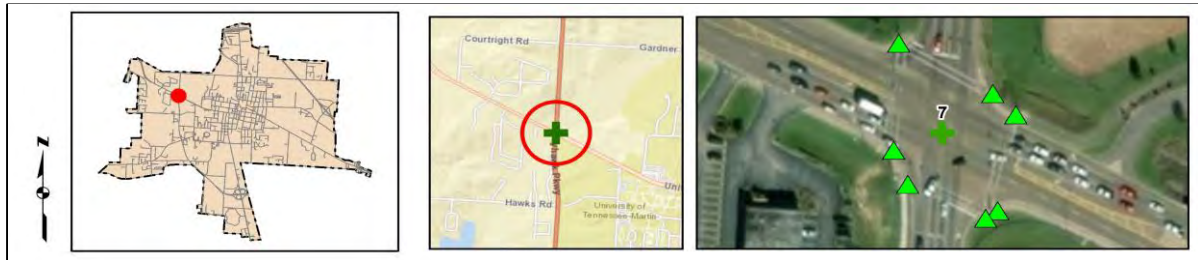
Project Location

Intersection Issues	Crosswalk				Possible Solutions
	N	E	S	W	
Path of travel pavement condition	Good	Poor	Poor	Poor	Repave roadway and install crosswalk pavement markings
Path of travel running slope is greater than 5%					
Path of travel cross slope is greater than 5%					
Crosswalk width is less than 6'					
Crosswalk striping condition	Good	Worn	Worn	Worn	Remove and replace crosswalk pavement markings

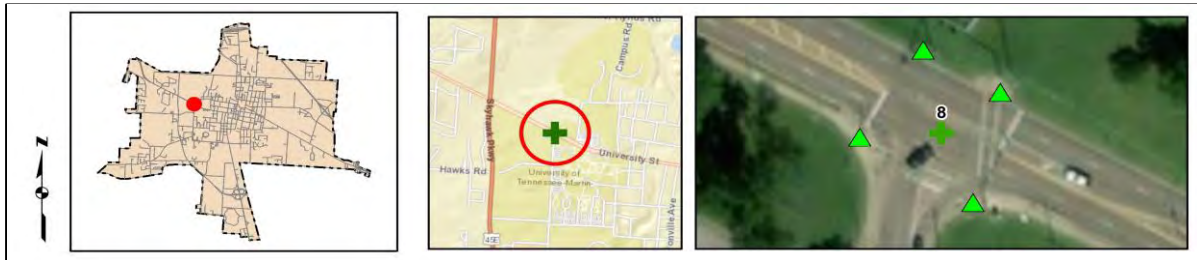
Project Location

Intersection Issues	Crosswalk				Possible Solutions
	N	E	S	W	
Path of travel pavement condition	N/A	Poor	Poor	Poor	Repave roadway and install crosswalk pavement markings
Path of travel running slope is greater than 5%	N/A				
Path of travel cross slope is greater than 5%	N/A				
Crosswalk width is less than 6'	N/A			N/A	
Crosswalk striping condition	N/A	Worn	Worn	None	Remove and replace crosswalk pavement markings

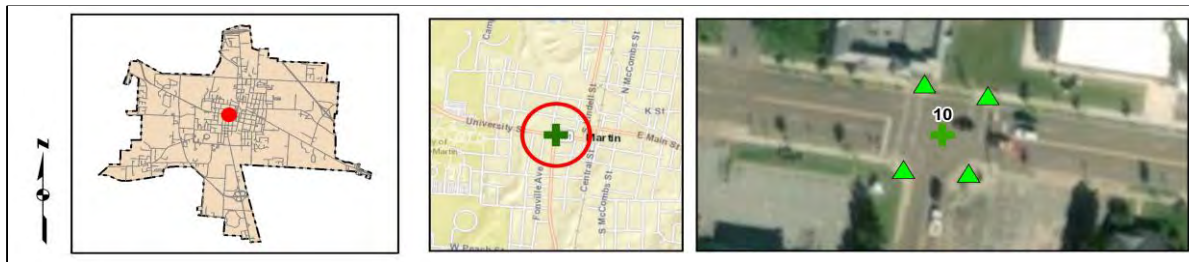
Project Location

Intersection Issues	Crosswalk				Possible Solutions
	N	E	S	W	
Path of travel pavement condition	N/A	Poor	Poor	Poor	Repave roadway and install crosswalk pavement markings
Path of travel running slope is greater than 5%	N/A				
Path of travel cross slope is greater than 5%	N/A				
Crosswalk width is less than 6'	N/A		N/A		
Crosswalk striping condition	N/A	Worn	None	Worn	Remove and replace crosswalk pavement markings

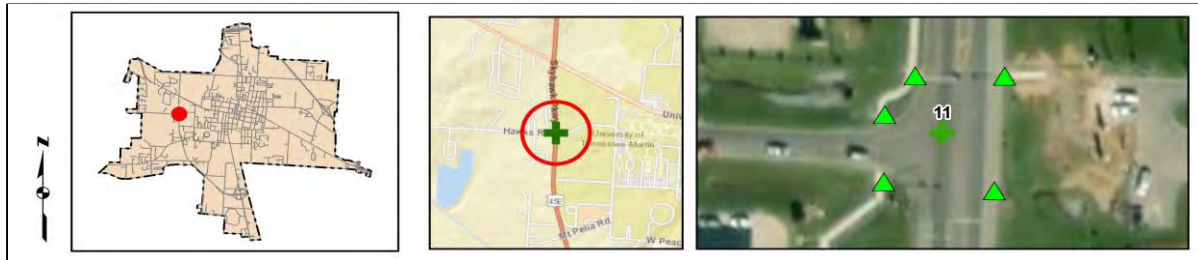
Project Location

Intersection Issues	Crosswalk				Possible Solutions
	N	E	S	W	
Path of travel pavement condition	Good	N/A	N/A	Good	Repave roadway and install crosswalk pavement markings
Path of travel running slope is greater than 5%	X	N/A	N/A		
Path of travel cross slope is greater than 5%		N/A	N/A		
Crosswalk width is less than 6'		N/A	N/A		
Crosswalk striping condition	Good	N/A	N/A	Good

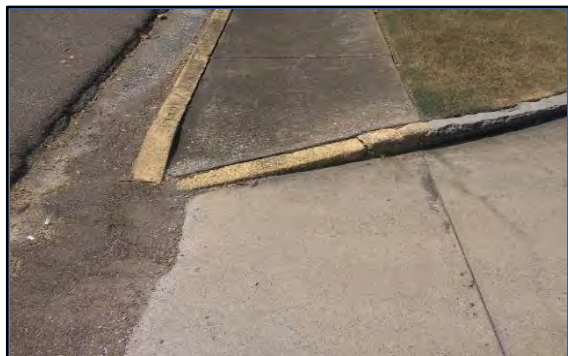
Corner 1 No Ramp (1z)

Curb Ramp Issues	Curb Ramp ID ('z', 'i', or 'CN' in ramp label indicates no existing ramp)	Possible Solutions
	1z 2z	
Curb ramp does not exist and is needed	X X	Install curb ramp; if median improvement, see shapefile
Curb ramp does not land in crosswalk		
No 4' x 4' clear space at base of curb ramp		
Curbed side is not 90° or has traversable adjacent surface		
Flare cross slope is greater than 10%		
Curb ramp running slope is greater than 8.3%		
Blended transition running slope is greater than 5%		
Cut-thru ramp running slope is greater than 5%		
Curb ramp cross slope is greater than 2%		
Cut-thru ramp cross slope is greater than 2%		
Curb ramp width is less than 48"		
Cut-thru ramp width is less than 60"		
Permanent obstruction (>0.25") in curb ramp/landing/flares		
Temporary obstruction (>0.25") in curb ramp/landing/flares		
No textured surface at base of curb ramp		
No color contrast at base of curb ramp

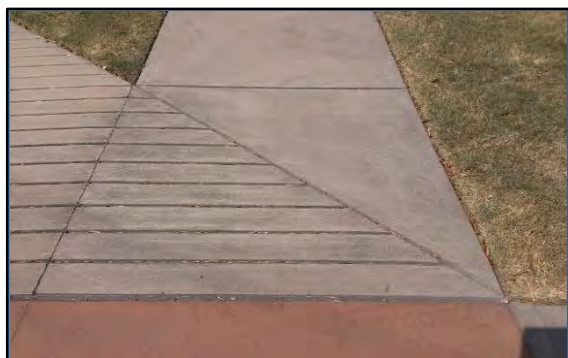
Corner 1 No Ramp (1z)

Curb Ramp Issues	Curb Ramp ID ('z', 'i', or 'CN' in ramp label indicates no existing ramp)	Possible Solutions
	1z 2z	
Curb ramp does not exist and is needed		For intersection, commercial driveway, and park ramps, install color truncated domes
Curb ramp does not land in crosswalk		
No 4' x 4' clear space at base of curb ramp		
Curbed side is not 90° or has traversable adjacent surface		
Flare cross slope is greater than 10%		
Curb ramp running slope is greater than 8.3%		
Blended transition running slope is greater than 5%		
Cut-thru ramp running slope is greater than 5%		
Curb ramp cross slope is greater than 2%		
Cut-thru ramp cross slope is greater than 2%		
Curb ramp width is less than 48"		
Cut-thru ramp width is less than 60"		
Permanent obstruction (>0.25") in curb ramp/landing/flares		
Temporary obstruction (>0.25") in curb ramp/landing/flares		
No textured surface at base of curb ramp	X X	
No color contrast at base of curb ramp	X X

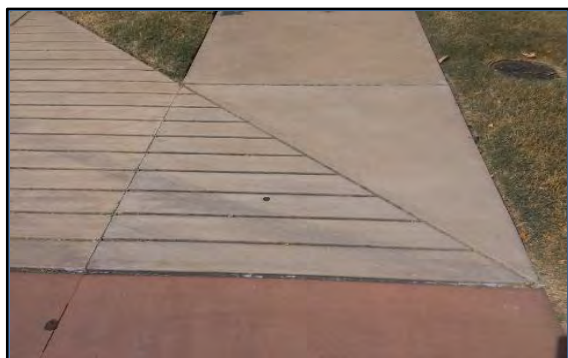
Corner 1 No Ramp (1z)

Curb Ramp Issues	Curb Ramp ID ('z', 'i', or 'CN' in ramp label indicates no existing ramp)		Possible Solutions
	1z	2z	
Curb ramp does not exist and is needed			For intersection, commercial driveway, and park ramps, install color truncated domes
Curb ramp does not land in crosswalk			
No 4' x 4' clear space at base of curb ramp			
Curbed side is not 90° or has traversable adjacent surface			
Flare cross slope is greater than 10%			
Curb ramp running slope is greater than 8.3%			
Blended transition running slope is greater than 5%			
Cut-thru ramp running slope is greater than 5%			
Curb ramp cross slope is greater than 2%			
Cut-thru ramp cross slope is greater than 2%			
Curb ramp width is less than 48"			
Cut-thru ramp width is less than 60"			
Permanent obstruction (>0.25') in curb ramp/landing/flares			
Temporary obstruction (>0.25') in curb ramp/landing/flares			
No textured surface at base of curb ramp	X	X

No color contrast at base of curb ramp	X	X	
Landing area does not exist and is needed			
Landing area is less than 5' x 5' or slopes greater than 2%			
Curb ramp transition onto roadway is greater than 0.25"			
Counter slope of the gutter or street at the foot of the curb ramp is greater than 5%			
Ponding occurs at base of curb ramp

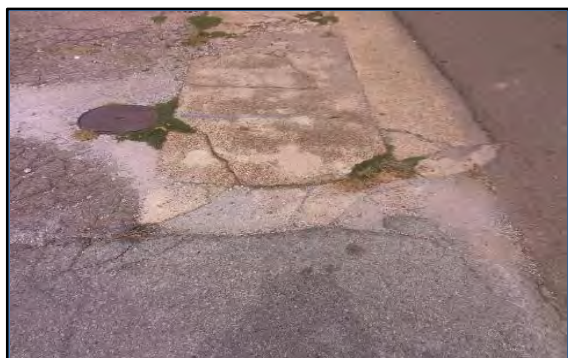
Corner 1 No Ramp (1z)

Curb Ramp Issues	Curb Ramp ID ('z', 'i', or 'CN' in ramp label indicates no existing ramp)		Possible Solutions
	1z	4z	
Curb ramp does not exist and is needed			For intersection, commercial driveway, and park ramps, install color truncated domes
Curb ramp does not land in crosswalk			
No 4' x 4' clear space at base of curb ramp			
Curbed side is not 90° or has traversable adjacent surface			
Flare cross slope is greater than 10%			
Curb ramp running slope is greater than 8.3%			
Blended transition running slope is greater than 5%			
Cut-thru ramp running slope is greater than 5%			
Curb ramp cross slope is greater than 2%			
Cut-thru ramp cross slope is greater than 2%			
Curb ramp width is less than 48"			
Cut-thru ramp width is less than 60"			
Permanent obstruction (>0.25") in curb ramp/landing/flares			
Temporary obstruction (>0.25") in curb ramp/landing/flares			
No textured surface at base of curb ramp	X	X

No color contrast at base of curb ramp	X	X	
Landing area does not exist and is needed			
Landing area is less than 5' x 5' or slopes greater than 2%			
Curb ramp transition onto roadway is greater than 0.25"			
Counter slope of the gutter or street at the foot of the curb ramp is greater than 5%			
Ponding occurs at base of curb ramp

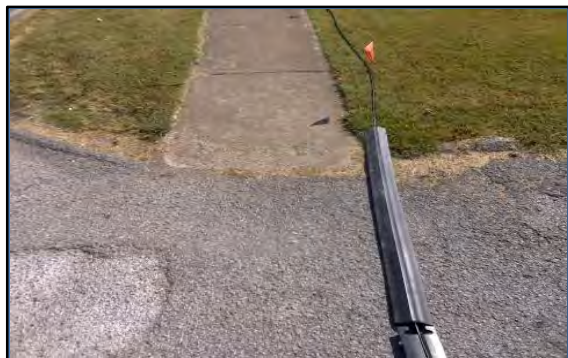
Corner 3 No Ramp (3z)

Curb Ramp Issues	Curb Ramp ID ('z', 'i', or 'CN' in ramp label indicates no existing ramp)		Possible Solutions
	3z	4z	
Curb ramp does not exist and is needed			For intersection, commercial driveway, and park ramps, install color truncated domes
Curb ramp does not land in crosswalk			
No 4' x 4' clear space at base of curb ramp			
Curbed side is not 90° or has traversable adjacent surface			
Flare cross slope is greater than 10%			
Curb ramp running slope is greater than 8.3%			
Blended transition running slope is greater than 5%			
Cut-thru ramp running slope is greater than 5%			
Curb ramp cross slope is greater than 2%			
Cut-thru ramp cross slope is greater than 2%			
Curb ramp width is less than 48"			
Cut-thru ramp width is less than 60"			
Permanent obstruction (>0.25') in curb ramp/landing/flares			
Temporary obstruction (>0.25') in curb ramp/landing/flares			
No textured surface at base of curb ramp	X	X

No color contrast at base of curb ramp	X	X	
Landing area does not exist and is needed			
Landing area is less than 5' x 5' or slopes greater than 2%			
Curb ramp transition onto roadway is greater than 0.25"			
Counter slope of the gutter or street at the foot of the curb ramp is greater than 5%			
Ponding occurs at base of curb ramp

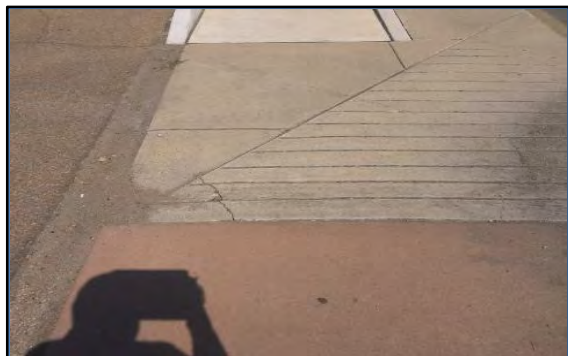
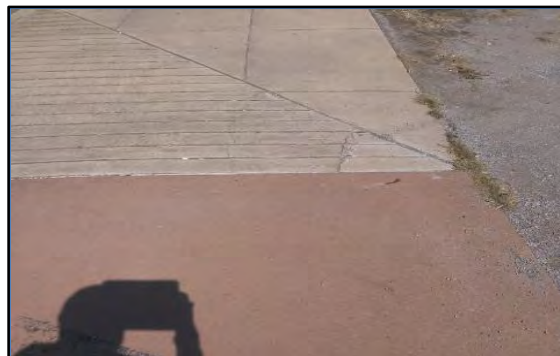
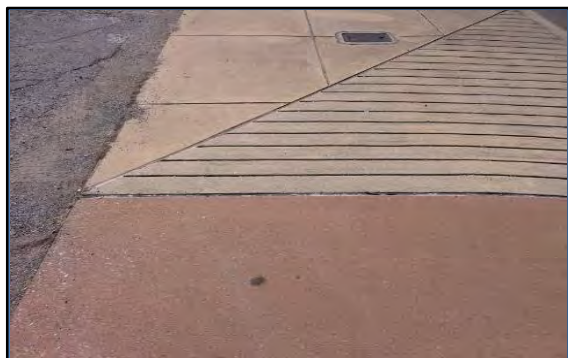
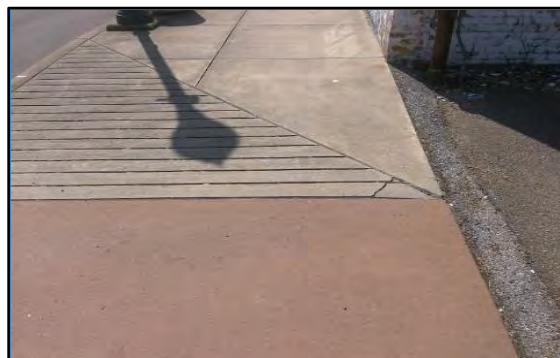
Landing area does not exist and is needed					
Landing area is less than 5' x 5' or slopes greater than 2%					
Curb ramp transition onto roadway is greater than 0.25"					
Counter slope of the gutter or street at the foot of the curb ramp is greater than 5%					
Ponding occurs at base of curb ramp

For intersection, commercial driveway, and park ramps, install color truncated domes

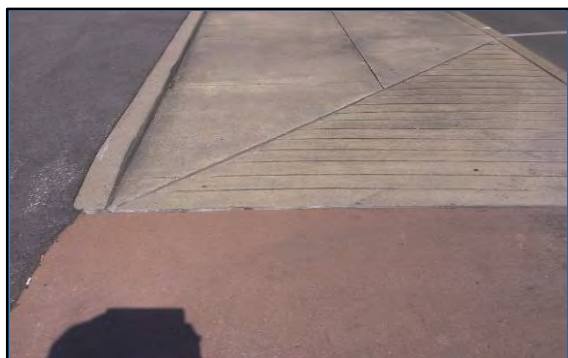
Corner 1 No Ramp (1z)

Curb Ramp Issues	Curb Ramp ID ('z', 'i', or 'CN' in ramp label indicates no existing ramp)				Possible Solutions
	1z	2z	3z	4z	
Curb ramp does not exist and is needed					
Curb ramp does not land in crosswalk					
No 4' x 4' clear space at base of curb ramp					
Curbed side is not 90° or has traversable adjacent surface					
Flare cross slope is greater than 10%					
Curb ramp running slope is greater than 8.3%					
Blended transition running slope is greater than 5%					
Cut-thru ramp running slope is greater than 5%					
Curb ramp cross slope is greater than 2%					
Cut-thru ramp cross slope is greater than 2%					
Curb ramp width is less than 48"					
Cut-thru ramp width is less than 60"					
Permanent obstruction (>0.25") in curb ramp/landing/flares					
Temporary obstruction (>0.25") in curb ramp/landing/flares					
No textured surface at base of curb ramp	X	X	X	X	For intersection, commercial driveway, and park ramps, install color truncated domes

No color contrast at base of curb ramp	X	X	X	X	
Landing area does not exist and is needed					
Landing area is less than 5' x 5' or slopes greater than 2%					
Curb ramp transition onto roadway is greater than 0.25"					
Counter slope of the gutter or street at the foot of the curb ramp is greater than 5%					
Ponding occurs at base of curb ramp

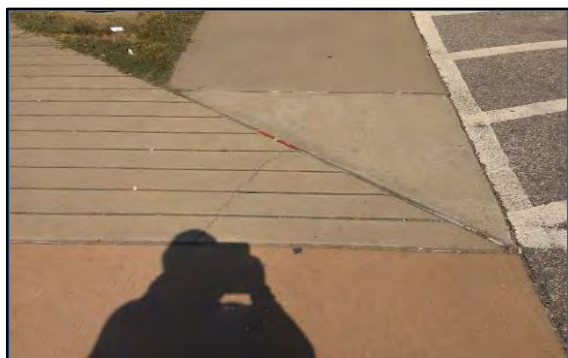
Corner 2 No Ramp (2z)

Curb Ramp Issues	Curb Ramp ID ('z', 'i', or 'CN' in ramp label indicates no existing ramp)		Possible Solutions
	2z	3z	
Curb ramp does not exist and is needed			For intersection, commercial driveway, and park ramps, install color truncated domes
Curb ramp does not land in crosswalk			
No 4' x 4' clear space at base of curb ramp			
Curbed side is not 90° or has traversable adjacent surface			
Flare cross slope is greater than 10%			
Curb ramp running slope is greater than 8.3%			
Blended transition running slope is greater than 5%			
Cut-thru ramp running slope is greater than 5%			
Curb ramp cross slope is greater than 2%			
Cut-thru ramp cross slope is greater than 2%			
Curb ramp width is less than 48"			
Cut-thru ramp width is less than 60"			
Permanent obstruction (>0.25") in curb ramp/landing/flares			
Temporary obstruction (>0.25") in curb ramp/landing/flares			
No textured surface at base of curb ramp	X	X

No color contrast at base of curb ramp	X	X	
Landing area does not exist and is needed			
Landing area is less than 5' x 5' or slopes greater than 2%			
Curb ramp transition onto roadway is greater than 0.25"			
Counter slope of the gutter or street at the foot of the curb ramp is greater than 5%			
Ponding occurs at base of curb ramp

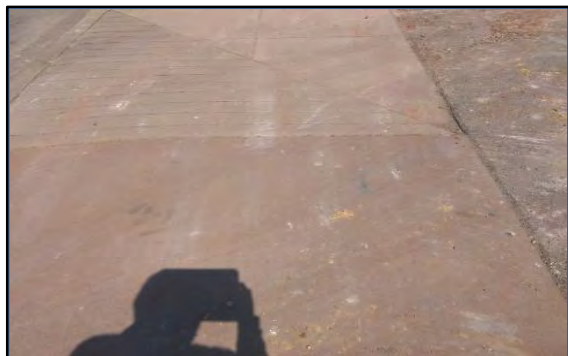
Corner 2 No Ramp (2z)

Curb Ramp Issues	Curb Ramp ID ('z', 'i', or 'CN' in ramp label indicates no existing ramp)		Possible Solutions
	2z	3z	
Curb ramp does not exist and is needed			For intersection, commercial driveway, and park ramps, install color truncated domes
Curb ramp does not land in crosswalk			
No 4' x 4' clear space at base of curb ramp			
Curbed side is not 90° or has traversable adjacent surface			
Flare cross slope is greater than 10%			
Curb ramp running slope is greater than 8.3%			
Blended transition running slope is greater than 5%			
Cut-thru ramp running slope is greater than 5%			
Curb ramp cross slope is greater than 2%			
Cut-thru ramp cross slope is greater than 2%			
Curb ramp width is less than 48"			
Cut-thru ramp width is less than 60"			
Permanent obstruction (>0.25") in curb ramp/landing/flares			
Temporary obstruction (>0.25") in curb ramp/landing/flares			
No textured surface at base of curb ramp	X	X

No color contrast at base of curb ramp	X	X	
Landing area does not exist and is needed			
Landing area is less than 5' x 5' or slopes greater than 2%			
Curb ramp transition onto roadway is greater than 0.25"			
Counter slope of the gutter or street at the foot of the curb ramp is greater than 5%			
Ponding occurs at base of curb ramp

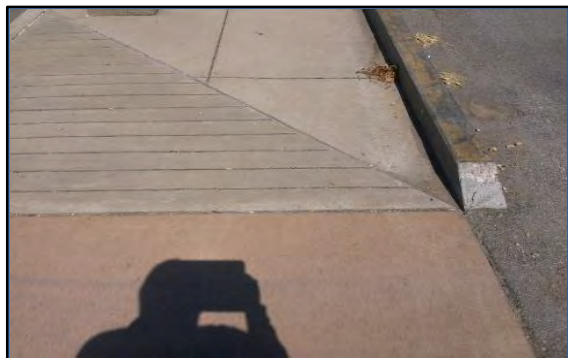
Corner 2 No Ramp (2z)

Curb Ramp Issues	Curb Ramp ID ('z', 'i', or 'CN' in ramp label indicates no existing ramp)		Possible Solutions
	2z	3z	
Curb ramp does not exist and is needed			For intersection, commercial driveway, and park ramps, install color truncated domes
Curb ramp does not land in crosswalk			
No 4' x 4' clear space at base of curb ramp			
Curbed side is not 90° or has traversable adjacent surface			
Flare cross slope is greater than 10%			
Curb ramp running slope is greater than 8.3%			
Blended transition running slope is greater than 5%			
Cut-thru ramp running slope is greater than 5%			
Curb ramp cross slope is greater than 2%			
Cut-thru ramp cross slope is greater than 2%			
Curb ramp width is less than 48"			
Cut-thru ramp width is less than 60"			
Permanent obstruction (>0.25") in curb ramp/landing/flares			
Temporary obstruction (>0.25") in curb ramp/landing/flares			
No textured surface at base of curb ramp	X	X

No color contrast at base of curb ramp	X	X	
Landing area does not exist and is needed			
Landing area is less than 5' x 5' or slopes greater than 2%			
Curb ramp transition onto roadway is greater than 0.25"			
Counter slope of the gutter or street at the foot of the curb ramp is greater than 5%			
Ponding occurs at base of curb ramp

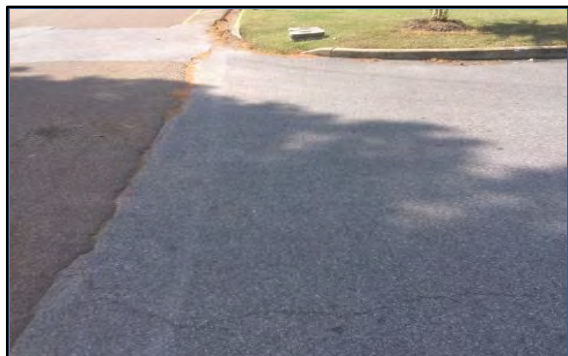
Corner 1 No Ramp (1z)

Curb Ramp Issues	Curb Ramp ID ('z', 'i', or 'CN' in ramp label indicates no existing ramp)	Possible Solutions
Curb ramp does not exist and is needed	1z 2A	Install curb ramp; if median improvement, see shapefile
Curb ramp does not land in crosswalk		
No 4' x 4' clear space at base of curb ramp		
Curbed side is not 90° or has traversable adjacent surface		
Flare cross slope is greater than 10%		
Curb ramp running slope is greater than 8.3%	X	
Blended transition running slope is greater than 5%		
Cut-thru ramp running slope is greater than 5%		
Curb ramp cross slope is greater than 2%	X	Remove and replace curb ramp
Cut-thru ramp cross slope is greater than 2%		
Curb ramp width is less than 48"		
Cut-thru ramp width is less than 60"		
Permanent obstruction (>0.25") in curb ramp/landing/flares	X	
Temporary obstruction (>0.25") in curb ramp/landing/flares		
No textured surface at base of curb ramp	X	
No color contrast at base of curb ramp	X	For intersection, commercial driveway, and park ramps, install color truncated domes

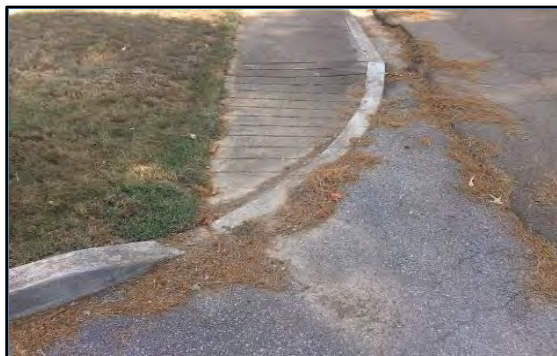
Ramp 2A

Landing area does not exist and is needed		
Landing area is less than 5' x 5' or slopes greater than 2%	X	Remove and replace landing area
Curb ramp transition onto roadway is greater than 0.25"	X	Fix curb ramp transition
Counter slope of the gutter or street at the foot of the curb ramp is greater than 5%	X	Fix curb ramp counter slope
Ponding occurs at base of curb ramp	X	Fix ponding

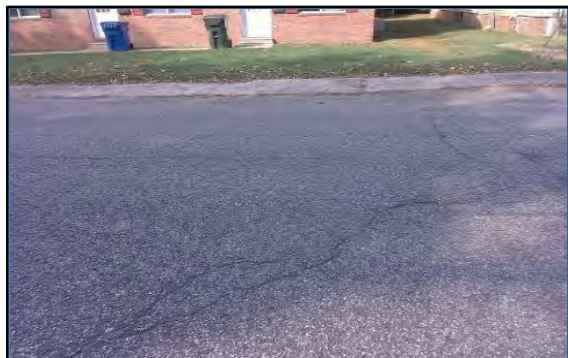
Corner 1 No Ramp (1z)

Curb Ramp Issues	Curb Ramp ID ('z', 'i', or 'CN' in ramp label indicates no existing ramp)				Possible Solutions
	1z	2z	3z	4z	
Curb ramp does not exist and is needed	X				Install curb ramp; if median improvement, see shapefile
Curb ramp does not land in crosswalk					
No 4' x 4' clear space at base of curb ramp					
Curbed side is not 90° or has traversable adjacent surface					
Flare cross slope is greater than 10%					
Curb ramp running slope is greater than 8.3%					
Blended transition running slope is greater than 5%					
Cut-thru ramp running slope is greater than 5%					
Curb ramp cross slope is greater than 2%					
Cut-thru ramp cross slope is greater than 2%					
Curb ramp width is less than 48"					
Cut-thru ramp width is less than 60"					
Permanent obstruction (>0.25") in curb ramp/landing/flares					
Temporary obstruction (>0.25") in curb ramp/landing/flares					
No textured surface at base of curb ramp			X	X

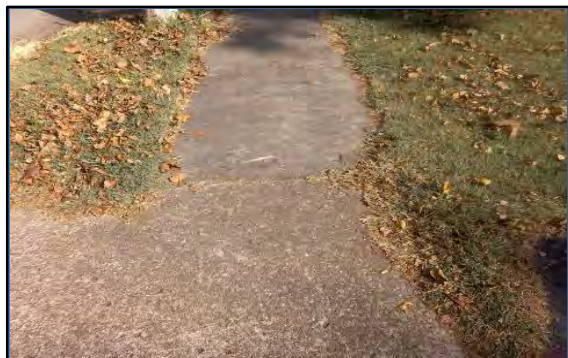
Corner 3 No Ramp (3z)

Curb Ramp Issues	Curb Ramp ID ('z', 'i', or 'CN' in ramp label indicates no existing ramp)		Possible Solutions
	3z	4z	
Curb ramp does not exist and is needed			For intersection, commercial driveway, and park ramps, install color truncated domes
Curb ramp does not land in crosswalk			
No 4' x 4' clear space at base of curb ramp			
Curbed side is not 90° or has traversable adjacent surface			
Flare cross slope is greater than 10%			
Curb ramp running slope is greater than 8.3%			
Blended transition running slope is greater than 5%			
Cut-thru ramp running slope is greater than 5%			
Curb ramp cross slope is greater than 2%			
Cut-thru ramp cross slope is greater than 2%			
Curb ramp width is less than 48"			
Cut-thru ramp width is less than 60"			
Permanent obstruction (>0.25") in curb ramp/landing/flares			
Temporary obstruction (>0.25") in curb ramp/landing/flares			
No textured surface at base of curb ramp	X	X

No color contrast at base of curb ramp	X	X	
Landing area does not exist and is needed			
Landing area is less than 5' x 5' or slopes greater than 2%			
Curb ramp transition onto roadway is greater than 0.25"			
Counter slope of the gutter or street at the foot of the curb ramp is greater than 5%			
Ponding occurs at base of curb ramp

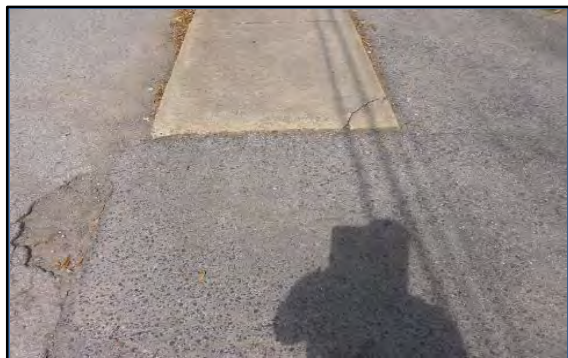
Corner 2 No Ramp (2z)

Curb Ramp Issues	Curb Ramp ID ('z', 'i', or 'CN' in ramp label indicates no existing ramp)		Possible Solutions
	2z	3z	
Curb ramp does not exist and is needed			For intersection, commercial driveway, and park ramps, install color truncated domes
Curb ramp does not land in crosswalk			
No 4' x 4' clear space at base of curb ramp			
Curbed side is not 90° or has traversable adjacent surface			
Flare cross slope is greater than 10%			
Curb ramp running slope is greater than 8.3%			
Blended transition running slope is greater than 5%			
Cut-thru ramp running slope is greater than 5%			
Curb ramp cross slope is greater than 2%			
Cut-thru ramp cross slope is greater than 2%			
Curb ramp width is less than 48"			
Cut-thru ramp width is less than 60"			
Permanent obstruction (>0.25") in curb ramp/landing/flares			
Temporary obstruction (>0.25") in curb ramp/landing/flares			
No textured surface at base of curb ramp	X	X

No color contrast at base of curb ramp	X	X	
Landing area does not exist and is needed			
Landing area is less than 5' x 5' or slopes greater than 2%			
Curb ramp transition onto roadway is greater than 0.25"			
Counter slope of the gutter or street at the foot of the curb ramp is greater than 5%			
Ponding occurs at base of curb ramp

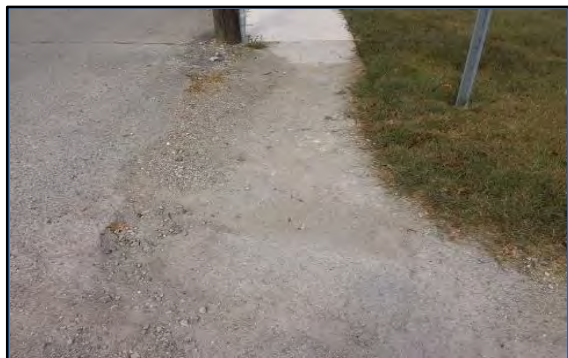
Corner 2 No Ramp (2z)

Curb Ramp Issues	Curb Ramp ID ('z', 'i', or 'CN' in ramp label indicates no existing ramp)		Possible Solutions
	2z	3z	
Curb ramp does not exist and is needed			For intersection, commercial driveway, and park ramps, install color truncated domes
Curb ramp does not land in crosswalk			
No 4' x 4' clear space at base of curb ramp			
Curbed side is not 90° or has traversable adjacent surface			
Flare cross slope is greater than 10%			
Curb ramp running slope is greater than 8.3%			
Blended transition running slope is greater than 5%			
Cut-thru ramp running slope is greater than 5%			
Curb ramp cross slope is greater than 2%			
Cut-thru ramp cross slope is greater than 2%			
Curb ramp width is less than 48"			
Cut-thru ramp width is less than 60"			
Permanent obstruction (>0.25") in curb ramp/landing/flares			
Temporary obstruction (>0.25") in curb ramp/landing/flares			
No textured surface at base of curb ramp	X	X

No color contrast at base of curb ramp	X	X	
Landing area does not exist and is needed			
Landing area is less than 5' x 5' or slopes greater than 2%			
Curb ramp transition onto roadway is greater than 0.25"			
Counter slope of the gutter or street at the foot of the curb ramp is greater than 5%			
Ponding occurs at base of curb ramp

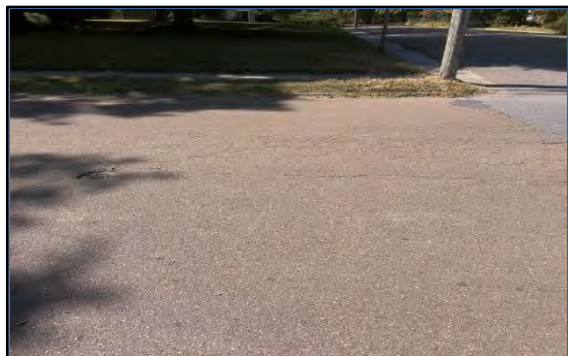
Corner 1 No Ramp (1z)

Curb Ramp Issues	Curb Ramp ID ('z', 'i', or 'CN' in ramp label indicates no existing ramp)				Possible Solutions
	1z	2A	3z	4z	
Curb ramp does not exist and is needed			X		Install curb ramp; if median improvement, see shapefile
Curb ramp does not land in crosswalk					
No 4' x 4' clear space at base of curb ramp					Remove and replace curb ramp
Curbed side is not 90° or has traversable adjacent surface					
Flare cross slope is greater than 10%					
Curb ramp running slope is greater than 8.3%		X			
Blended transition running slope is greater than 5%					
Cut-thru ramp running slope is greater than 5%					
Curb ramp cross slope is greater than 2%		X			
Cut-thru ramp cross slope is greater than 2%					
Curb ramp width is less than 48"					
Cut-thru ramp width is less than 60"					
Permanent obstruction (>0.25") in curb ramp/landing/flares		X			For intersection, commercial driveway, and park ramps, install color truncated domes

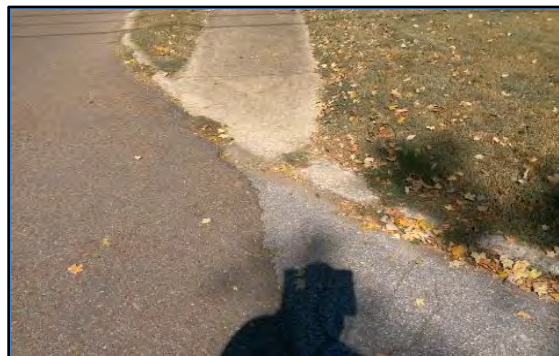
Ramp 2A

Temporary obstruction (>0.25") in curb ramp/landing/flares		X			
No textured surface at base of curb ramp		X			Remove and replace landing area
No color contrast at base of curb ramp		X			
Landing area does not exist and is needed					Fix curb ramp transition
Landing area is less than 5' x 5' or slopes greater than 2%		X			
Curb ramp transition onto roadway is greater than 0.25"		X			Fix ponding
Counter slope of the gutter or street at the foot of the curb ramp is greater than 5%					
Ponding occurs at base of curb ramp		X

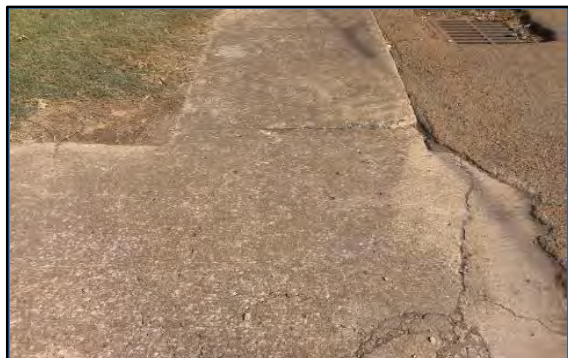
Corner 2 No Ramp (2z)

Curb ramp transition onto roadway is greater than 0.25"		
Counter slope of the gutter or street at the foot of the curb ramp is greater than 5%		
Ponding occurs at base of curb ramp

For intersection, commercial driveway, and park ramps, install color truncated domes

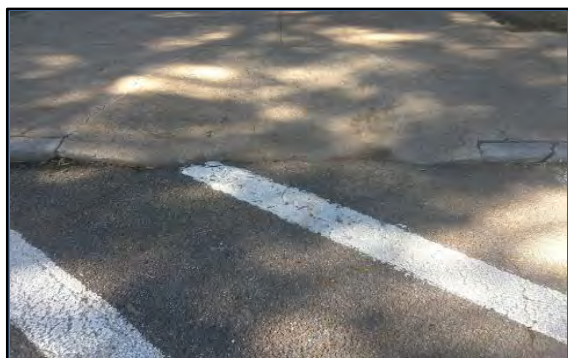
Ramp 1A

Curb Ramp Issues	Curb Ramp ID ('z', 'i', or 'CN' in ramp label indicates no existing ramp)		Possible Solutions
	1A	2z	
Curb ramp does not exist and is needed			
Curb ramp does not land in crosswalk			
No 4' x 4' clear space at base of curb ramp			
Curbed side is not 90° or has traversable adjacent surface			
Flare cross slope is greater than 10%	X		
Curb ramp running slope is greater than 8.3%			
Blended transition running slope is greater than 5%			
Cut-thru ramp running slope is greater than 5%			
Curb ramp cross slope is greater than 2%	X		Remove and replace curb ramp
Cut-thru ramp cross slope is greater than 2%			
Curb ramp width is less than 48"			
Cut-thru ramp width is less than 60"			
Permanent obstruction (>0.25") in curb ramp/landing/flares	X		
Temporary obstruction (>0.25") in curb ramp/landing/flares			
No textured surface at base of curb ramp	X	X	For intersection, commercial driveway, and park ramps, install color truncated domes

No color contrast at base of curb ramp	X	X	
Landing area does not exist and is needed			
Landing area is less than 5' x 5' or slopes greater than 2%	X		Remove and replace landing area
Curb ramp transition onto roadway is greater than 0.25"	X		Fix curb ramp transition
Counter slope of the gutter or street at the foot of the curb ramp is greater than 5%	X		Fix curb ramp counter slope
Ponding occurs at base of curb ramp	X		Fix ponding

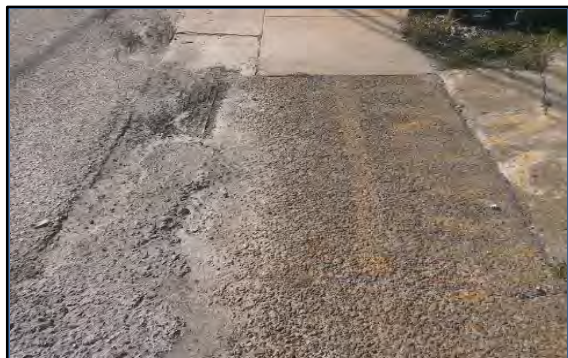
Corner 1 No Ramp (1z)

Landing area is less than 5' x 5' or slopes greater than 2%		
Curb ramp transition onto roadway is greater than 0.25"		
Counter slope of the gutter or street at the foot of the curb ramp is greater than 5%		
Ponding occurs at base of curb ramp

For intersection, commercial driveway, and park ramps, install color truncated domes

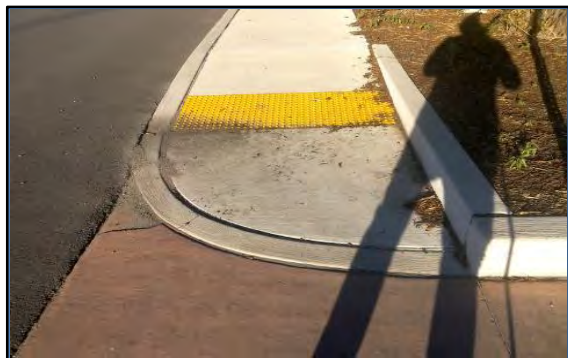
Ramp 1A

Curb Ramp Issues	Curb Ramp ID ('z', 'v', or 'CN' in ramp label indicates no existing ramp)		Possible Solutions
	1A	2A	
Curb ramp does not exist and is needed			Remove and replace curb ramp
Curb ramp does not land in crosswalk			
No 4' x 4' clear space at base of curb ramp			
Curbed side is not 90° or has traversable adjacent surface			
Flare cross slope is greater than 10%			
Curb ramp running slope is greater than 8.3%			
Blended transition running slope is greater than 5%			
Cut-thru ramp running slope is greater than 5%			
Curb ramp cross slope is greater than 2%	X		
Cut-thru ramp cross slope is greater than 2%			
Curb ramp width is less than 48"			
Cut-thru ramp width is less than 60"			
Permanent obstruction (>0.25") in curb ramp/landing/flares			
Temporary obstruction (>0.25") in curb ramp/landing/flares			
No textured surface at base of curb ramp			
No color contrast at base of curb ramp			Fix ponding

Landing area does not exist and is needed			
Landing area is less than 5' x 5' or slopes greater than 2%			
Curb ramp transition onto roadway is greater than 0.25"			
Counter slope of the gutter or street at the foot of the curb ramp is greater than 5%			
Ponding occurs at base of curb ramp	X	X

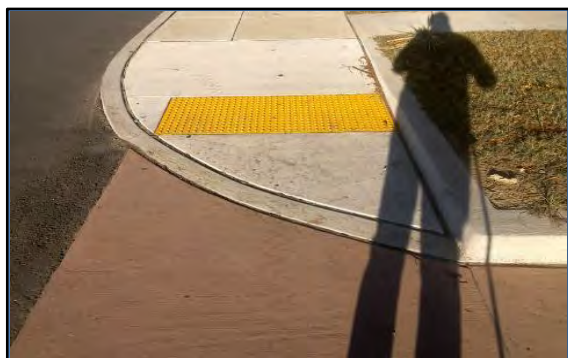
Ramp 1A

Curb Ramp Issues	Curb Ramp ID ('z', 'v', or 'CN' in ramp label indicates no existing ramp)	Possible Solutions
	1A 2A	
Curb ramp does not exist and is needed		
Curb ramp does not land in crosswalk		
No 4' x 4' clear space at base of curb ramp		
Curbed side is not 90° or has traversable adjacent surface		
Flare cross slope is greater than 10%		
Curb ramp running slope is greater than 8.3%		
Blended transition running slope is greater than 5%		
Cut-thru ramp running slope is greater than 5%		
Curb ramp cross slope is greater than 2%		
Cut-thru ramp cross slope is greater than 2%		
Curb ramp width is less than 48"		
Cut-thru ramp width is less than 60"		
Permanent obstruction (>0.25") in curb ramp/landing/flares		
Temporary obstruction (>0.25") in curb ramp/landing/flares		
No textured surface at base of curb ramp		
No color contrast at base of curb ramp		
Landing area does not exist and is needed		
Landing area is less than 5' x 5' or slopes greater than 2%

Curb ramp transition onto roadway is greater than 0.25"		
Counter slope of the gutter or street at the foot of the curb ramp is greater than 5%		
Ponding occurs at base of curb ramp	X X	Fix ponding

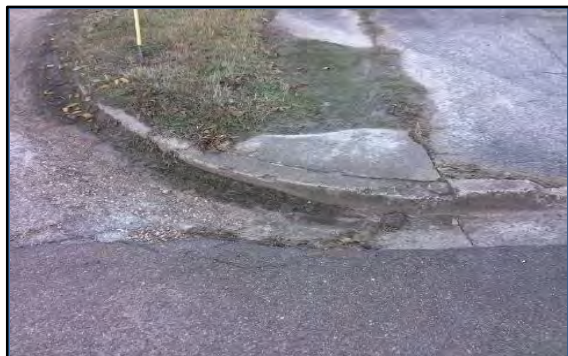
Corner 1 No Ramp (1z)

Curb Ramp Issues	Curb Ramp ID ('z', 'i', or 'CN' in ramp label indicates no existing ramp)				Possible Solutions
	1z	2z	3z	4z	
Curb ramp does not exist and is needed	X	X			Install curb ramp; if median improvement, see shapefile
Curb ramp does not land in crosswalk					
No 4' x 4' clear space at base of curb ramp					
Curbed side is not 90° or has traversable adjacent surface					
Flare cross slope is greater than 10%					
Curb ramp running slope is greater than 8.3%					
Blended transition running slope is greater than 5%					
Cut-thru ramp running slope is greater than 5%					
Curb ramp cross slope is greater than 2%					
Cut-thru ramp cross slope is greater than 2%					
Curb ramp width is less than 48"					
Cut-thru ramp width is less than 60"					
Permanent obstruction (>0.25') in curb ramp/landing/flares					
Temporary obstruction (>0.25') in curb ramp/landing/flares					
No textured surface at base of curb ramp

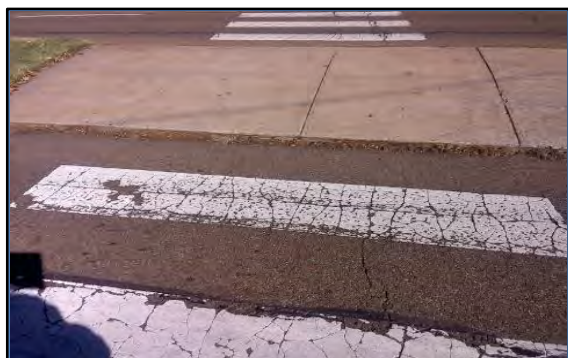
East Median No Ramp (Ez)

Curb Ramp Issues	Curb Ramp ID ('z', 'i', or 'CN' in ramp label indicates no existing ramp)			Possible Solutions
	Ez	2z	3z	
Curb ramp does not exist and is needed	X	X	X	Install curb ramp; if median improvement, see shapefile
Curb ramp does not land in crosswalk				
No 4' x 4' clear space at base of curb ramp				
Curbed side is not 90° or has traversable adjacent surface				
Flare cross slope is greater than 10%				
Curb ramp running slope is greater than 8.3%				
Blended transition running slope is greater than 5%				
Cut-thru ramp running slope is greater than 5%				
Curb ramp cross slope is greater than 2%				
Cut-thru ramp cross slope is greater than 2%				
Curb ramp width is less than 48"				
Cut-thru ramp width is less than 60"				
Permanent obstruction (>0.25') in curb ramp/landing/flares				
Temporary obstruction (>0.25') in curb ramp/landing/flares				
No textured surface at base of curb ramp				
No color contrast at base of curb ramp

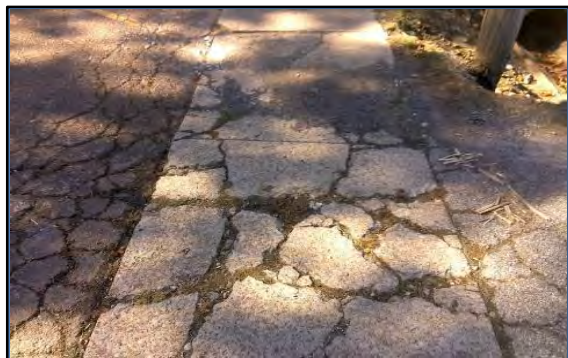
Corner 1 No Ramp (1z)

Curb Ramp Issues	Curb Ramp ID ('z', 'i', or 'CN' in ramp label indicates no existing ramp)		Possible Solutions
	1z	2z	
Curb ramp does not exist and is needed			For intersection, commercial driveway, and park ramps, install color truncated domes
Curb ramp does not land in crosswalk			
No 4' x 4' clear space at base of curb ramp			
Curbed side is not 90° or has traversable adjacent surface			
Flare cross slope is greater than 10%			
Curb ramp running slope is greater than 8.3%			
Blended transition running slope is greater than 5%			
Cut-thru ramp running slope is greater than 5%			
Curb ramp cross slope is greater than 2%			
Cut-thru ramp cross slope is greater than 2%			
Curb ramp width is less than 48"			
Cut-thru ramp width is less than 60"			
Permanent obstruction (>0.25") in curb ramp/landing/flares			
Temporary obstruction (>0.25") in curb ramp/landing/flares			
No textured surface at base of curb ramp	X	X

No color contrast at base of curb ramp	X	X	
Landing area does not exist and is needed			
Landing area is less than 5' x 5' or slopes greater than 2%			
Curb ramp transition onto roadway is greater than 0.25"			
Counter slope of the gutter or street at the foot of the curb ramp is greater than 5%			
Ponding occurs at base of curb ramp

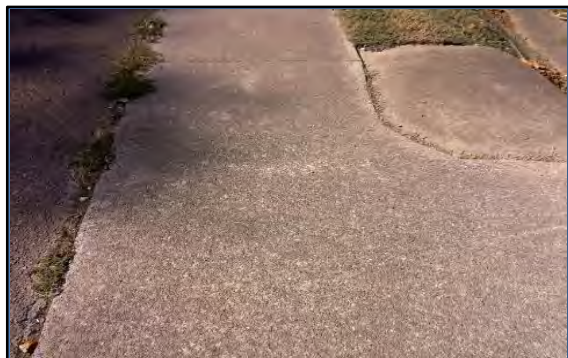
Corner 1 No Ramp (1z)

Curb Ramp Issues	Curb Ramp ID ('z', 'i', or 'CN' in ramp label indicates no existing ramp)	Possible Solutions
	1z 2z	
Curb ramp does not exist and is needed		For intersection, commercial driveway, and park ramps, install color truncated domes
Curb ramp does not land in crosswalk		
No 4' x 4' clear space at base of curb ramp		
Curbed side is not 90° or has traversable adjacent surface		
Flare cross slope is greater than 10%		
Curb ramp running slope is greater than 8.3%		
Blended transition running slope is greater than 5%		
Cut-thru ramp running slope is greater than 5%		
Curb ramp cross slope is greater than 2%		
Cut-thru ramp cross slope is greater than 2%		
Curb ramp width is less than 48"		
Cut-thru ramp width is less than 60"		
Permanent obstruction (>0.25') in curb ramp/landing/flares		
Temporary obstruction (>0.25') in curb ramp/landing/flares		
No textured surface at base of curb ramp	X X	
No color contrast at base of curb ramp	X X

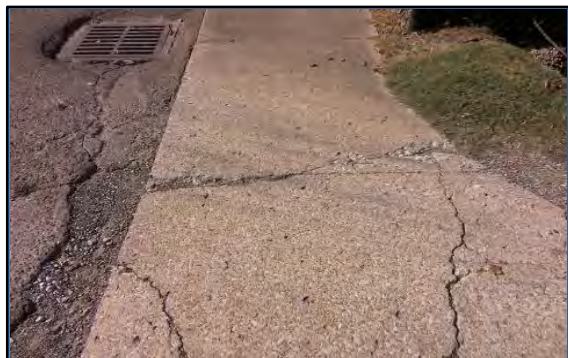
Corner 1 No Ramp (1z)

Curb ramp transition onto roadway is greater than 0.25"		
Counter slope of the gutter or street at the foot of the curb ramp is greater than 5%		
Ponding occurs at base of curb ramp

For intersection, commercial driveway, and park ramps, install color truncated domes

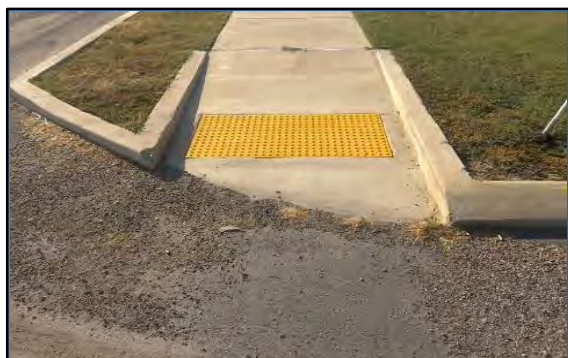
Ramp 1A

Curb Ramp Issues	Curb Ramp ID ('z', 'i', or 'CN' in ramp label indicates no existing ramp)	Possible Solutions
	1A 2A	
Curb ramp does not exist and is needed		
Curb ramp does not land in crosswalk		
No 4' x 4' clear space at base of curb ramp		
Curbed side is not 90° or has traversable adjacent surface		
Flare cross slope is greater than 10%		
Curb ramp running slope is greater than 8.3%		
Blended transition running slope is greater than 5%		
Cut-thru ramp running slope is greater than 5%		
Curb ramp cross slope is greater than 2%		
Cut-thru ramp cross slope is greater than 2%		
Curb ramp width is less than 48"		
Cut-thru ramp width is less than 60"		
Permanent obstruction (>0.25") in curb ramp/landing/flares		
Temporary obstruction (>0.25") in curb ramp/landing/flares		
No textured surface at base of curb ramp		
No color contrast at base of curb ramp		
Landing area does not exist and is needed		
Landing area is less than 5' x 5' or slopes greater than 2%

Curb ramp transition onto roadway is greater than 0.25"		
Counter slope of the gutter or street at the foot of the curb ramp is greater than 5%		
Ponding occurs at base of curb ramp	X	Fix ponding

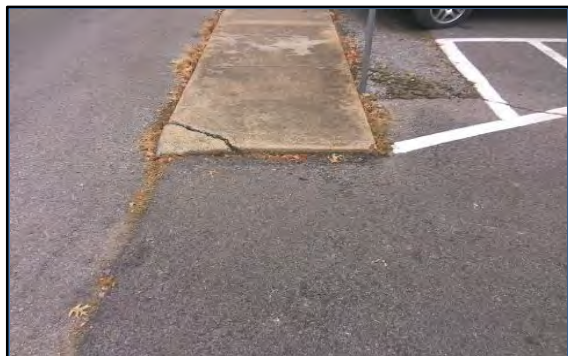
Curb Ramp Issues	Curb Ramp ID ('z', 'i', or 'CN' in ramp label indicates no existing ramp)		Possible Solutions
	2z	3z	
Curb ramp does not exist and is needed			For intersection, commercial driveway, and park ramps, install color truncated domes
Curb ramp does not land in crosswalk			
No 4' x 4' clear space at base of curb ramp			
Curbed side is not 90° or has traversable adjacent surface			
Flare cross slope is greater than 10%			
Curb ramp running slope is greater than 8.3%			
Blended transition running slope is greater than 5%			
Cut-thru ramp running slope is greater than 5%			
Curb ramp cross slope is greater than 2%			
Cut-thru ramp cross slope is greater than 2%			
Curb ramp width is less than 48"			
Cut-thru ramp width is less than 60"			
Permanent obstruction (>0.25") in curb ramp/landing/flares			
Temporary obstruction (>0.25") in curb ramp/landing/flares			
No textured surface at base of curb ramp	X	X

No color contrast at base of curb ramp	X	X	
Landing area does not exist and is needed			
Landing area is less than 5' x 5' or slopes greater than 2%			
Curb ramp transition onto roadway is greater than 0.25"			
Counter slope of the gutter or street at the foot of the curb ramp is greater than 5%			
Ponding occurs at base of curb ramp

Corner 2 No Ramp (2z)

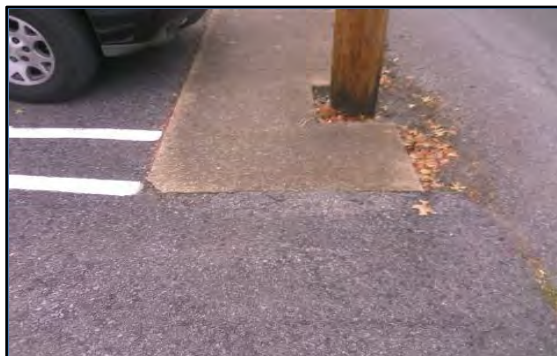
Corner 3 No Ramp (3z)

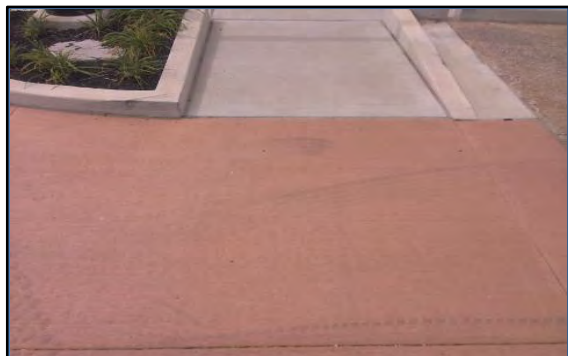
Corner 1 No Ramp (1z)

For intersection, commercial driveway, and park ramps, install color truncated domes

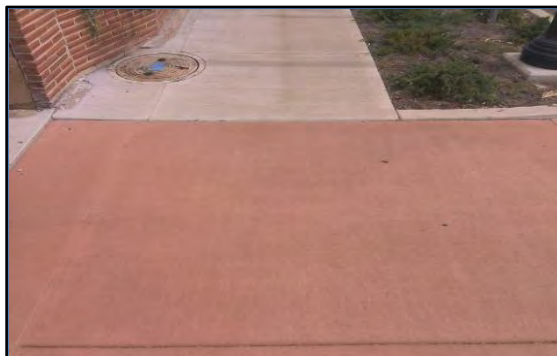
Corner 2 No Ramp (2z)

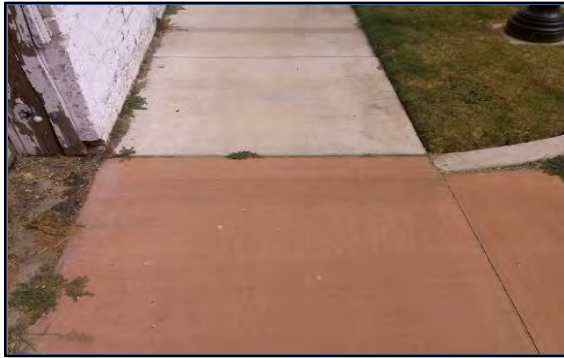
Corner 2 No Ramp (2z)

For intersection, commercial driveway, and park ramps, install color truncated domes

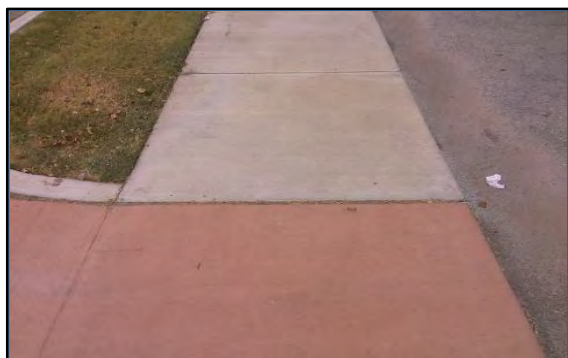
Curb Ramp Issues	Curb Ramp ID ('z', 'i', or 'CN' in ramp label indicates no existing ramp)		Possible Solutions
	1z	2z	
Curb ramp does not exist and is needed			
Curb ramp does not land in crosswalk			
No 4' x 4' clear space at base of curb ramp			
Curbed side is not 90° or has traversable adjacent surface			
Flare cross slope is greater than 10%			
Curb ramp running slope is greater than 8.3%			
Blended transition running slope is greater than 5%			
Cut-thru ramp running slope is greater than 5%			
Curb ramp cross slope is greater than 2%			
Cut-thru ramp cross slope is greater than 2%			
Curb ramp width is less than 48"			
Cut-thru ramp width is less than 60"			
Permanent obstruction (>0.25') in curb ramp/landing/flares			
Temporary obstruction (>0.25') in curb ramp/landing/flares			
No textured surface at base of curb ramp	X	X	For intersection, commercial driveway, and park ramps, install color truncated domes

No color contrast at base of curb ramp	X	X	
Landing area does not exist and is needed			
Landing area is less than 5' x 5' or slopes greater than 2%			
Curb ramp transition onto roadway is greater than 0.25"			
Counter slope of the gutter or street at the foot of the curb ramp is greater than 5%			
Ponding occurs at base of curb ramp

Corner 1 No Ramp (1z)

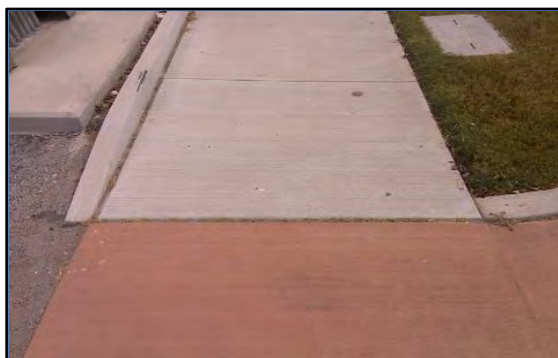
Corner 2 No Ramp (2z)
