ADA Self-Evaluation and Transition Plan

January 2020

Opera House
RESTAURANT

Prepared by:

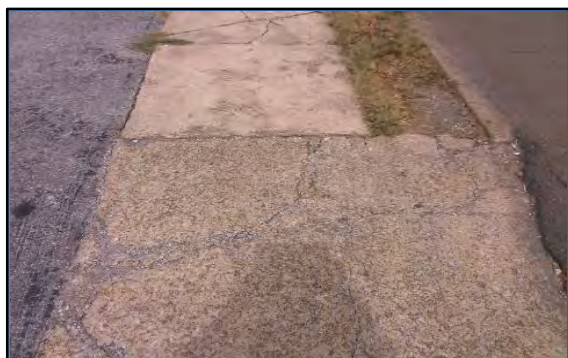
Curb Ramp Issues	Curb Ramp ID ('z', 'i', or 'CN' in ramp label indicates no existing ramp)		Possible Solutions
	1z	4z	
Curb ramp does not exist and is needed			For intersection, commercial driveway, and park ramps, install color truncated domes
Curb ramp does not land in crosswalk			
No 4' x 4' clear space at base of curb ramp			
Curbed side is not 90° or has traversable adjacent surface			
Flare cross slope is greater than 10%			
Curb ramp running slope is greater than 8.3%			
Blended transition running slope is greater than 5%			
Cut-thru ramp running slope is greater than 5%			
Curb ramp cross slope is greater than 2%			
Cut-thru ramp cross slope is greater than 2%			
Curb ramp width is less than 48"			
Cut-thru ramp width is less than 60"			
Permanent obstruction (>0.25") in curb ramp/landing/flares			
Temporary obstruction (>0.25") in curb ramp/landing/flares			
No textured surface at base of curb ramp	X	X

No color contrast at base of curb ramp	X	X	
Landing area does not exist and is needed			
Landing area is less than 5' x 5' or slopes greater than 2%			
Curb ramp transition onto roadway is greater than 0.25"			
Counter slope of the gutter or street at the foot of the curb ramp is greater than 5%			
Ponding occurs at base of curb ramp

Corner 1 No Ramp (1z)

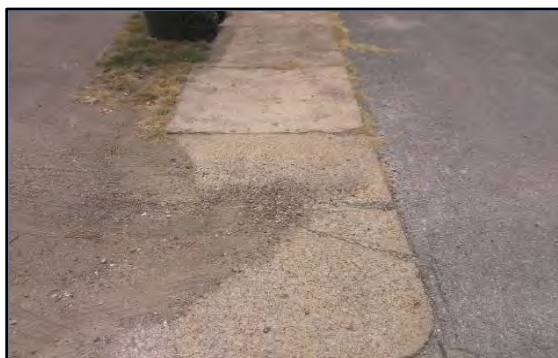
Corner 4 No Ramp (4z)

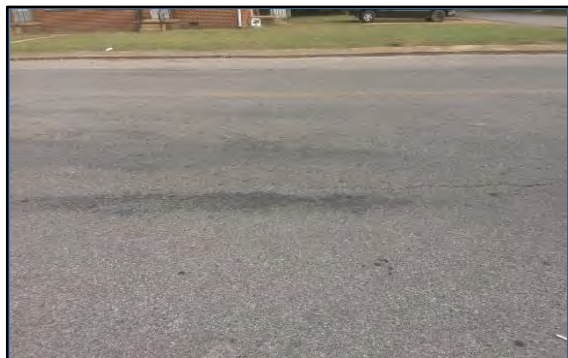
Corner 1 No Ramp (1z)

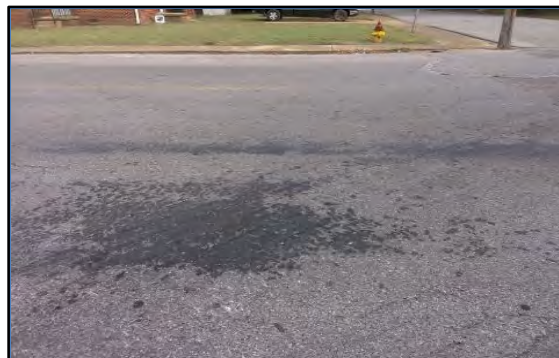
Corner 2 No Ramp (2z)

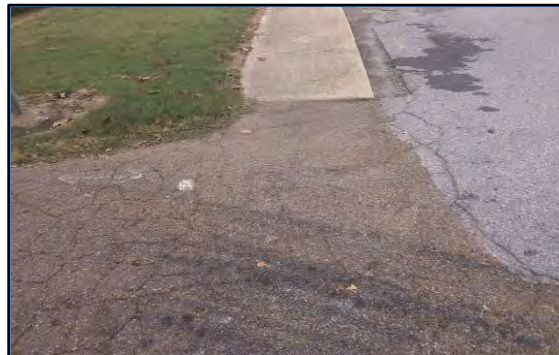
Corner 4 No Ramp (4z)

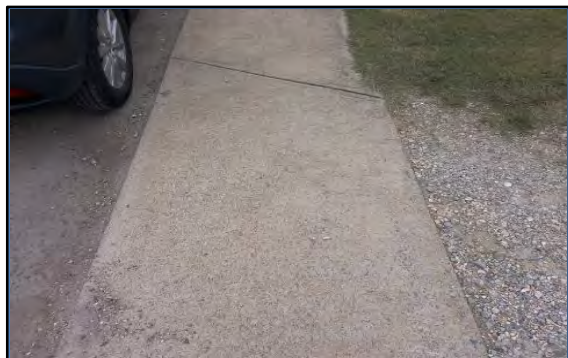
Corner 3 No Ramp (3z)

For intersection, commercial driveway, and park ramps, install color truncated domes

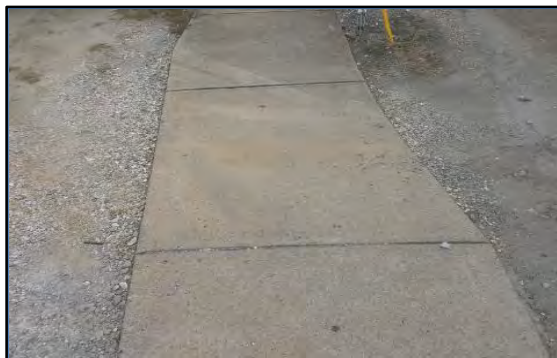
Corner 4 No Ramp (4z)

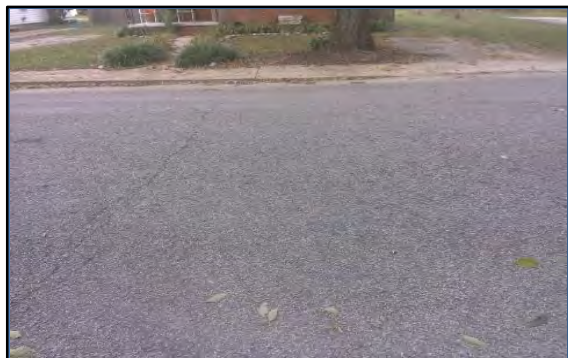
Curb Ramp Issues	Curb Ramp ID ('z', 'i', or 'CN' in ramp label indicates no existing ramp)				Possible Solutions
	1z	2z	3z	4z	
Curb ramp does not exist and is needed					For intersection, commercial driveway, and park ramps, install color truncated domes
Curb ramp does not land in crosswalk					
No 4' x 4' clear space at base of curb ramp					
Curbed side is not 90° or has traversable adjacent surface					
Flare cross slope is greater than 10%					
Curb ramp running slope is greater than 8.3%					
Blended transition running slope is greater than 5%					
Cut-thru ramp running slope is greater than 5%					
Curb ramp cross slope is greater than 2%					
Cut-thru ramp cross slope is greater than 2%					
Curb ramp width is less than 48"					
Cut-thru ramp width is less than 60"					
Permanent obstruction (>0.25") in curb ramp/landing/flares					
Temporary obstruction (>0.25") in curb ramp/landing/flares					
No textured surface at base of curb ramp			X	X

No color contrast at base of curb ramp			X	X	
Landing area does not exist and is needed					
Landing area is less than 5' x 5' or slopes greater than 2%					
Curb ramp transition onto roadway is greater than 0.25"					
Counter slope of the gutter or street at the foot of the curb ramp is greater than 5%					
Ponding occurs at base of curb ramp

Corner 1 No Ramp (1z)

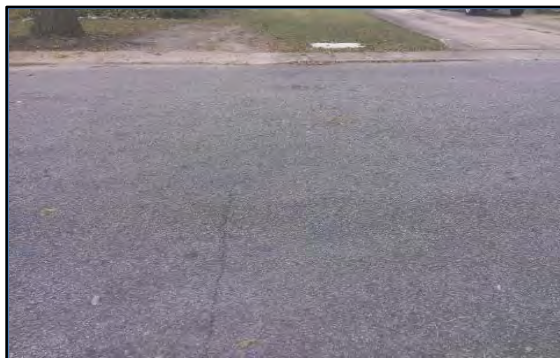
Corner 2 No Ramp (2z)

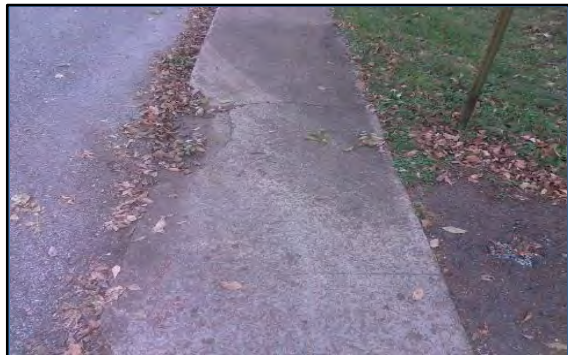
Corner 3 No Ramp (3z)

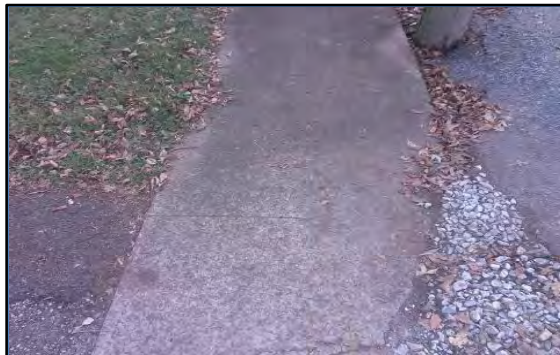
Corner 4 No Ramp (4z)

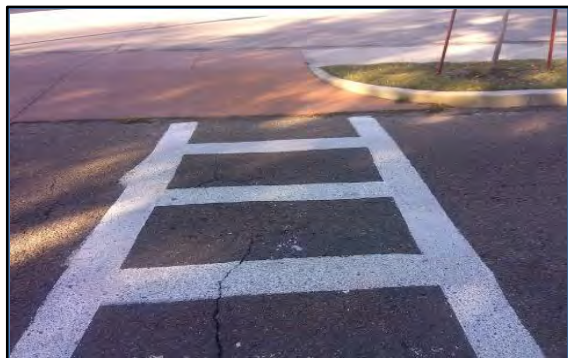
Curb Ramp Issues	Curb Ramp ID ('z', 'i', or 'CN' in ramp label indicates no existing ramp)		Possible Solutions
	2z	3A	
Curb ramp does not exist and is needed	X		Install curb ramp; if median improvement, see shapefile
Curb ramp does not land in crosswalk			
No 4' x 4' clear space at base of curb ramp			
Curbed side is not 90° or has traversable adjacent surface			
Flare cross slope is greater than 10%		X	
Curb ramp running slope is greater than 8.3%		X	
Blended transition running slope is greater than 5%			
Cut-thru ramp running slope is greater than 5%			
Curb ramp cross slope is greater than 2%			Remove and replace curb ramp
Cut-thru ramp cross slope is greater than 2%			
Curb ramp width is less than 48"			
Cut-thru ramp width is less than 60"			
Permanent obstruction (>0.25") in curb ramp/landing/flares			
Temporary obstruction (>0.25") in curb ramp/landing/flares			
No textured surface at base of curb ramp		X

Corner 2 No Ramp (2z)

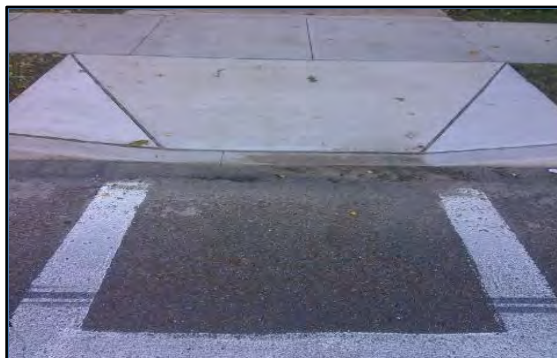
Ramp 3A

No color contrast at base of curb ramp		X	
Landing area does not exist and is needed			For intersection, commercial driveway, and park ramps, install color truncated domes
Landing area is less than 5' x 5' or slopes greater than 2%			
Curb ramp transition onto roadway is greater than 0.25"			
Counter slope of the gutter or street at the foot of the curb ramp is greater than 5%			
Ponding occurs at base of curb ramp		X	Fix ponding

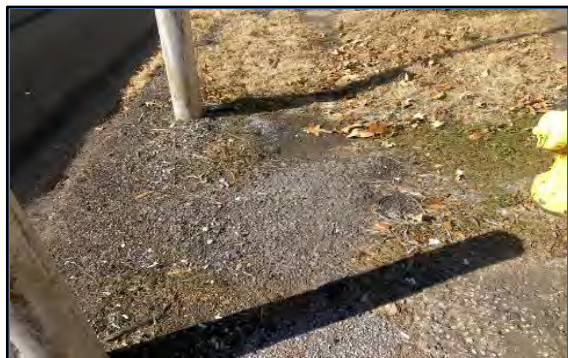
Curb Ramp Issues	Curb Ramp ID ('z', 'i', or 'CN' in ramp label indicates no existing ramp)				Possible Solutions
	1z	2z	3z	4z	
Curb ramp does not exist and is needed					
Curb ramp does not land in crosswalk					
No 4' x 4' clear space at base of curb ramp					
Curbed side is not 90° or has traversable adjacent surface					
Flare cross slope is greater than 10%					
Curb ramp running slope is greater than 8.3%					
Blended transition running slope is greater than 5%					
Cut-thru ramp running slope is greater than 5%					
Curb ramp cross slope is greater than 2%					
Cut-thru ramp cross slope is greater than 2%					
Curb ramp width is less than 48"					
Cut-thru ramp width is less than 60"					
Permanent obstruction (>0.25') in curb ramp/landing/flares					
Temporary obstruction (>0.25') in curb ramp/landing/flares					
No textured surface at base of curb ramp	X	X	X	X	For intersection, commercial driveway, and park ramps, install color truncated domes

No color contrast at base of curb ramp	X	X	X	X	
Landing area does not exist and is needed					
Landing area is less than 5' x 5' or slopes greater than 2%					
Curb ramp transition onto roadway is greater than 0.25"					
Counter slope of the gutter or street at the foot of the curb ramp is greater than 5%					
Ponding occurs at base of curb ramp

Corner 1 No Ramp (1z)

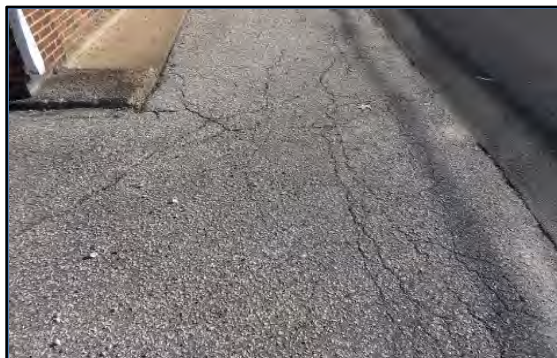
Corner 2 No Ramp (2z)

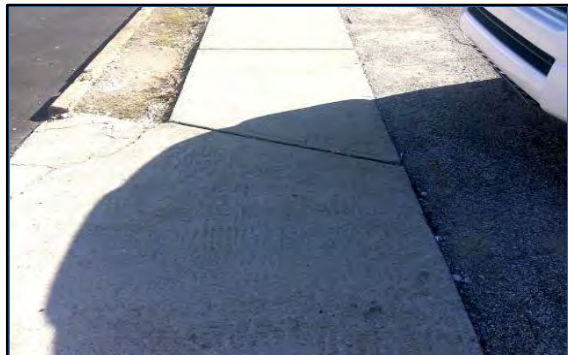
Corner 3 No Ramp (3z)

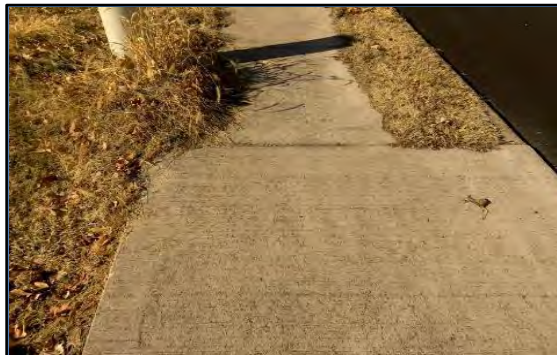
Corner 4 No Ramp (4z)

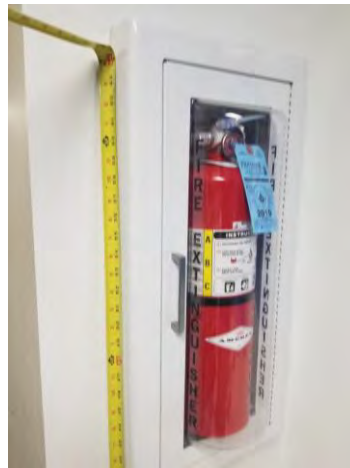
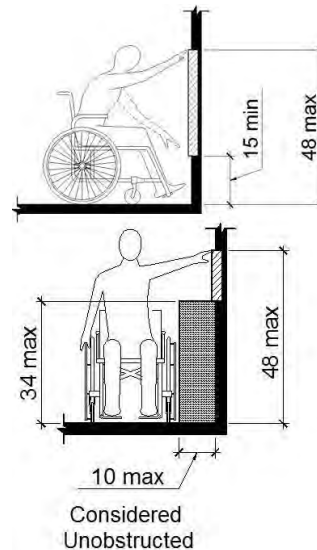
4 (Low): Should be completed as soon as possible due to being a technical violation, but may not result in providing greater access to persons with disabilities. (Includes; Findings that are technical violations but provide a moderate to low increase in accessibility compared to the financial impact on the entity)

Fire extinguisher handle is at 60". The fire extinguisher is not positioned correctly for either a side or front approach.

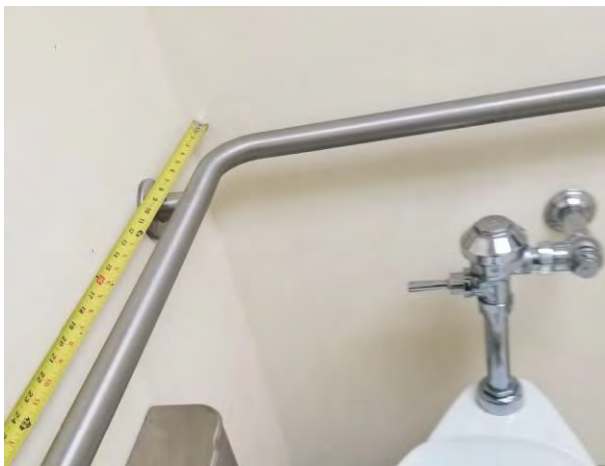
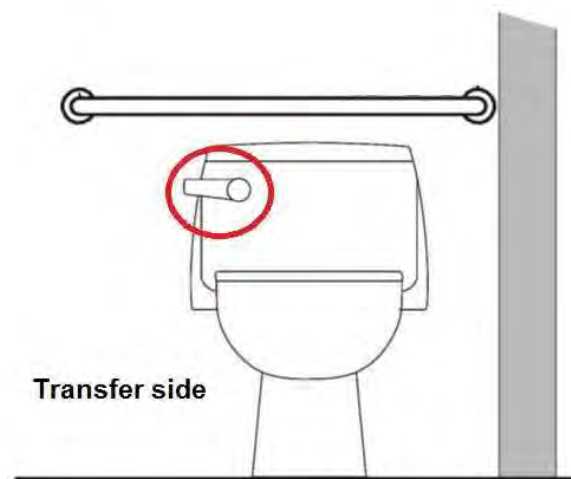
3 (Moderate): Should be completed as soon as possible, but there may be other items that will provide greater access to persons with disabilities. (Includes; Findings that have a high financial impact on the entity in relationship to the degree of access provided)

The flush handle is located on the wrong side of the toilet.

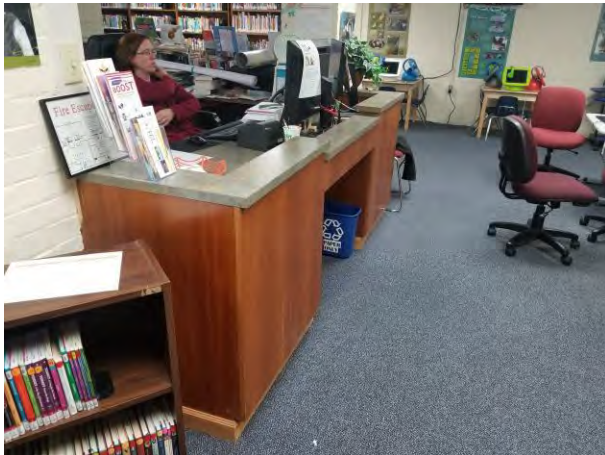
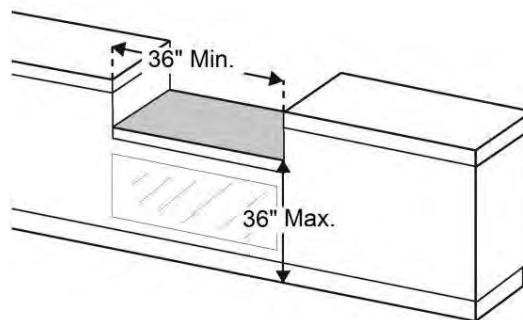
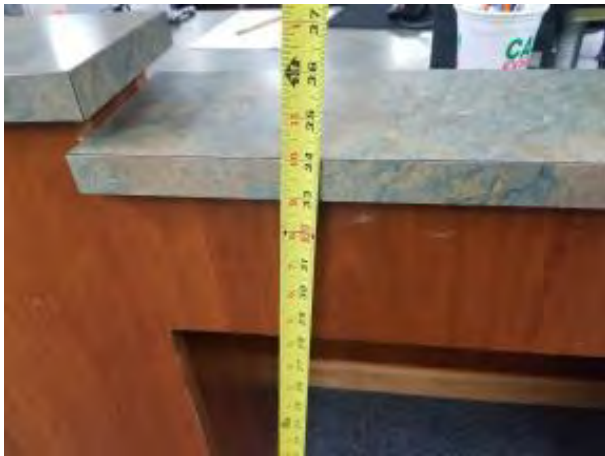
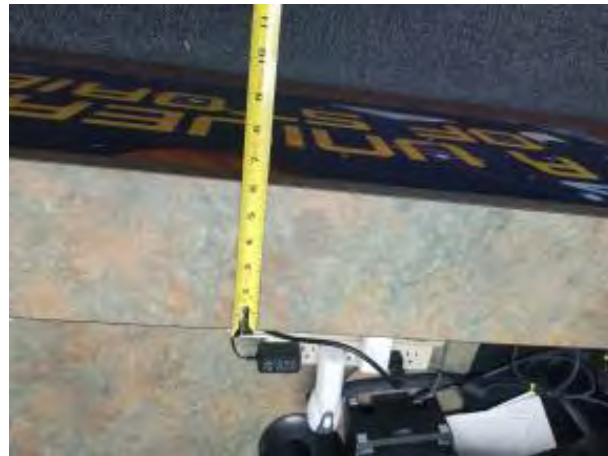
2 (Important): Should be completed as soon as possible. (Includes; Findings that would remove barriers to the greatest number of people to your goods and services)

Counter depth is 6". The accessible portion of the countertop does not extend the same depth as the sales or service counter top.

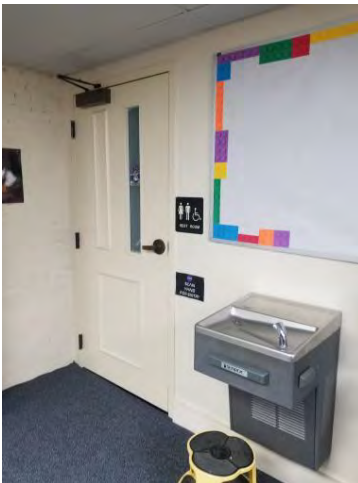
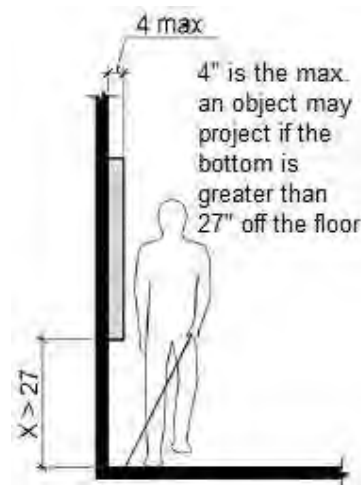
4 (Low): Should be completed as soon as possible due to being a technical violation, but may not result in providing greater access to persons with disabilities. (Includes; Findings that are technically violations but provide a moderate to low increase in accessibility compared to the financial impact on the entity)

Drinking fountain not enclosed. The drinking fountain projects more than 4 inches into the circulation path.

Wall-mounted objects that have leading edges between 27 inches and 80 inches from the floor must not project more than 4 inches into the circulation path. Protruding objects that extend to the floor or within 27 inches of the floor are cane detectable and are therefore not hazardous. Where it is necessary or desirable to have objects protrude from the wall, a manner of cane detection must be provided.

Citation: 2010 ADAS Section 307.2

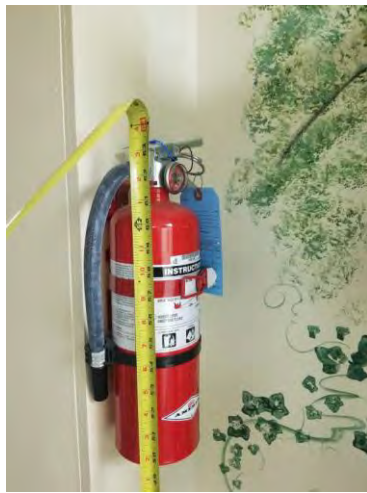
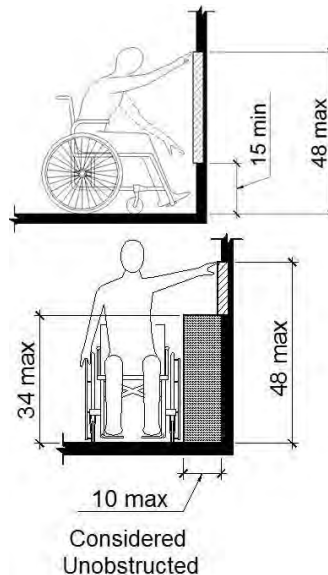
4 (Low): Should be completed as soon as possible due to being a technical violation, but may not result in providing greater access to persons with disabilities. (Includes; Findings that are technically violations but provide a moderate to low increase in accessibility compared to the financial impact on the entity)

Fire extinguisher is 62" to handle. The fire extinguisher is not positioned correctly for either a side or front approach.

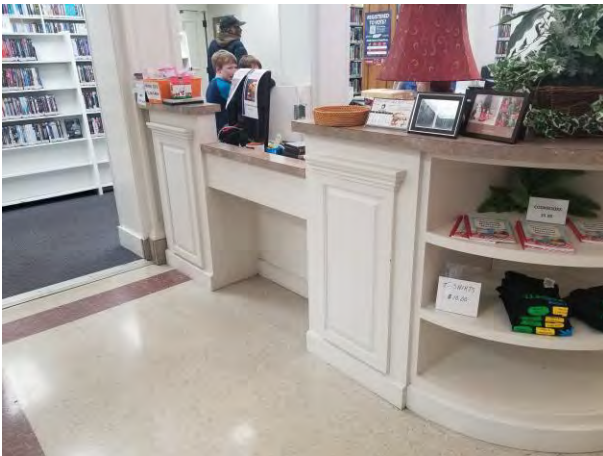
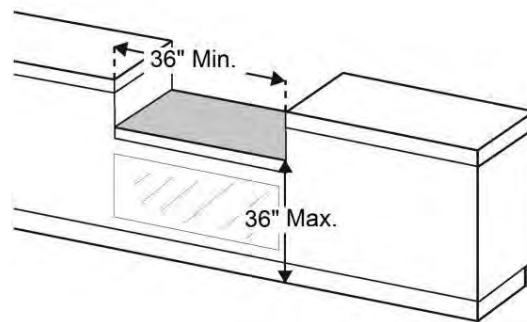
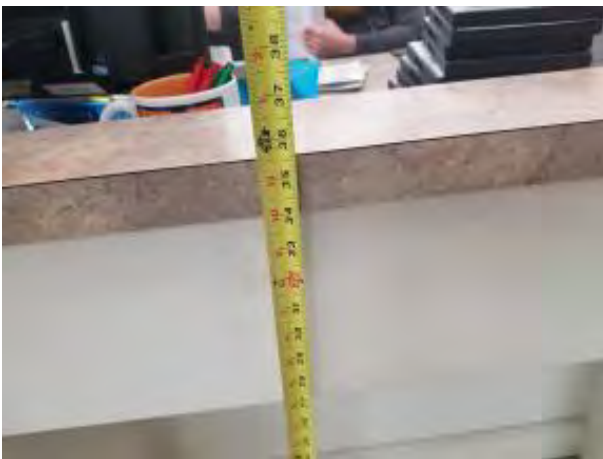
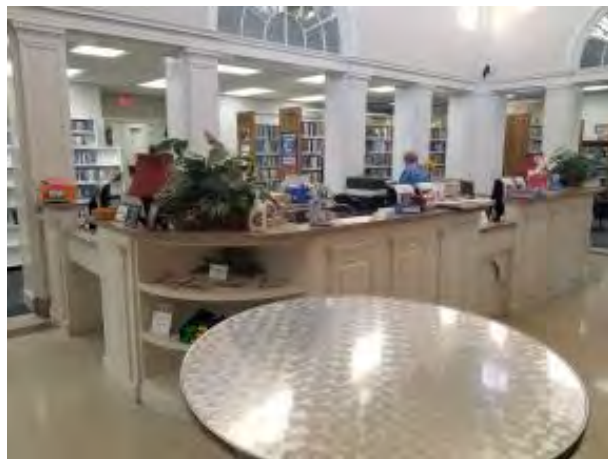
2 (Important): Should be completed as soon as possible. (Includes; Findings that would remove barriers to the greatest number of people to your goods and services)

The counter depth is 5". The accessible portion of the countertop does not extend the same depth as the sales or service counter top.

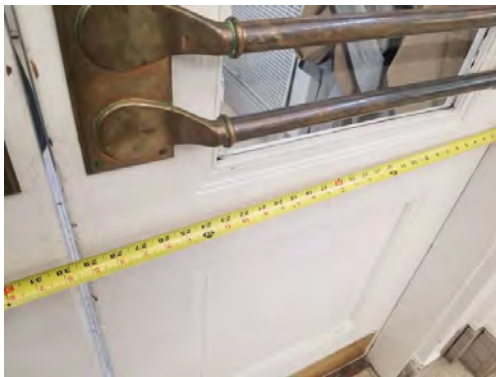
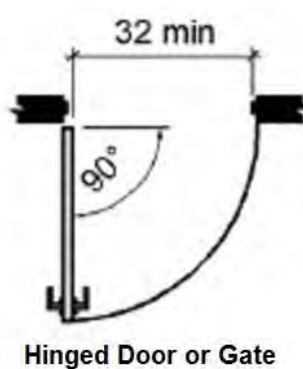
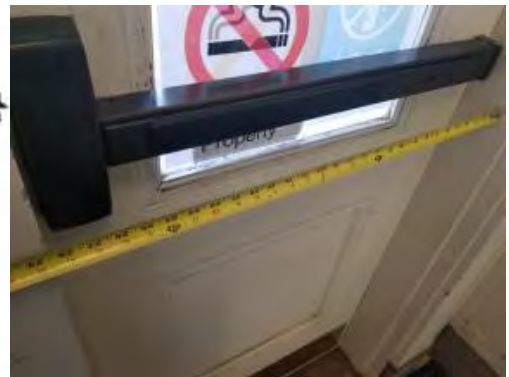
2 (Important): Should be completed as soon as possible. (Includes; Findings that would remove barriers to the greatest number of people to your goods and services)

The opening width at exit doors is 29.5". Neither leaves of the doorways provide at least 32 inches between the face of the door and the opposite stop. At least one of the active leaves of doorways with two leaves shall comply with clear width and maneuvering clearance.

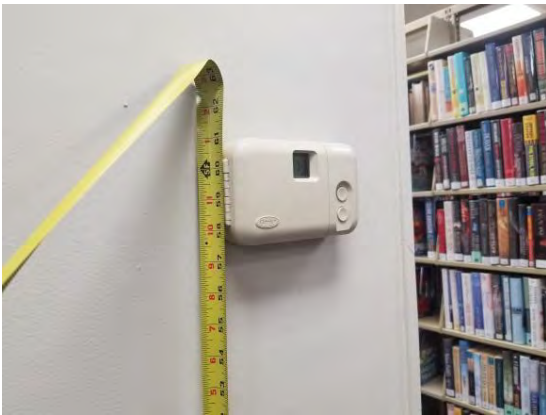
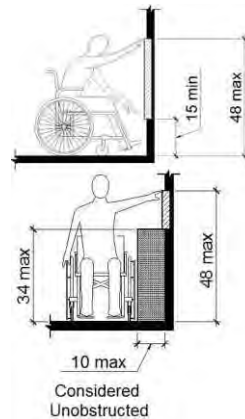
4 (Low): Should be completed as soon as possible due to being a technical violation, but may not result in providing greater access to persons with disabilities. (Includes; Findings that are technically violations but provide a moderate to low increase in accessibility compared to the financial impact on the entity)

The thermostat is not positioned correctly for either a side or front approach.

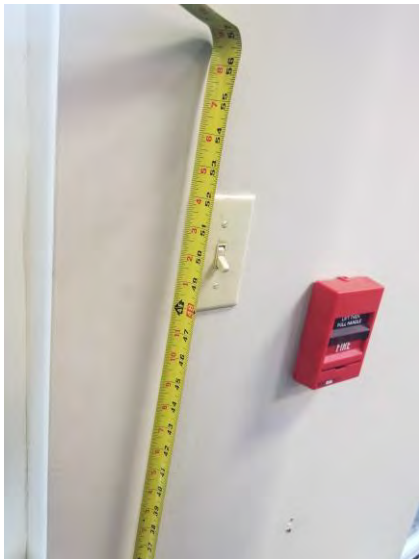
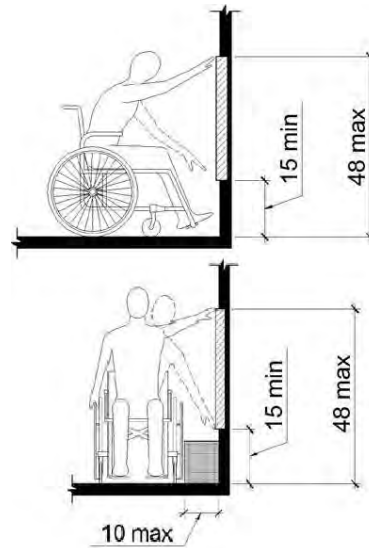
4 (Low): Should be completed as soon as possible due to being a technical violation, but may not result in providing greater access to persons with disabilities. (Includes; Findings that are technically violations but provide a moderate to low increase in accessibility compared to the financial impact on the entity)

Switch at entrance is 50" AFF. The receptacle/switch is not positioned correctly for either a side or front approach.

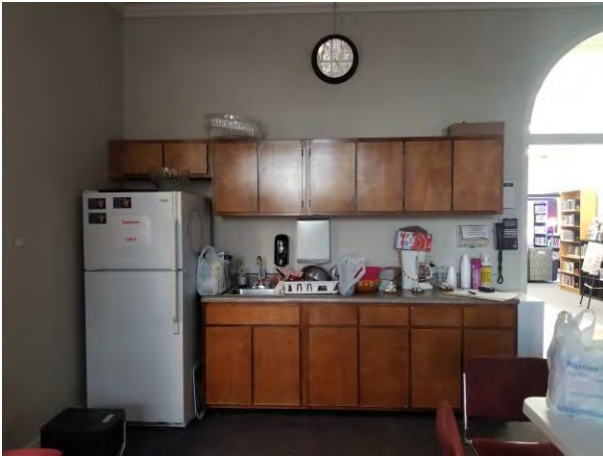
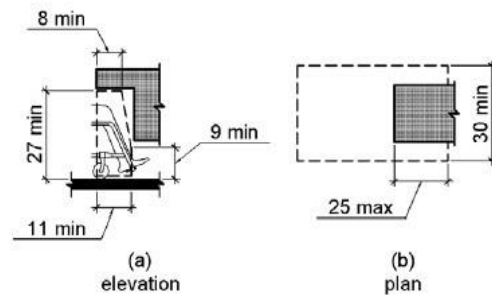
3 (Moderate): Should be completed as soon as possible, but there may be other items that will provide greater access to persons with disabilities. (Includes; Findings that have a high financial impact on the entity in relationship to the degree of access provided)

Knee and toe space has not been provided at the sink.

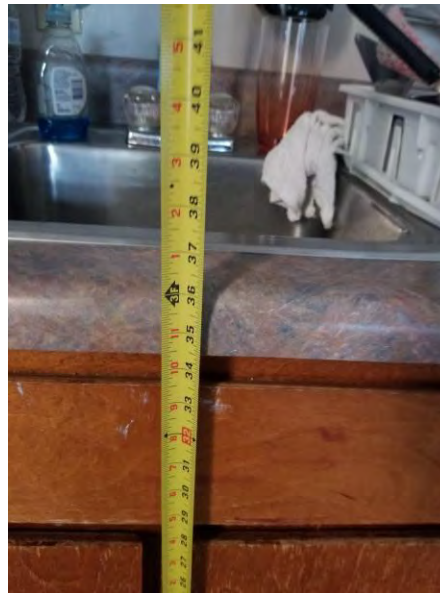
3 (Moderate): Should be completed as soon as possible, but there may be other items that will provide greater access to persons with disabilities. (Includes; Findings that have a high financial impact on the entity in relationship to the degree of access provided)

The top of the sink is too high.

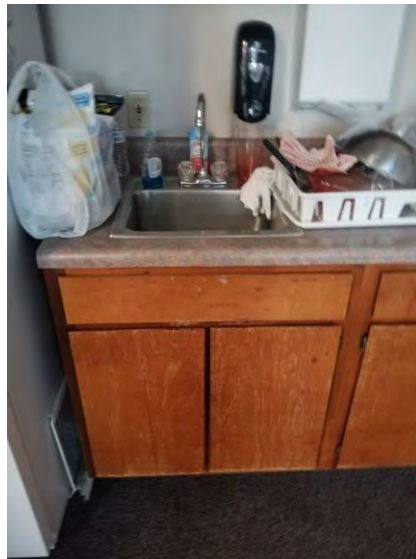
3 (Moderate): Should be completed as soon as possible, but there may be other items that will provide greater access to persons with disabilities. (Includes; Findings that have a high financial impact on the entity in relationship to the degree of access provided)

There are round turn handles at sink. The sink controls require tight grasping, tight pinching or twisting of the wrist to operate.

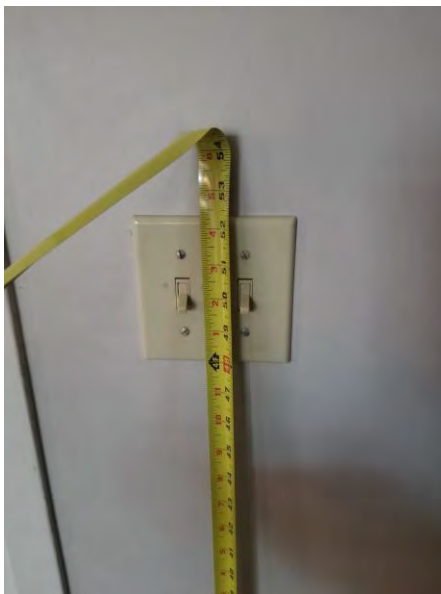
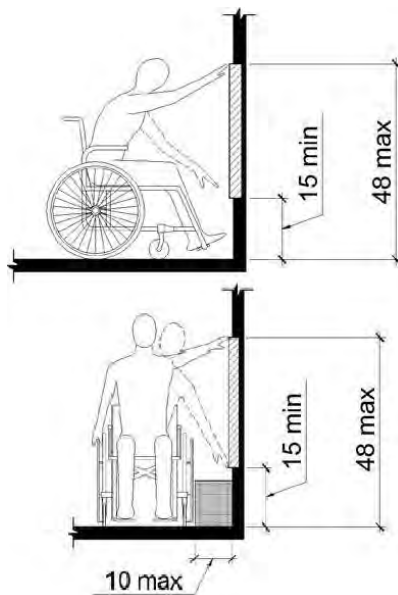
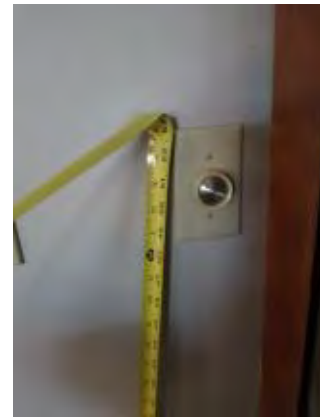
4 (Low): Should be completed as soon as possible due to being a technical violation, but may not result in providing greater access to persons with disabilities. (Includes; Findings that are technically violations but provide a moderate to low increase in accessibility compared to the financial impact on the entity)

Switches are at 50" AFF.

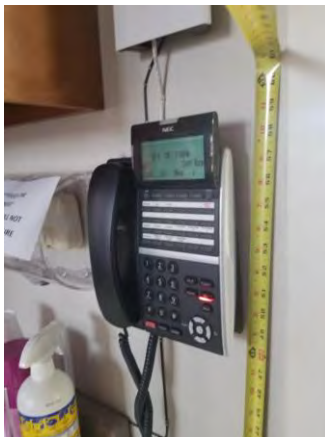
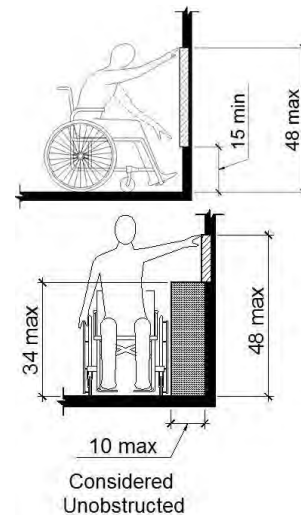
4 (Low): Should be completed as soon as possible due to being a technical violation, but may not result in providing greater access to persons with disabilities. (Includes; Findings that are technically violations but provide a moderate to low increase in accessibility compared to the financial impact on the entity)

It is 48" to bottom of telephone. The telephone is not positioned correctly for either a side or front approach.

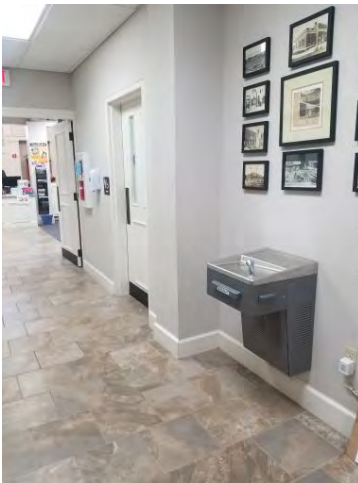
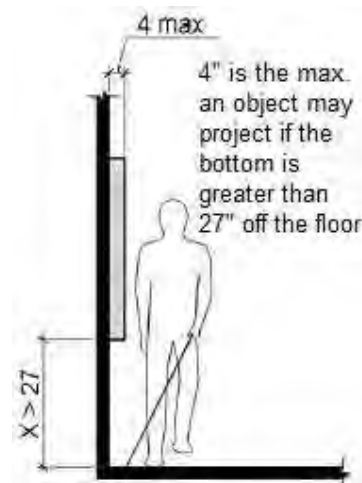
4 (Low): Should be completed as soon as possible due to being a technical violation, but may not result in providing greater access to persons with disabilities. (Includes; Findings that are technically violations but provide a moderate to low increase in accessibility compared to the financial impact on the entity)

The drinking fountain is not enclosed. The drinking fountain projects more than 4 inches into the circulation path.

Wall-mounted objects that have leading edges between 27 inches and 80 inches from the floor must not project more than 4 inches into the circulation path. Protruding objects that extend to the floor or within 27 inches of the floor are cane detectable and are therefore not hazardous. Where it is necessary or desirable to have objects protrude from the wall, a manner of cane detection must be provided.

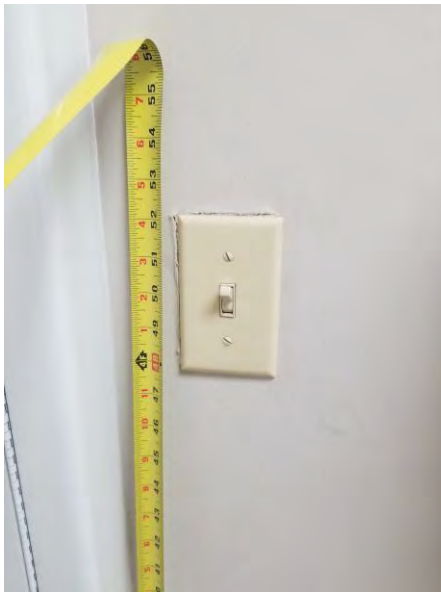
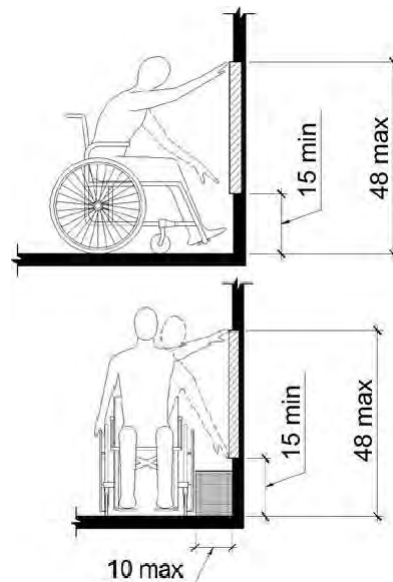
The switch is at 50". The receptacle/switch is not positioned correctly for either a side or front approach.

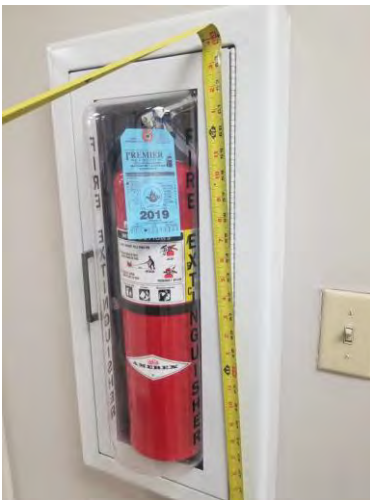
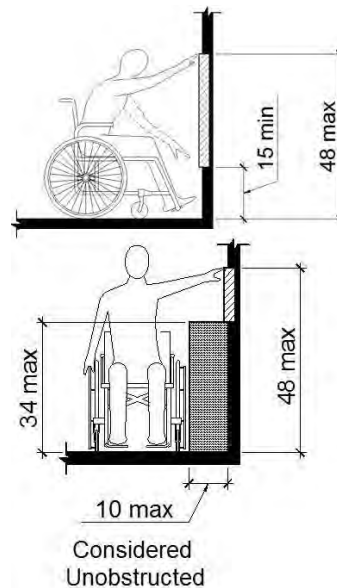
The fire extinguisher handle is at 60". The fire extinguisher is not positioned correctly for either a side or front approach.

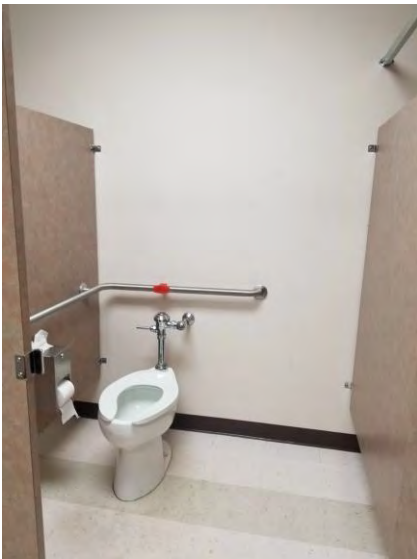
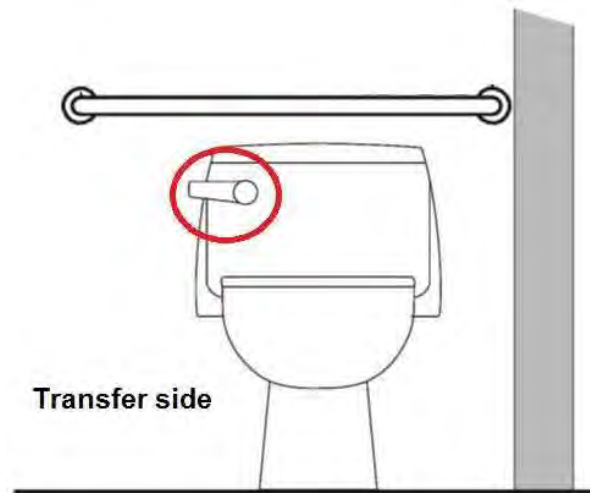
The flush handle is located on the wrong side of the toilet.

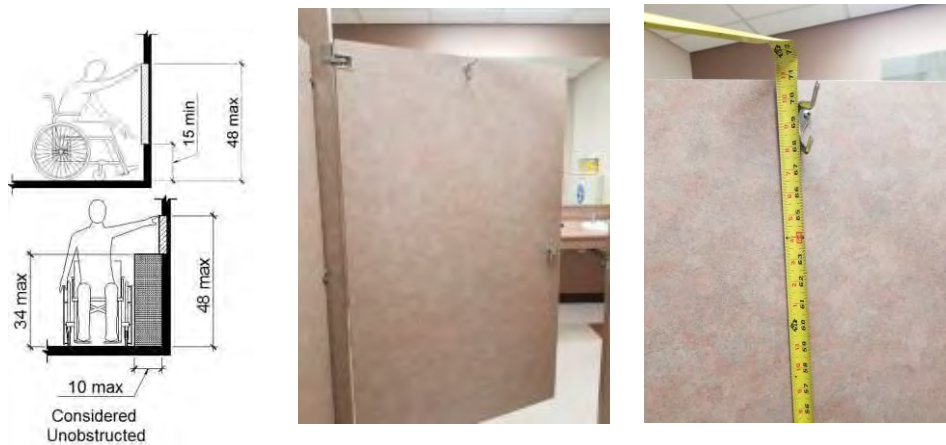
The coat hook is not positioned correctly for either a side or front approach.

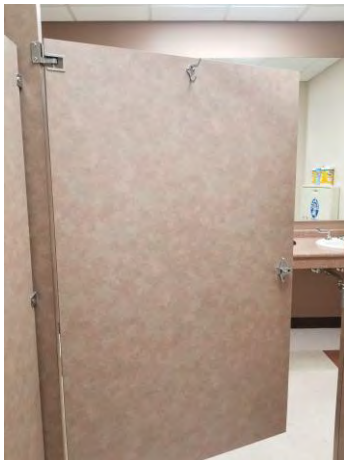
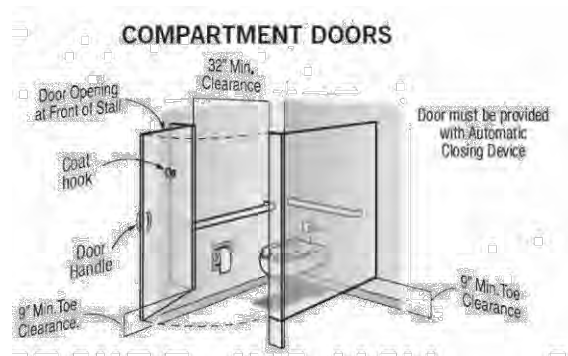
The compartment door is not self-closing.

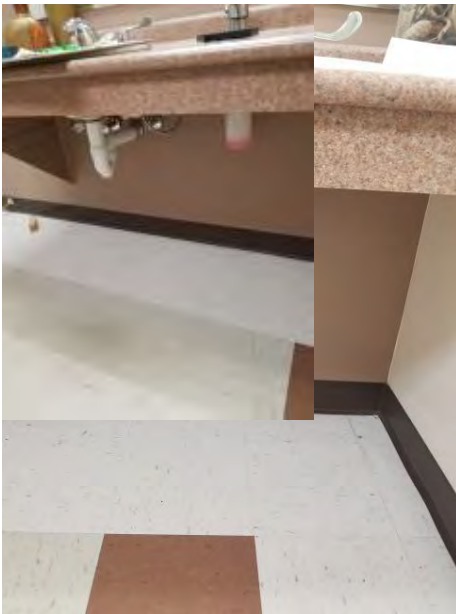
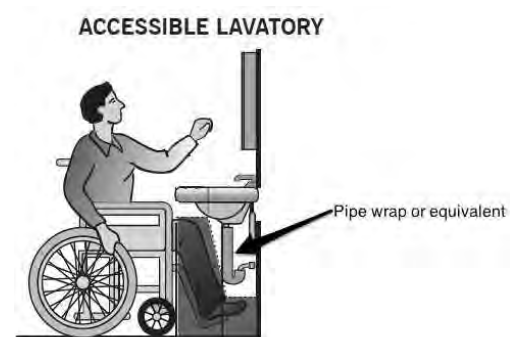
The water and drain pipes under the lavatory are not adequately insulated.

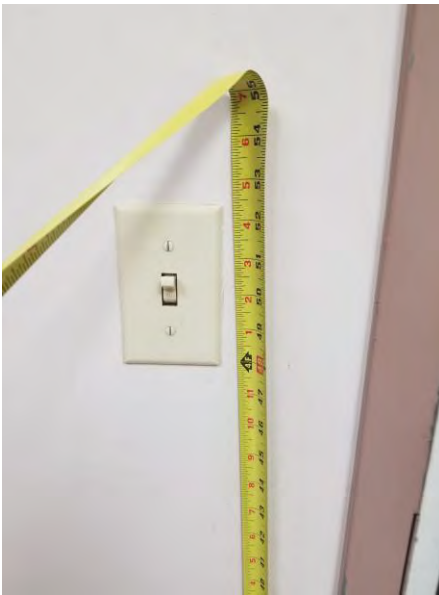
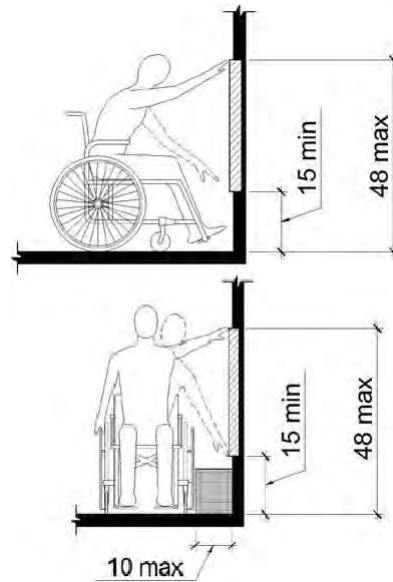
It is 50" to switch from the floor. The receptacle/switch is not positioned correctly for either a side or front approach.

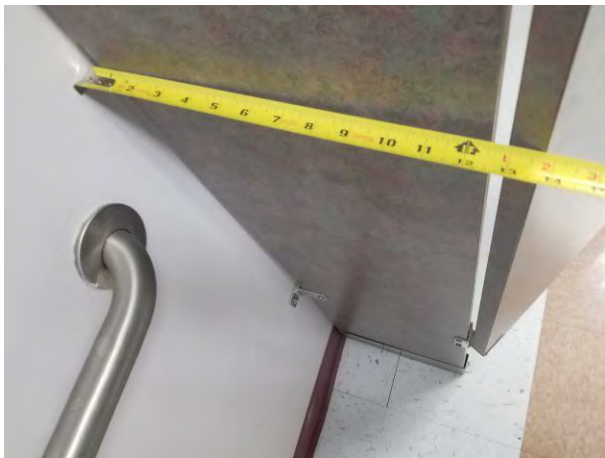
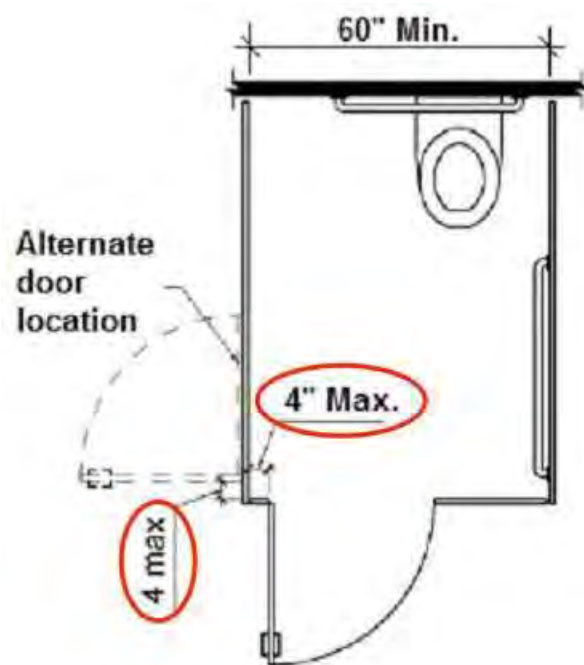
The door is 12" from wall. The compartment door is located too far from the partition or wall.

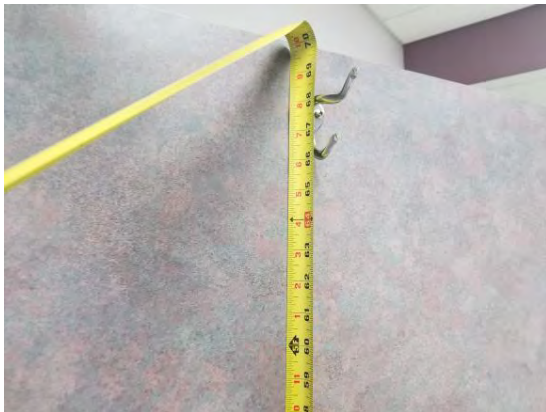
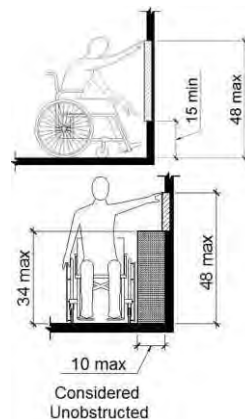
The coat hook is at 67". The coat hook is not positioned correctly for either a side or front approach.

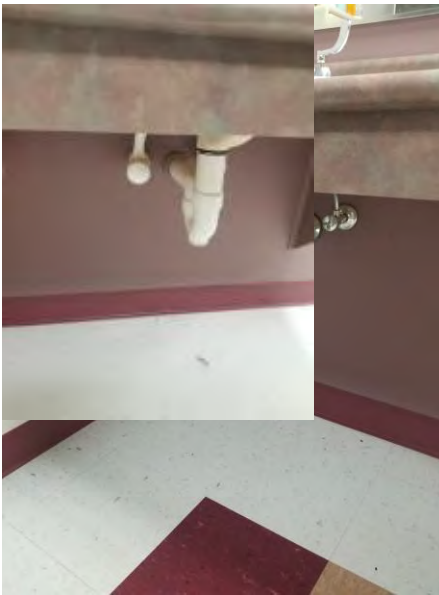
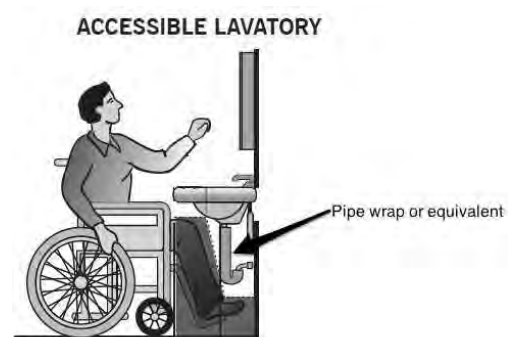
The water and drain pipes under the lavatory are not adequately insulated.

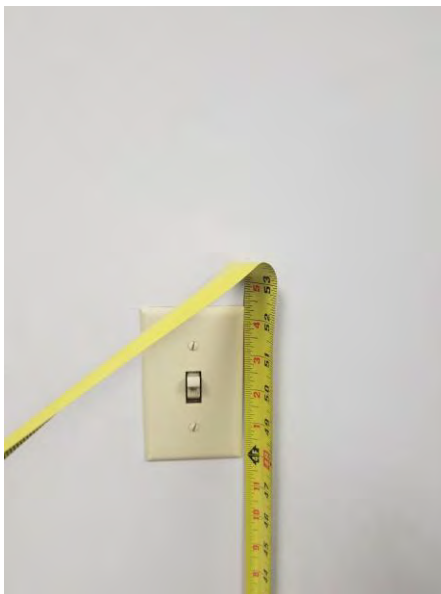
The switch is at 50". The receptacle/switch is not positioned correctly for either a side or front approach.

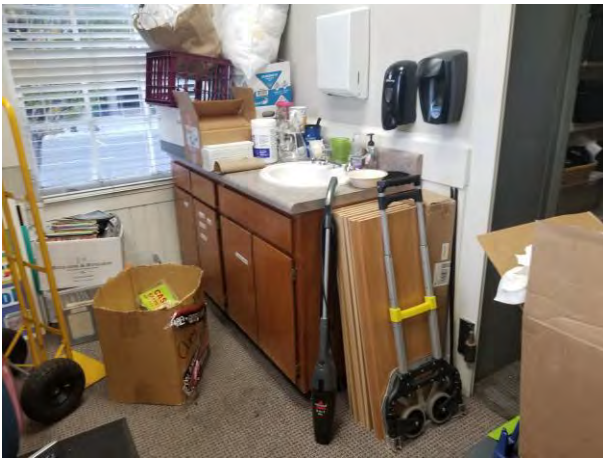
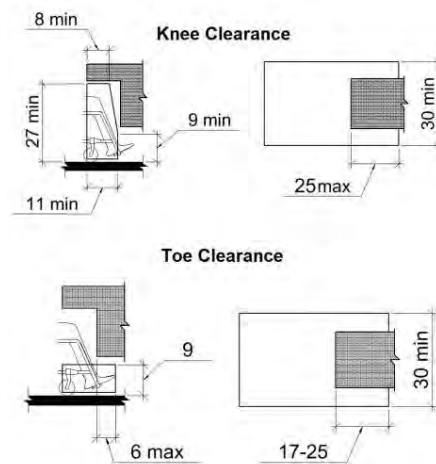
The knee and toe clearance has not been provided at the sink.

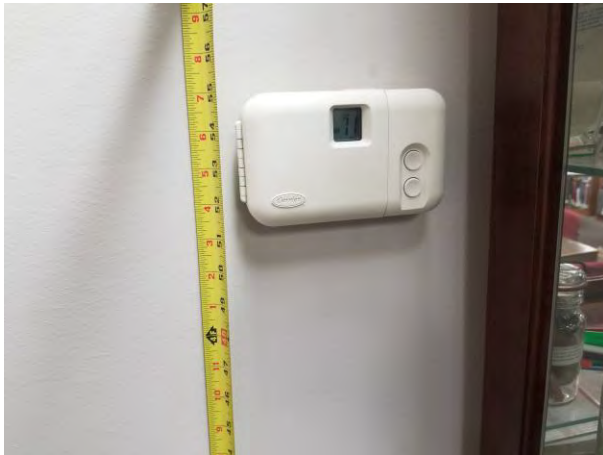
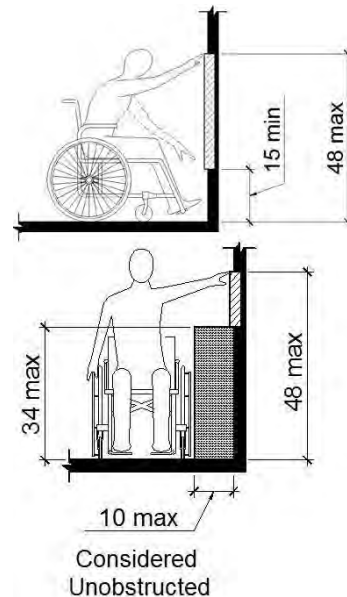
It is 51" to bottom of thermostat. The thermostat is not positioned correctly for either a side or front approach.

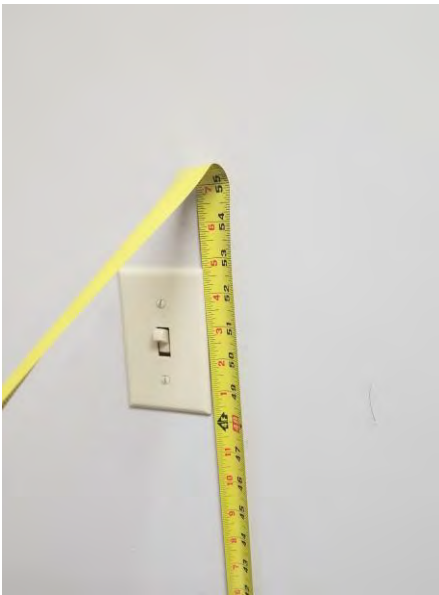
It is 50.5" to switch. The receptacle/switch is not positioned correctly for either a side or front approach.

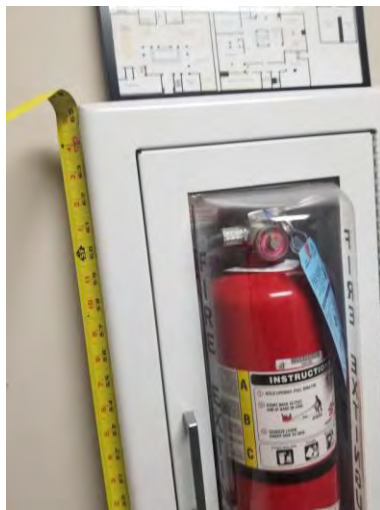
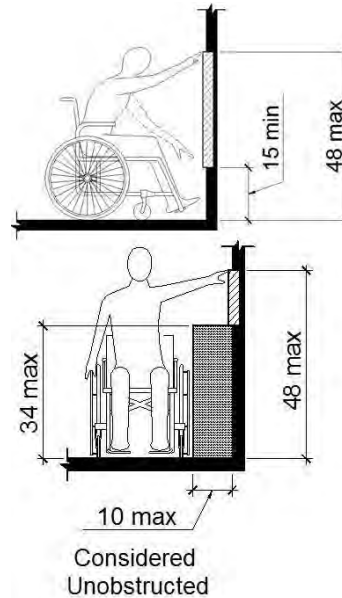
It is 60" to Fire Extinguisher Handle. The Fire Extinguisher is not positioned correctly for either a side or front approach.

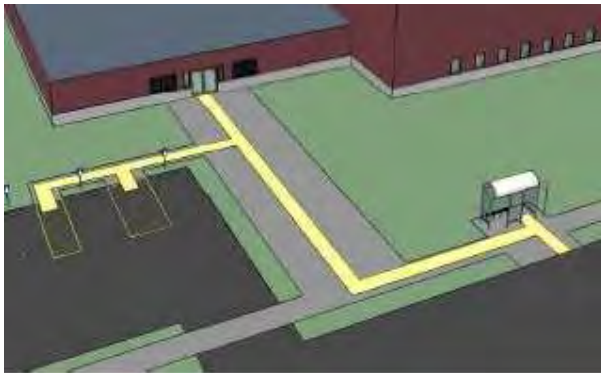
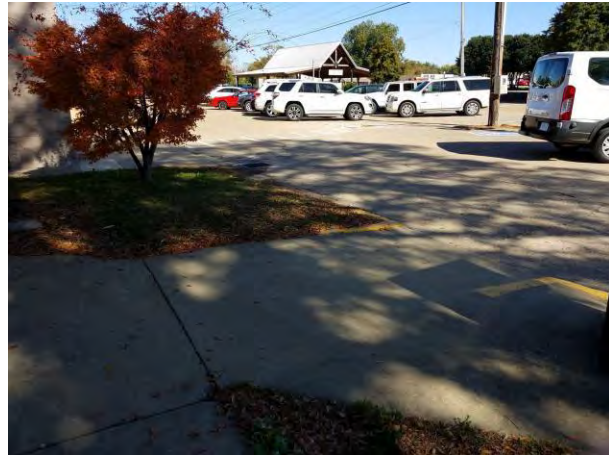
No curb ramp present at crosswalk. A section of sidewalk is missing along the route. Accessible parking spaces and access aisle directs to a crosswalk and sidewalk with no curb ramp, misleading users of the accessible route to the entrance.

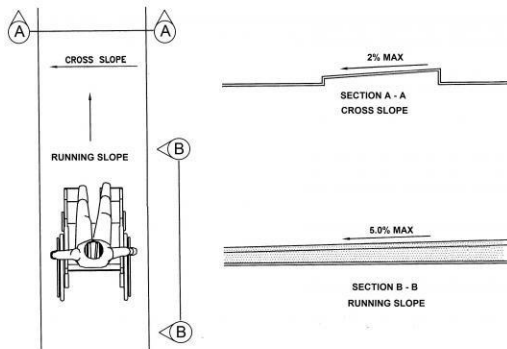
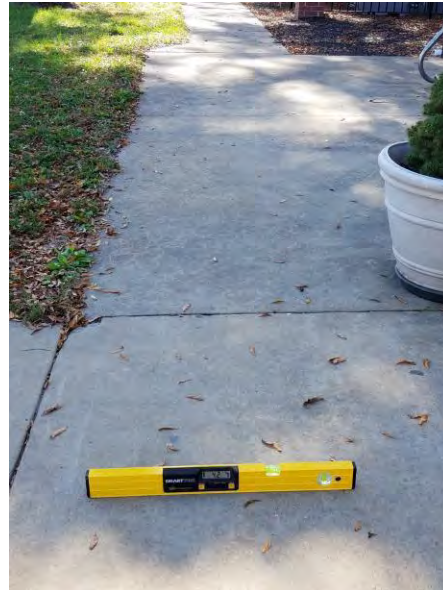
The sidewalk varies up to 4.2%

Replace sidewalk over 2% cross slope along accessible route.

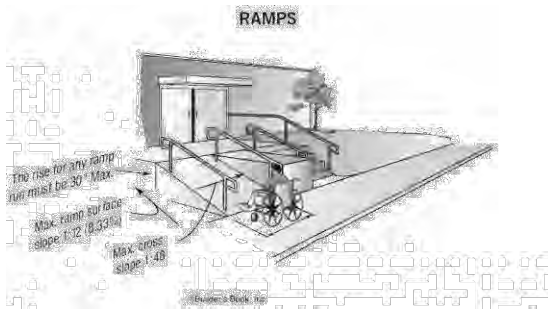
The ramp varies up to 10.2%

Replace ramp to provide running slopes less than 8.3%.

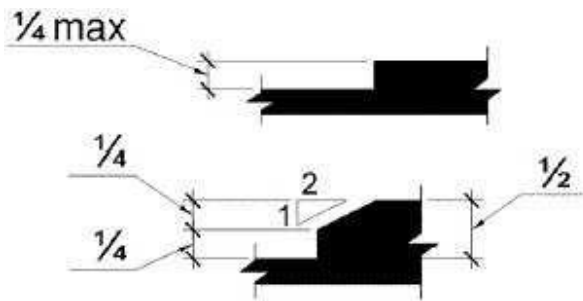
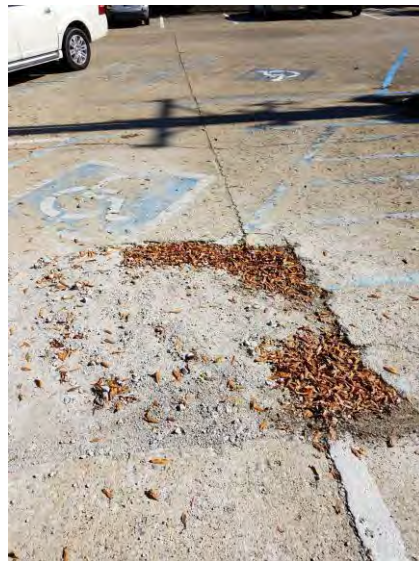
There is a gravel patch in parking and access aisle.

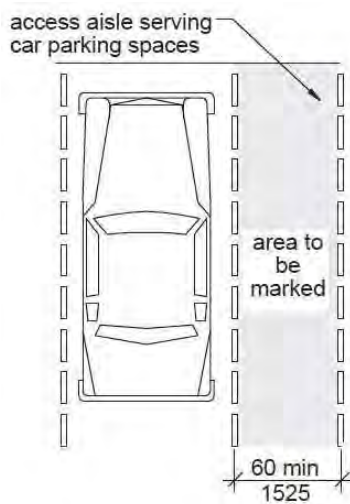
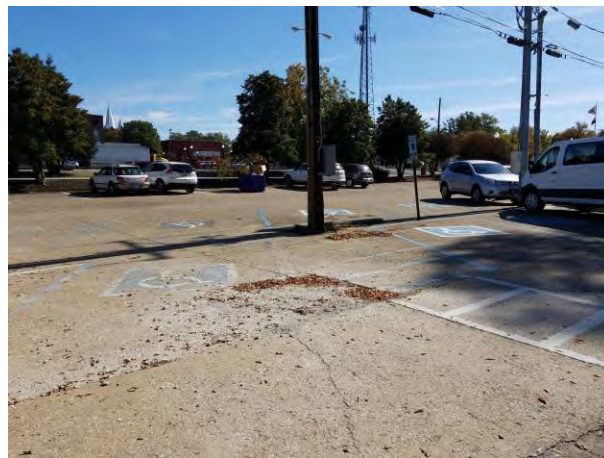
The access aisle is missing at the accessible parking stall.
