ADA Self-Evaluation and Transition Plan

January 2020

Opera House
RESTAURANT

Prepared by:

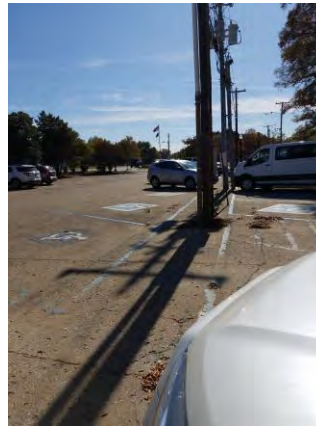
There are 6 spaces provided with 1 van accessible sign provided and 5 missing signs.

The required parking signage is missing. Parking space identification signs shall include the International Symbol of Accessibility (ISA). Signs identifying van parking spaces shall contain the designation "van accessible." All signs shall be 60 inches minimum above the finish floor or ground surface measured to the bottom of the sign.

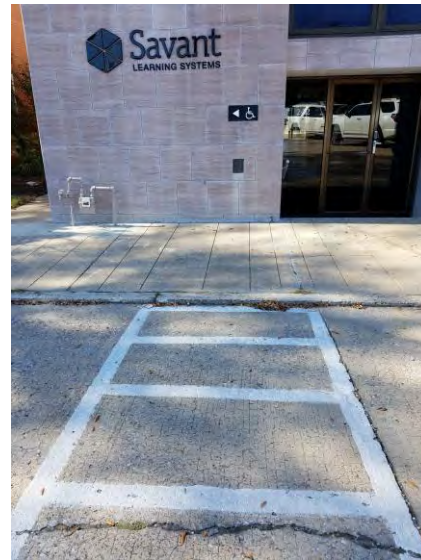
The transition from the curb ramp to the walk, gutter or street is not flush and free of abrupt changes in level.

Replace sidewalk to provide curb ramp with flush transition.

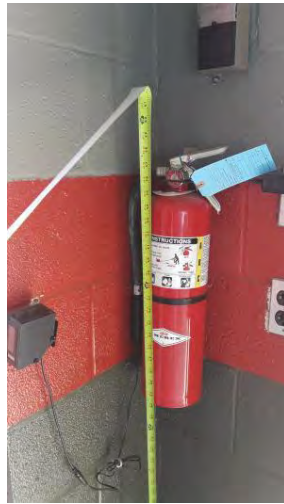
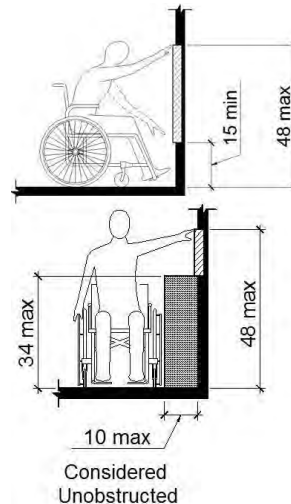
As Built:

The fire extinguisher is not positioned correctly for either a side or front approach.

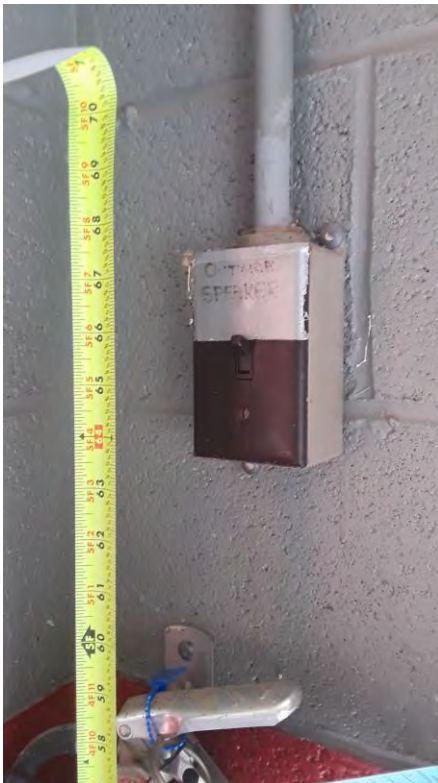
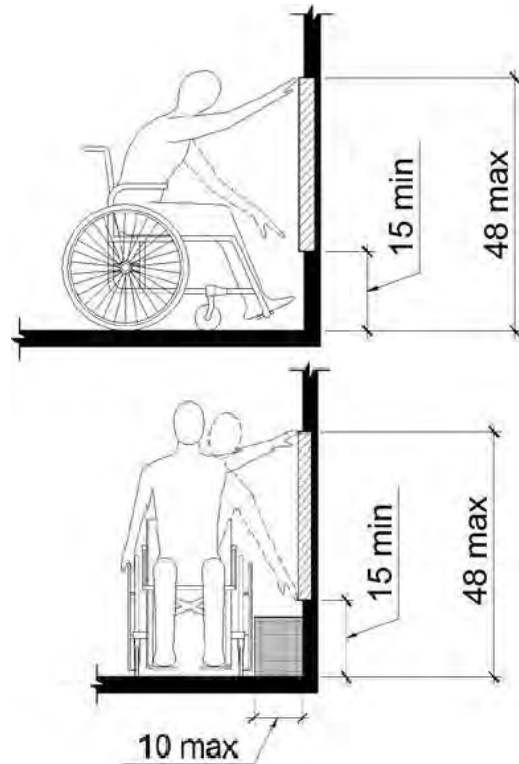
Bay Entrance**Finding: 2****Budget: \$1,250****Recommendation:**

**As Built:**

The switch 64" to bottom. The receptacle/switch is not positioned correctly for either a side or front approach.

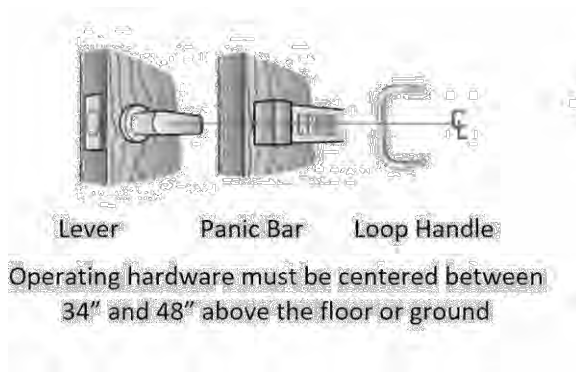
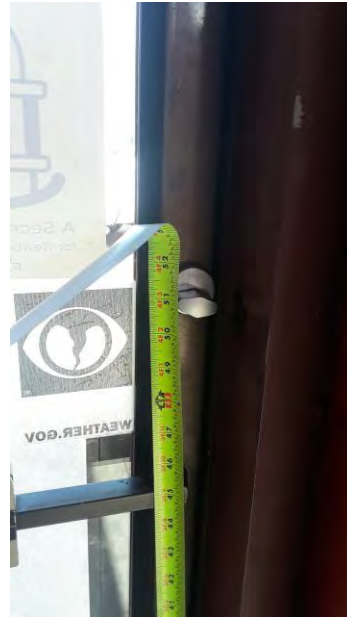
Bay Entrance**Finding: 3****Budget: \$4,200****Recommendation:**

**As Built:**

The key cylinder at 51" to center. The door operating hardware is too high.

PRIORITY 2 (Important)			
Estimated Cost	Location	Finding	Distress/ Description/ Recommendation
\$10,900	Total		
\$4,200	Bay Entrance	3	Lower cylinder to max 48" to top.
\$4,700	Office Corridor	5	Change door swing to other side.
\$2,000	Throughout	12	Provide +/- 26 lever type door handles on all doors with public access.

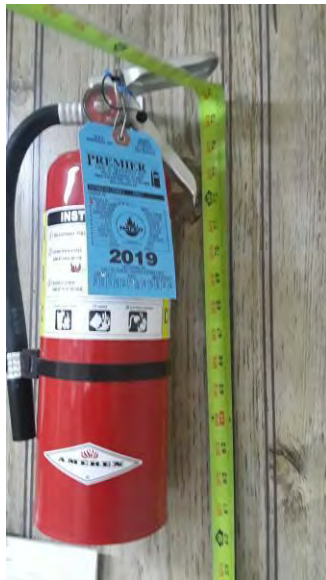
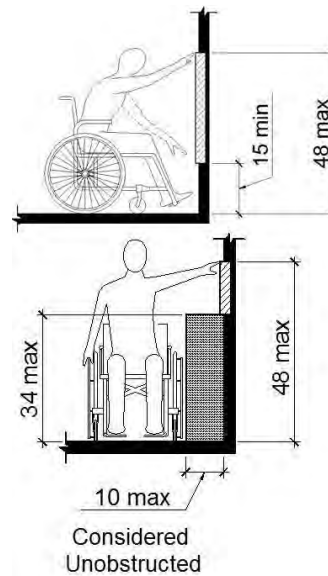
Office Corridor**Finding: 4****Budget: \$75****Recommendation:**

**As Built:**

The fire extinguisher is not positioned correctly for either a side or front approach.

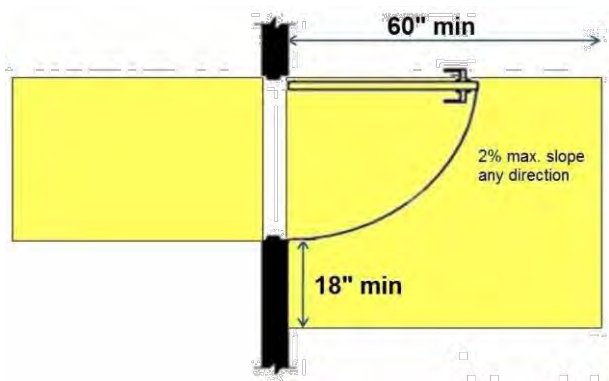
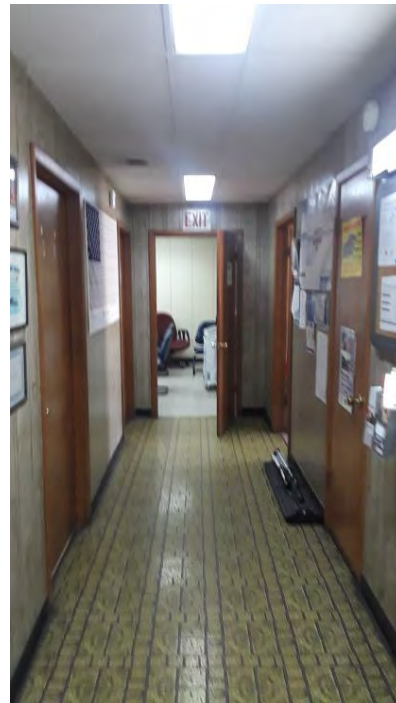
Office Corridor**Finding: 5****Budget: \$4,700****Recommendation:**

**As Built:**

The Latch Side is 10". The maneuvering space on the pull side of the door or gate does not adequately extend beyond the latch side of the door.

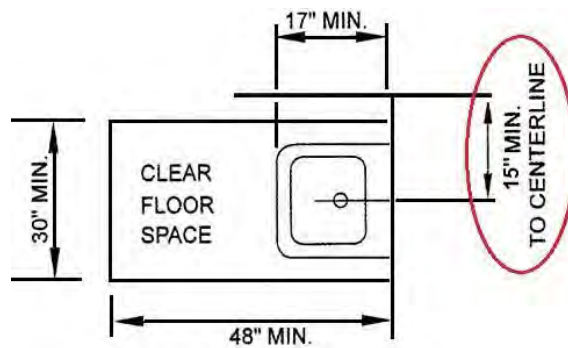
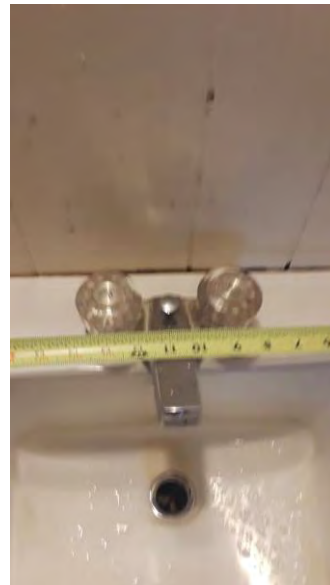
Front Office Restroom**Finding: 6****Budget: \$7,800****Recommendation:**

**As Built:**

It is 11" to centerline. The lavatory is too close to the side wall.

PRIORITY 3 (Moderate)			
Estimated Cost	Location	Finding	Distress/ Description/ Recommendation
\$11,800	Total		
\$7,800	Front Office Restroom	6-11	Further design required.
\$1,000	Parking	3	Restripe so that the access aisle serves both accessible spaces.
\$3,000	Parking	4	The parking lot serving the fire station has 4 total accessible spaces marked. Provide 3 spaces total, 1 of which must be van accessible. Include striping and signage upgrades to reach compliance.

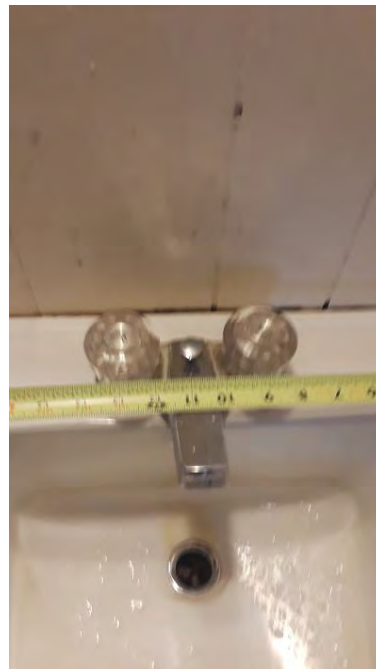
Front Office Restroom**Finding: 7****Budget: Refer to Finding 6****Recommendation:**

**As Built:**

Round handles are installed. The faucet controls require twisting of the wrist.

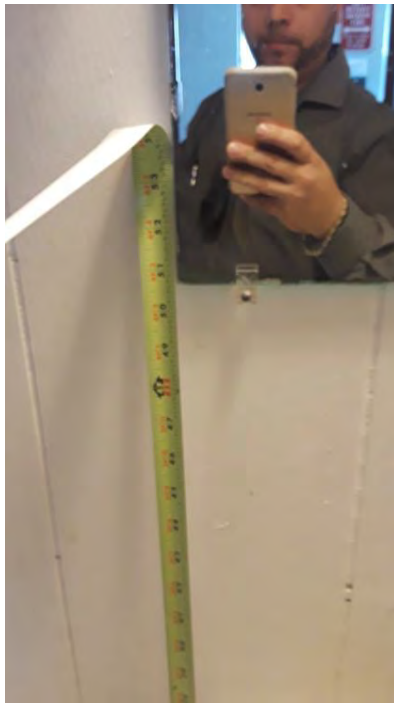
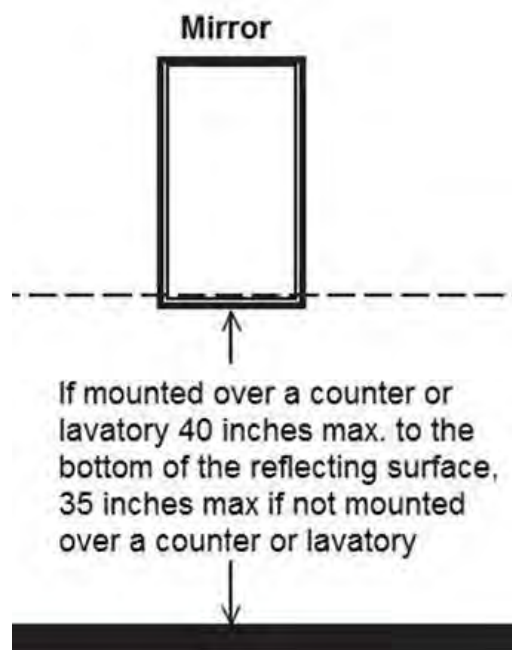
Front Office Restroom**Finding: 8****Budget: Refer to Finding 6****Recommendation:**

**As Built:**

The reflecting surface is 51". The mirror is mounted too high.

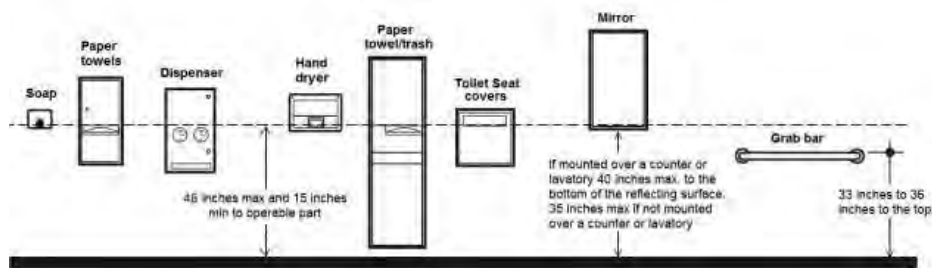
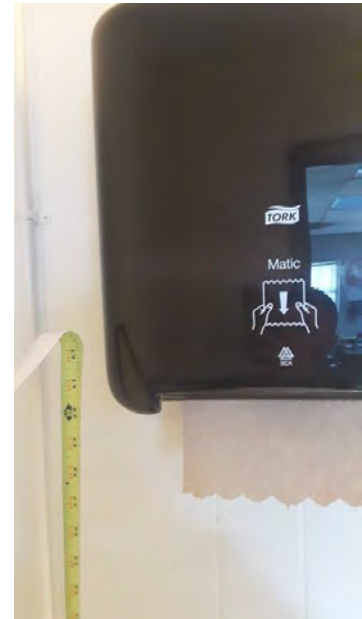
Front Office Restroom**Finding: 9****Budget: Refer to Finding 6****Recommendation:**

**As Built:**

The paper towel dispenser is 61" to bottom. The paper towel dispenser's operation mechanism is too high off the floor. Dispensers must have all operable parts a maximum of 48 inches above the floor.

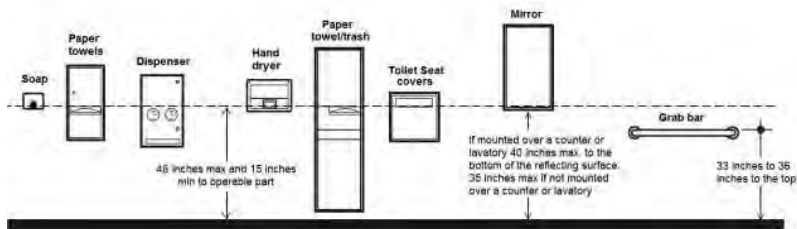
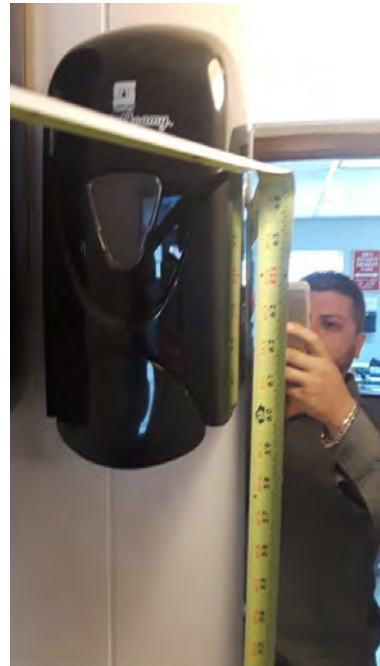
Front Office Restroom**Finding: 10****Budget: Refer to Finding 6****Recommendation:**

**As Built:**

The soap dispenser is 60" to push button. The hand sanitizer dispenser's operation mechanism is too high off the floor. Dispensers must have all operable parts a maximum of 48 inches above the floor.

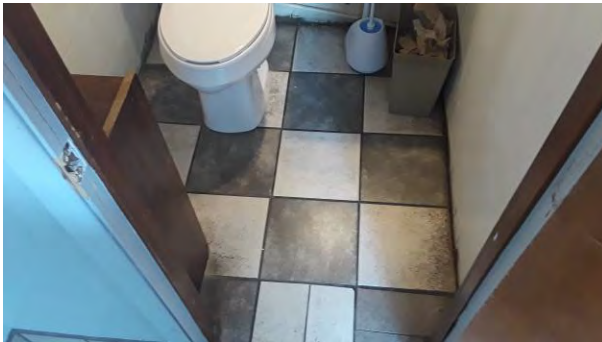
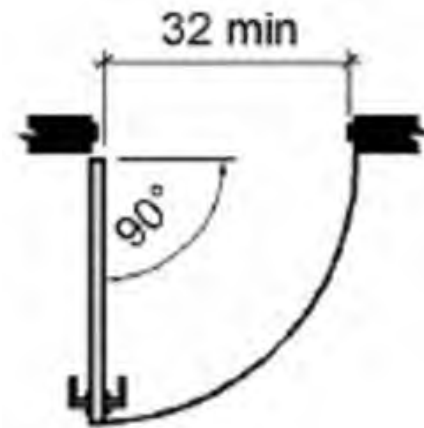
Front Office Restroom**Finding: 11****Budget: Refer to Finding 6****Recommendation:**

**Hinged Door or Gate****As Built:**

The door opening is 24". The door opening does not provide at least 32 inches between the face of the door and the opposite stop. Door openings shall provide a clear width of 32 inches minimum. Clear openings of doorways with swinging doors shall be measured between the face of the door and the stop, with the door opening 90 degrees. There shall be no projections into the required clear opening width lower than 34 inches above the finish floor or ground. Projections into the clear opening width between 34 inches and 80 inches above the finish floor or ground shall not exceed 4 inches.

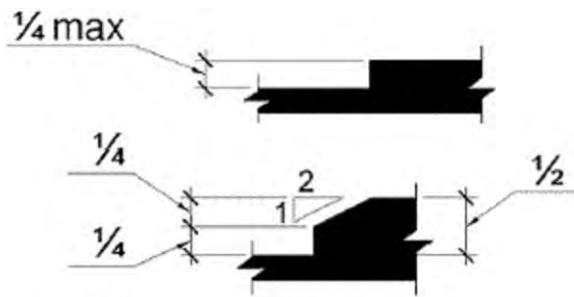
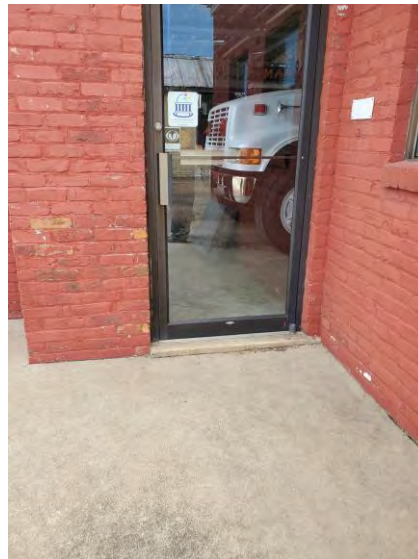
As Built:

The threshold is greater than 1/2 inch high.

PRIORITY 5 (Recommended)			
Estimated Cost	Location	Finding	Distress/ Description/ Recommendation
\$1,500	Total		
\$1,500	Entrance	1	This appears to be the main entrance to the building. Provide ramp at entrance or install signage identifying location of accessible entrance. Can access interior through large bay doors without obstruction.

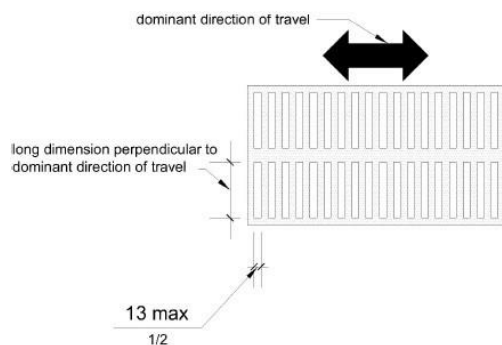
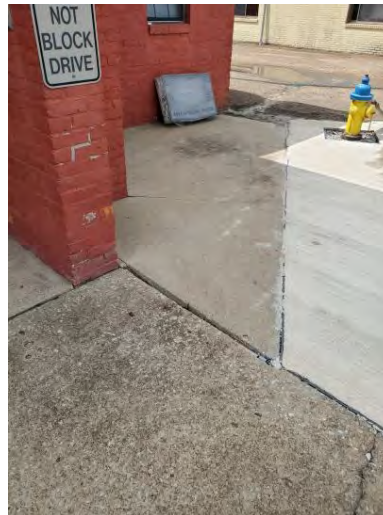
Entrance**Finding: 2****Budget: \$200****Recommendation:**

**As Built:**

The surface of the pedestrian access route has openings greater than 1/2 inch.

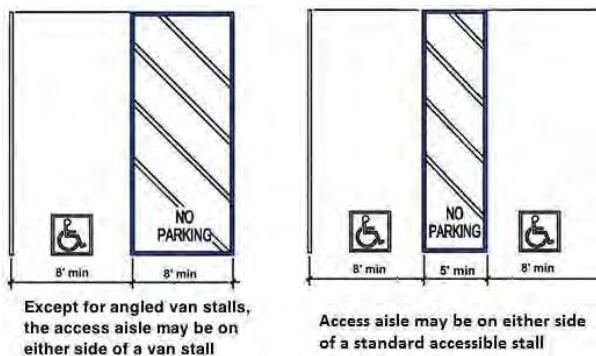
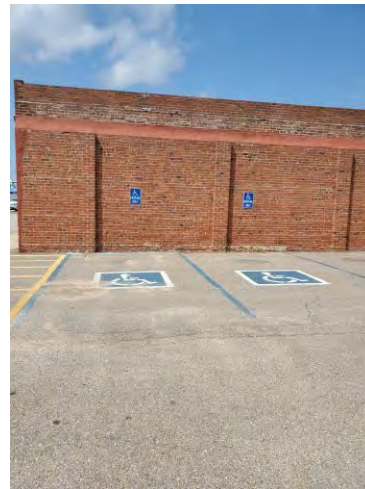
Parking**Finding: 3****Budget: \$1,000****Recommendation:**

**As Built:**

This accessible parking is in the City lot across the street from the fire station. It is on the closest route to fire station as there is no on site parking at the fire station.

The access aisle is missing at the accessible parking stall. Access aisles serving parking spaces shall adjoin an accessible route. Two parking spaces shall be permitted to share a common access aisle.

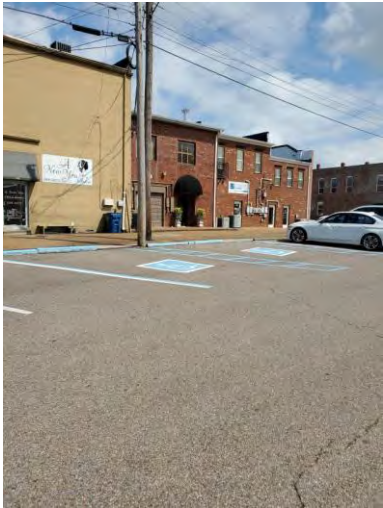
As Built:
There are no van accessible parking stalls. 4 stalls striped as accessible, no van designation, 2 have no signs, 1 with no access aisle, 2 with too small access aisle (3' aisle with 11' stalls).
One in every 6, minimum of one, required accessible stalls must be a van accessible stall. There are a total of (75) parking stalls in the parking lot that could be reasonably associated with this facility. There should be a minimum of (3) accessible stalls with a minimum of (1) being designed as van accessible.

Citation: 2010 ADAS Section 208.2
Parking spaces complying with 502 shall be provided in accordance with Table 208.2 except as required by 208.2.1, 208.2.2, and 208.2.3. Where more than one parking facility is provided on a site, the number of accessible spaces provided on the site shall be calculated according to the number of spaces required for each parking facility.

Recommendation:
The parking lot serving the fire station has 4 total accessible spaces marked. Provide 3 spaces total, 1 of which must be van accessible. Include striping and signage upgrades to reach compliance.

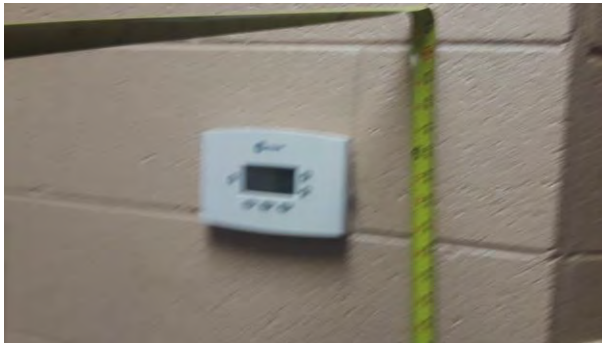
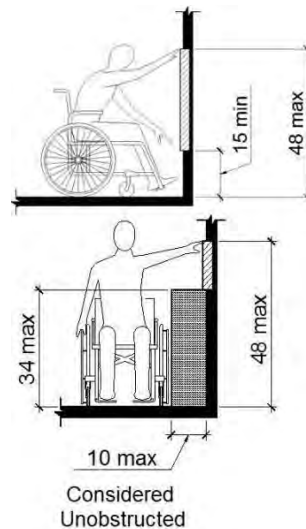
It is 56" to bottom of thermostat.

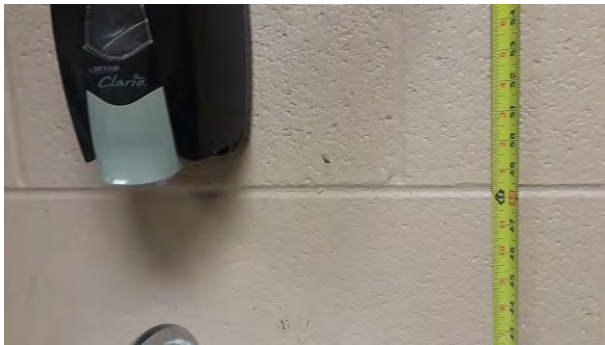
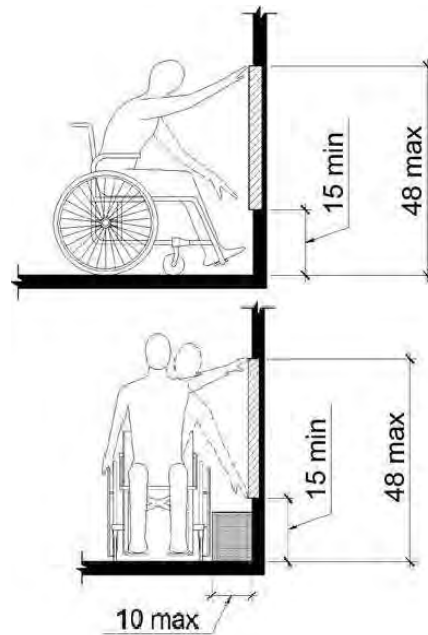
Pentagon Concessions**Finding: 2A****Budget: \$250****Recommendation:**

The soap dispenser 50" to push release.

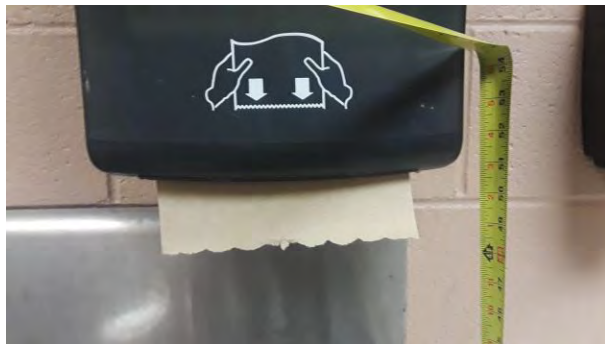
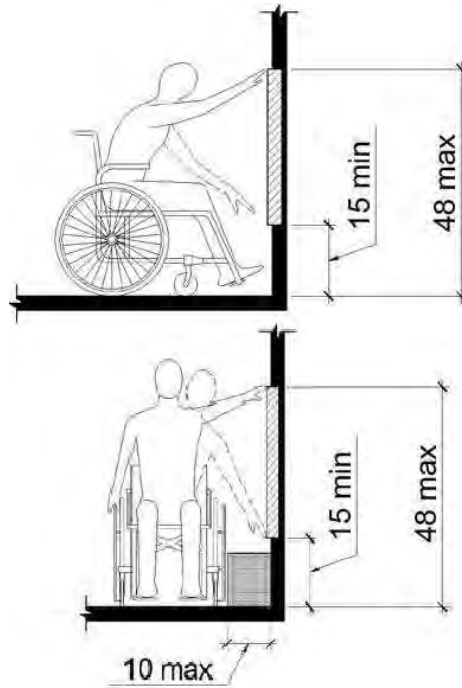
Pentagon Concessions**Finding: 3A****Budget: Refer to Finding 2A****Recommendation:**

The paper towel dispenser is 51" to bottom.

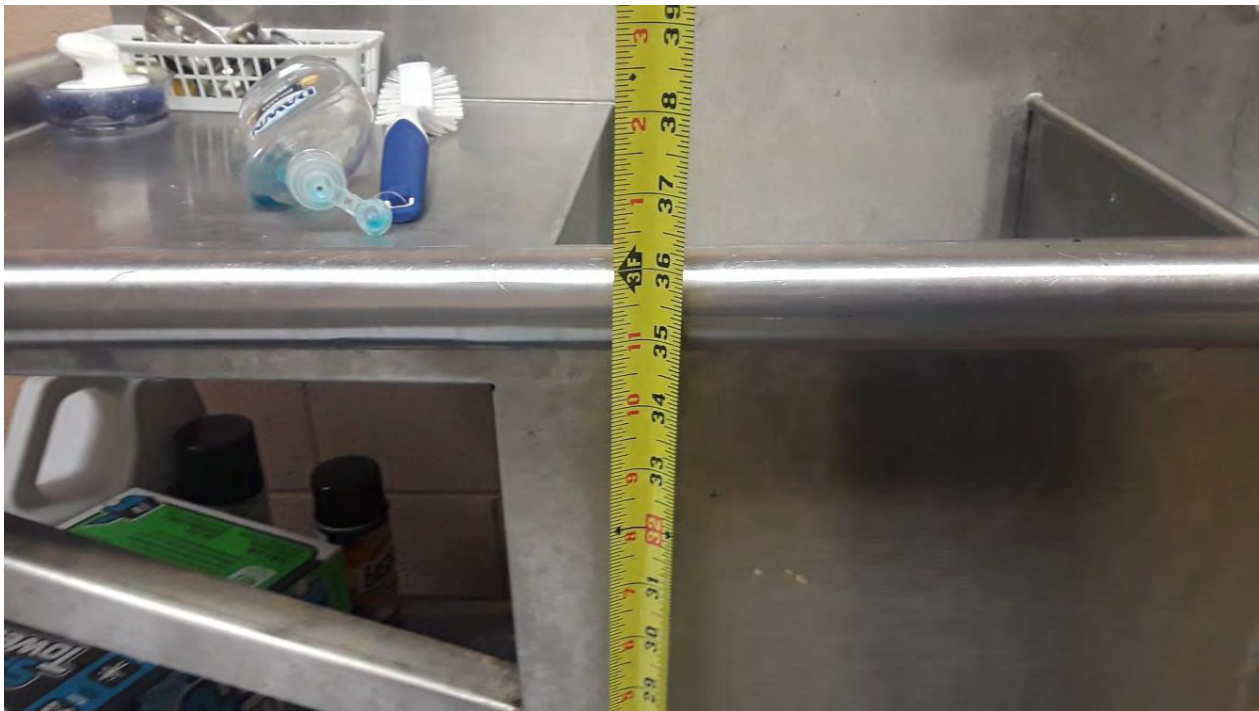
Pentagon Concessions**Finding: 4A****Budget: \$750****Recommendation:**

The 3 compartment sink is 36" AFF.

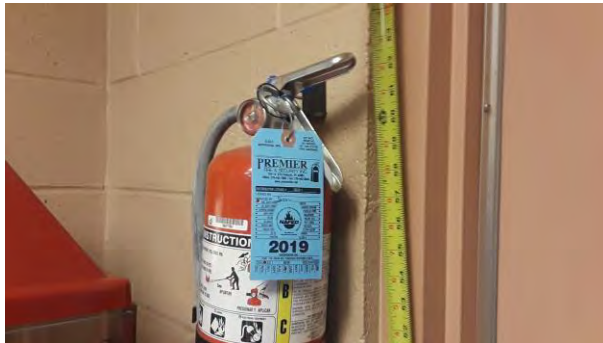
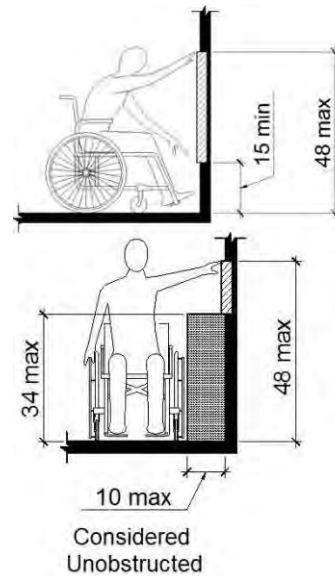
Pentagon Concessions**Finding: 5A****Budget: \$150****Recommendation:**

The fire extinguisher is 60" to handle.

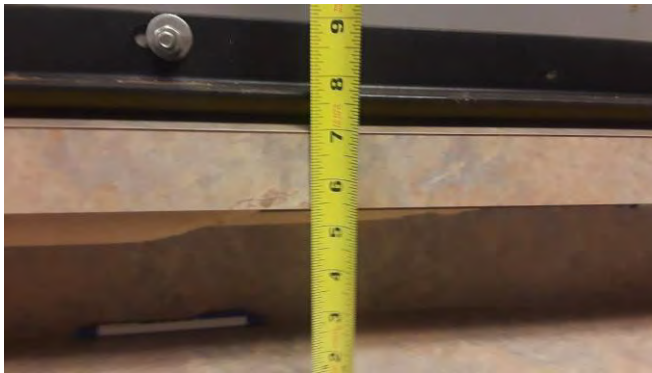
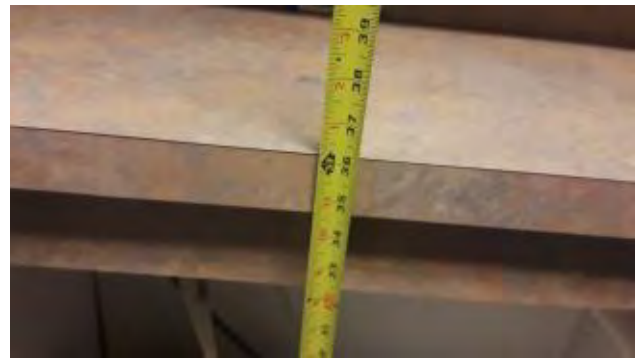
Pentagon Concessions**Finding: 6A****Budget: \$11,200****Recommendation:**

The counter is at 43" AFF.

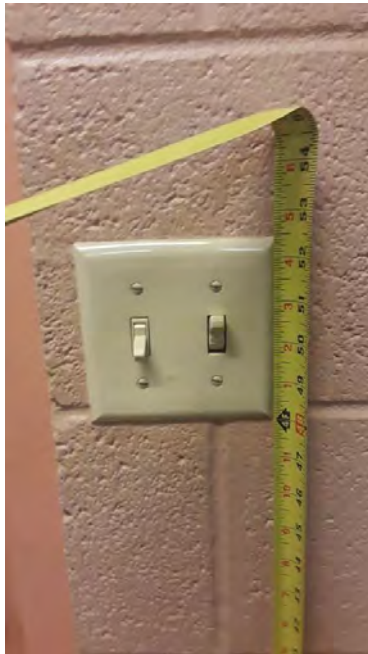
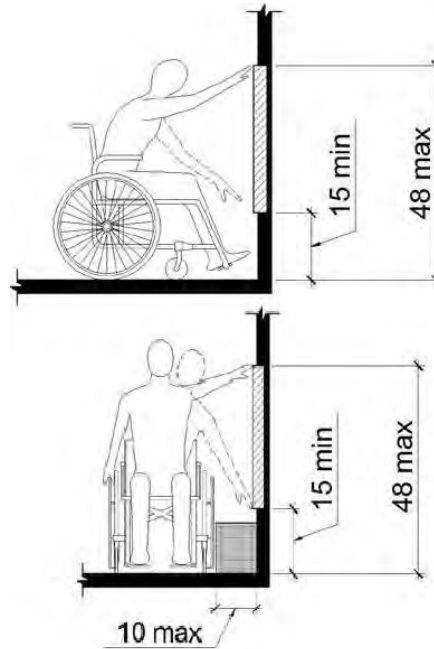
Pentagon Concessions**Finding: 7A****Budget: \$550****Recommendation:**

The switches are at 50.5" AFF.

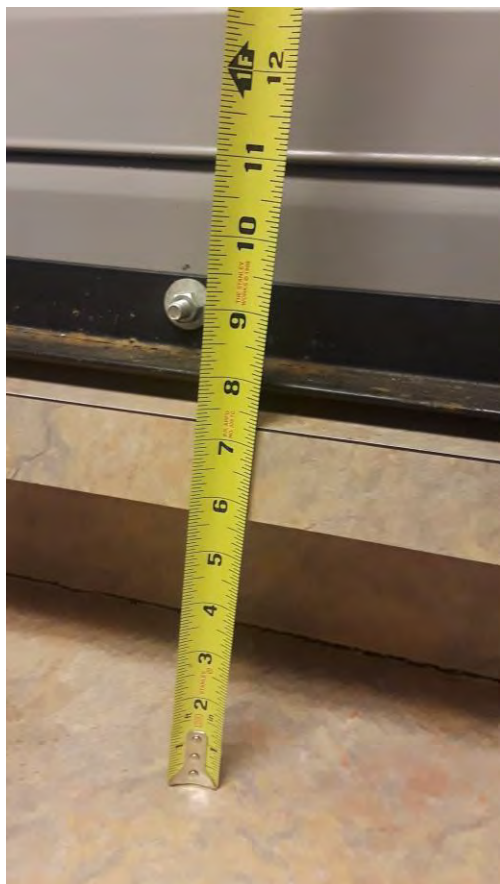
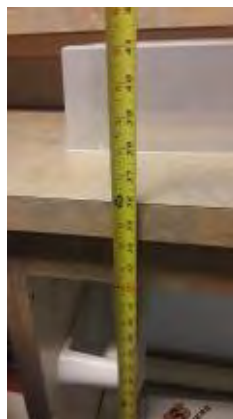
Pentagon Concessions**Finding: 8A****Budget: \$11,200****Recommendation:**

The countertop is 43" AFF.

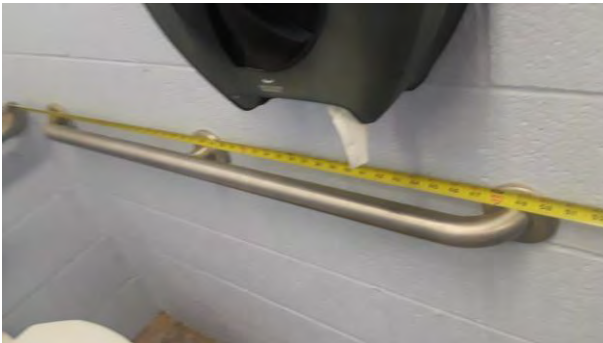
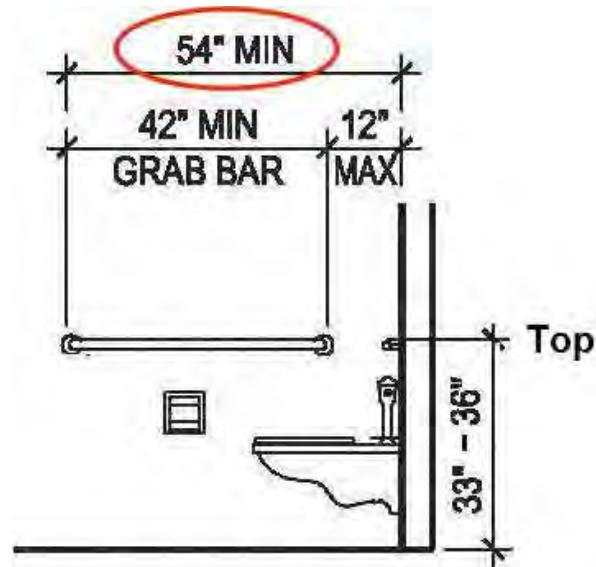
Pentagon Men's Restroom**Finding: 9A****Budget: \$350****Recommendation:**

The grab bar is 49" from wall. The side grab bar does not extend far enough from the rear wall.

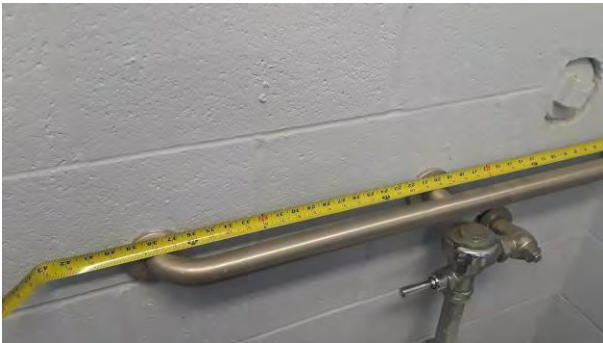
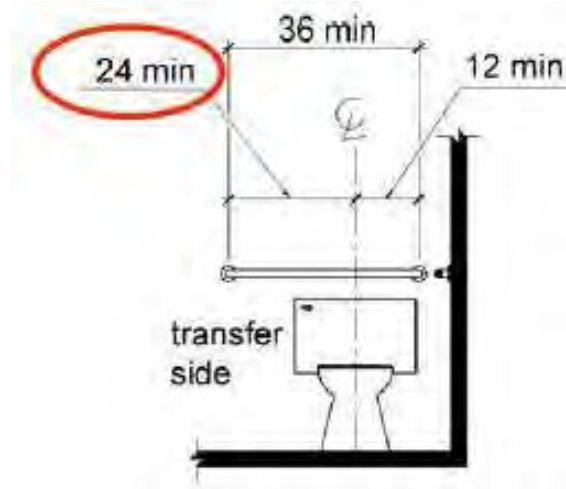
Pentagon Men's Restroom**Finding: 10A****Budget: Refer to Finding 9A****Recommendation:**

The rear grab bar only extends only 18".

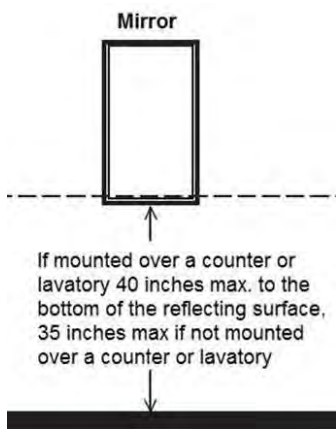
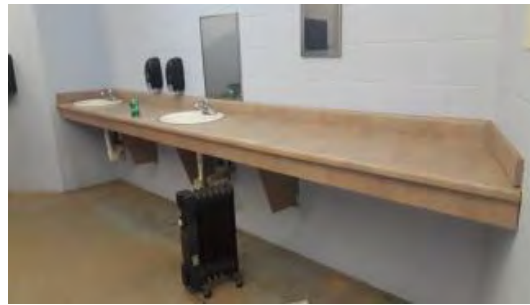
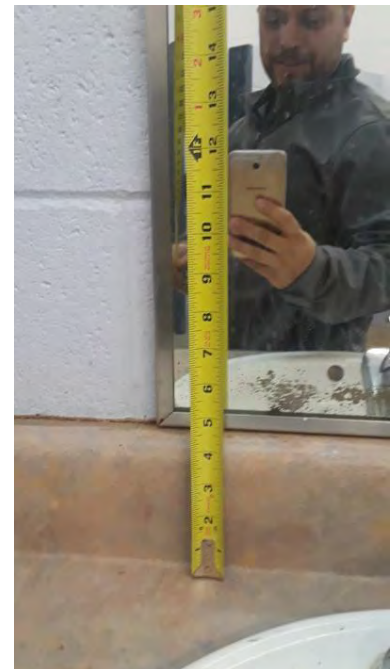
Pentagon Men's Restroom**Finding: 11A****Budget: \$2,400****Recommendation:**

The mirror at 42" to reflecting surface.

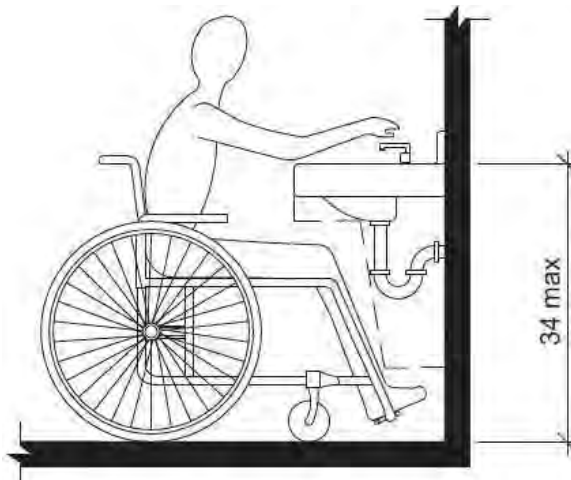
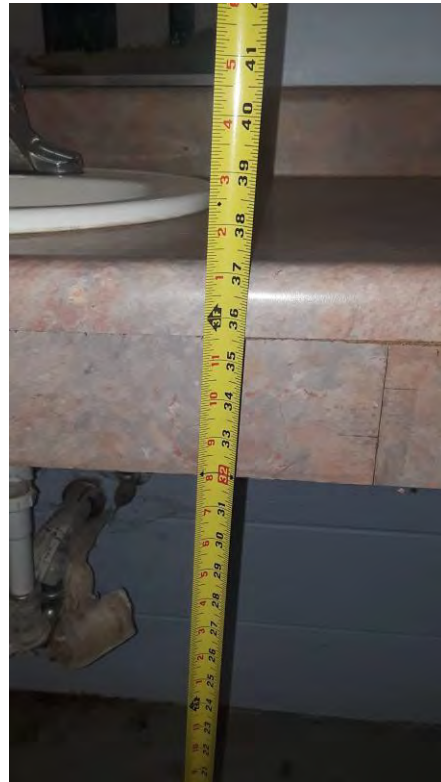
Pentagon Men's Restroom**Finding: 12A****Budget: Refer to Finding 11A****Recommendation:**

The countertop at 37" AFF. The top rim of the lavatory is too high.

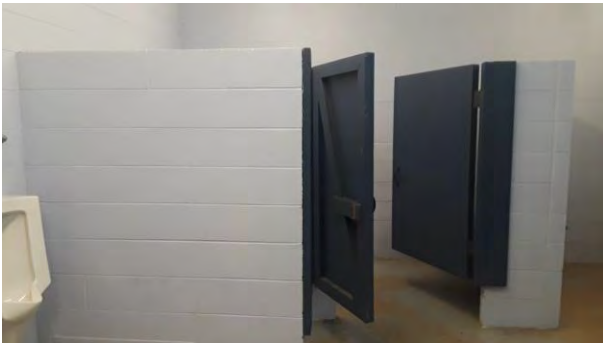
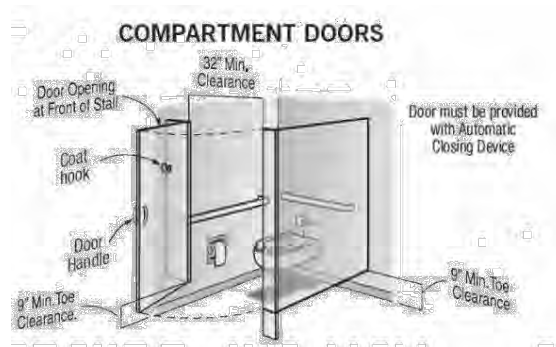
Pentagon Men's Restroom**Finding: 13A****Budget: \$350****Recommendation:**

The compartment door is not self closing.

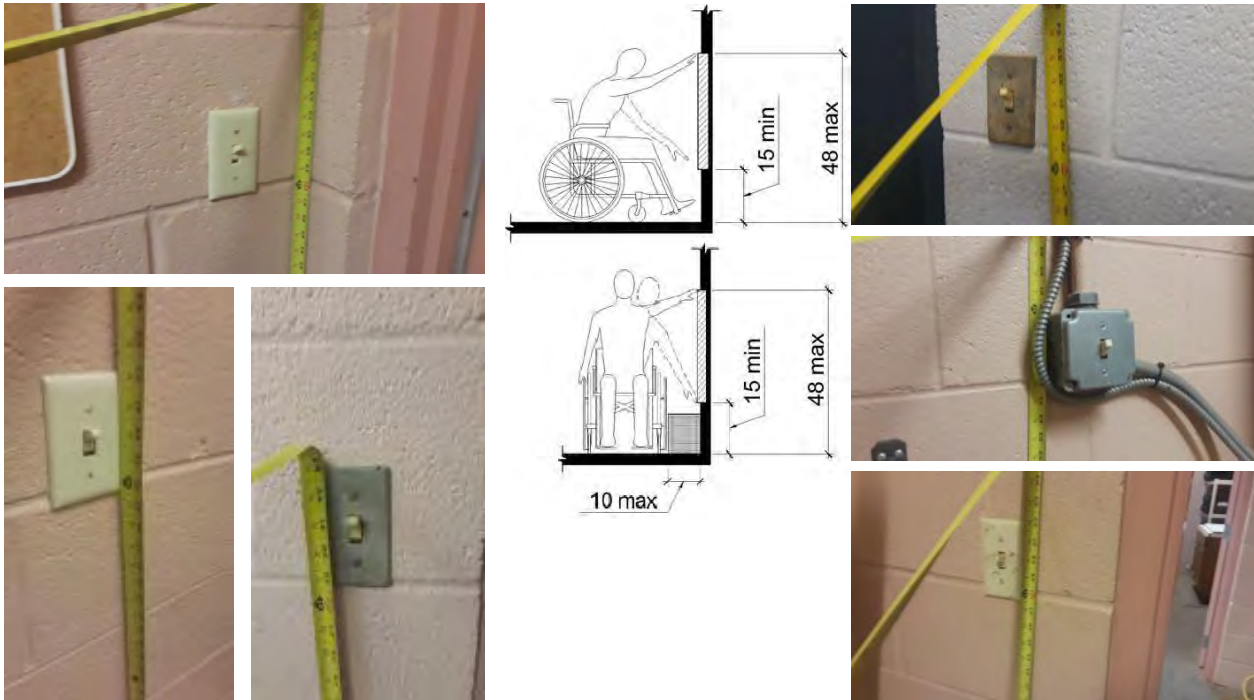
Throughout Pentagon Building**Finding: 14A****Budget: \$3,000****Recommendation:**

The switches at 50" AFF.

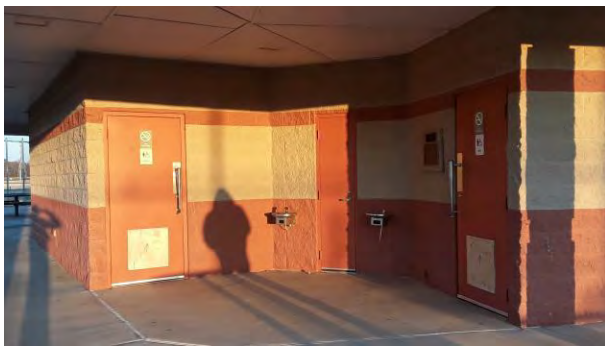
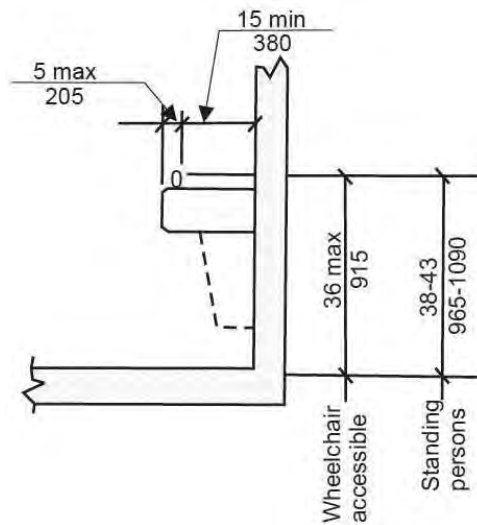
Pentagon Water Fountain**Finding: 15A****Budget: \$6,500****Recommendation:**

There is no drinking fountain for standing persons.

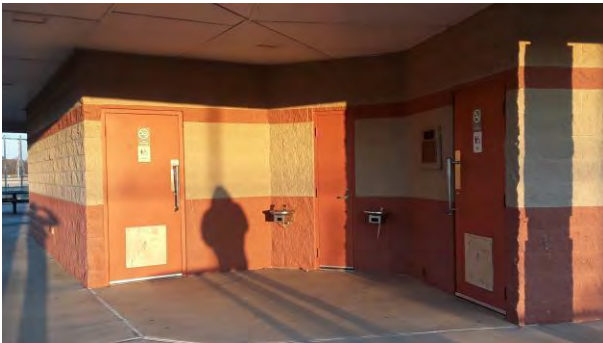
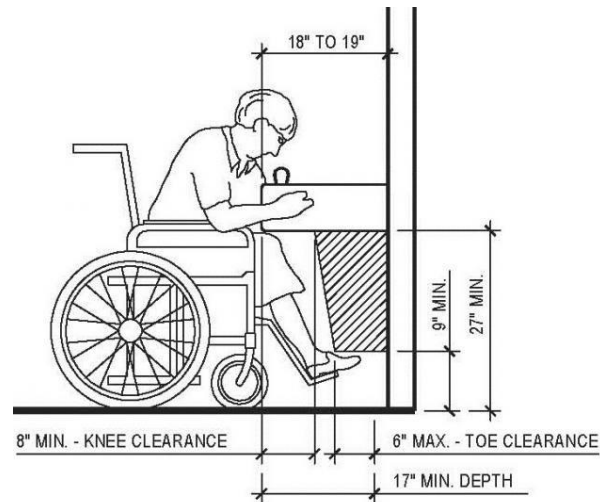
Pentagon Water Fountain**Finding: 16A****Budget: Refer to Finding 15A****Recommendation:**

The knee space is 13\".

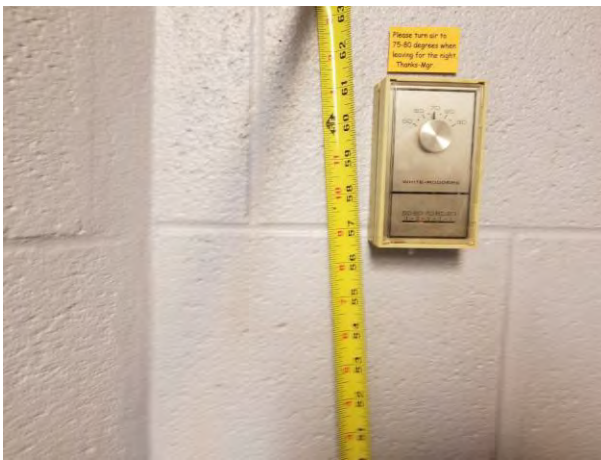
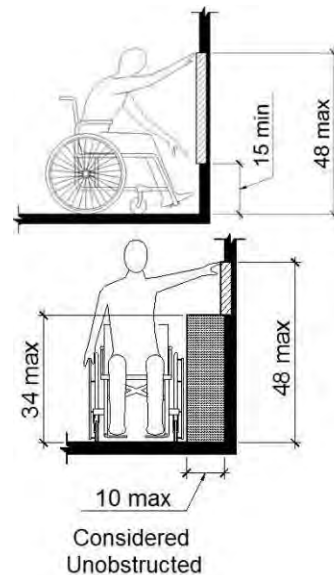
Baseball Concessions**Finding: 1B****Budget: \$1,200****Recommendation:**

The thermostat is at 57" AFF to bottom.

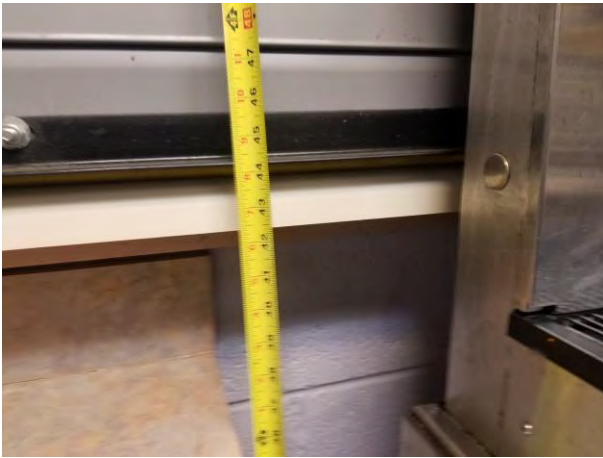
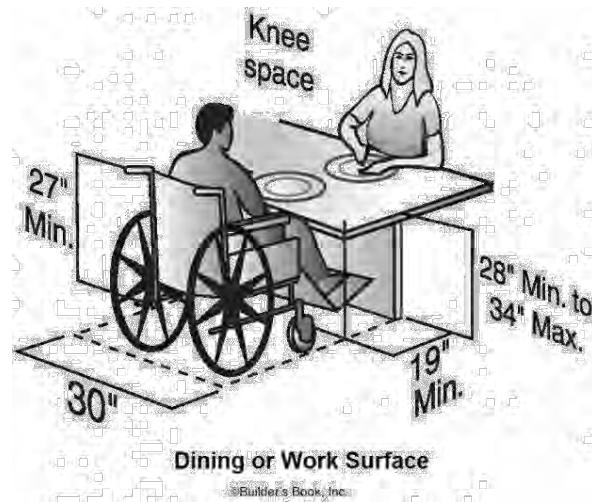
Baseball Concessions**Finding: 2B****Budget: \$15,500****Recommendation:**

The concessions counter is 44" AFF.

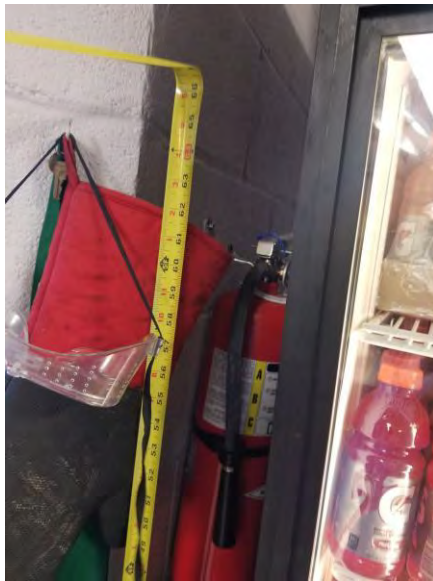
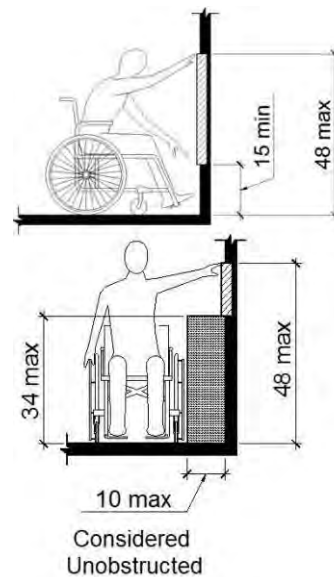
Baseball Concessions**Finding: 3B****Budget: \$100****Recommendation:**

The fire extinguisher is 60" to handle.

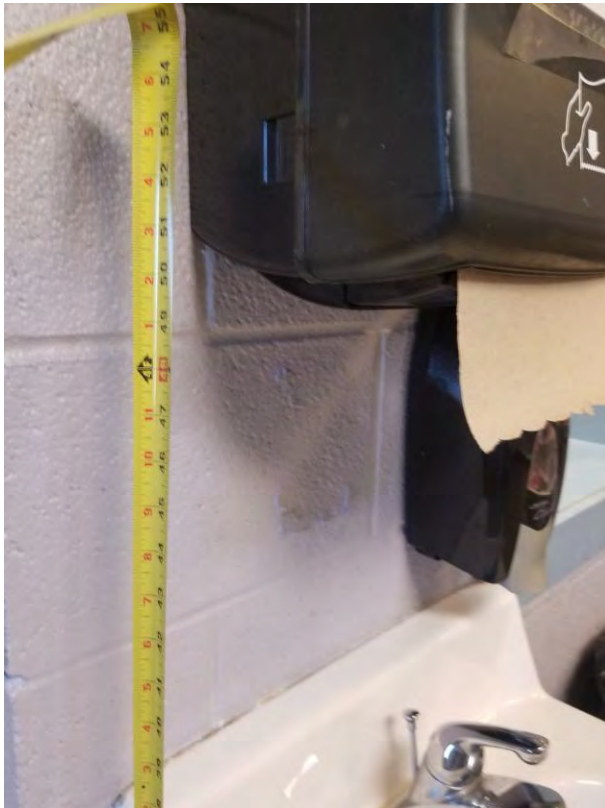
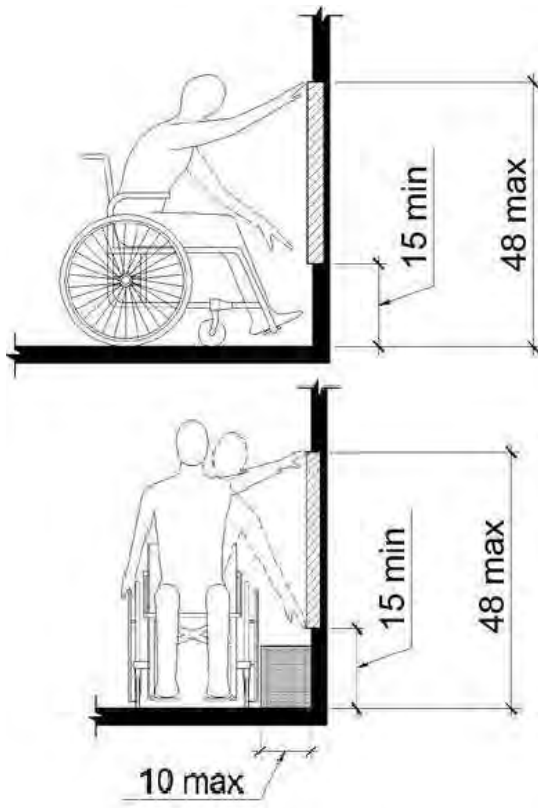
Baseball Concessions**Finding: 4B****Budget: \$100****Recommendation:**

The paper towel dispenser is 50" AFF.

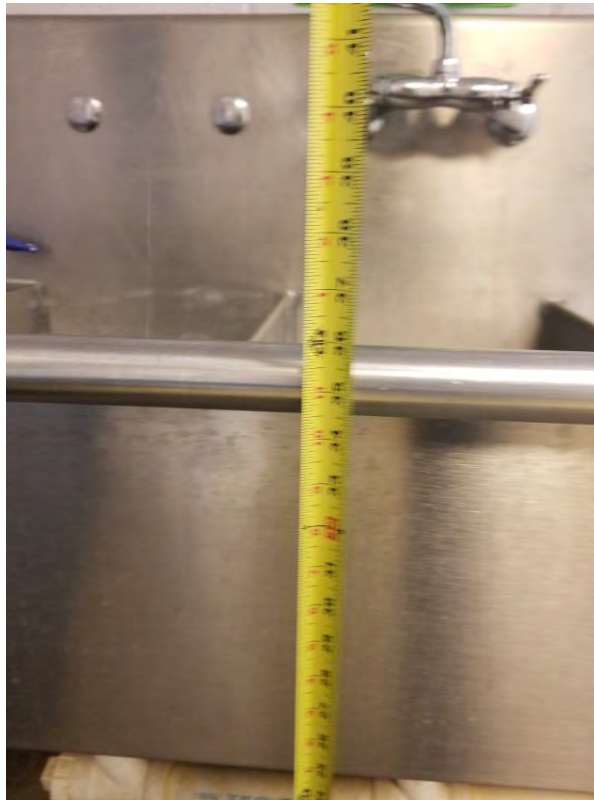
Baseball Concessions**Finding: 5B****Budget: \$500****Recommendation:**

The sink is at 36" AFF. The top of the sink is too high.

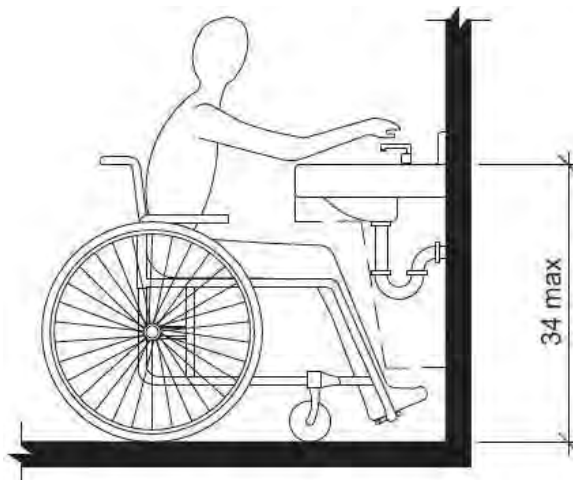
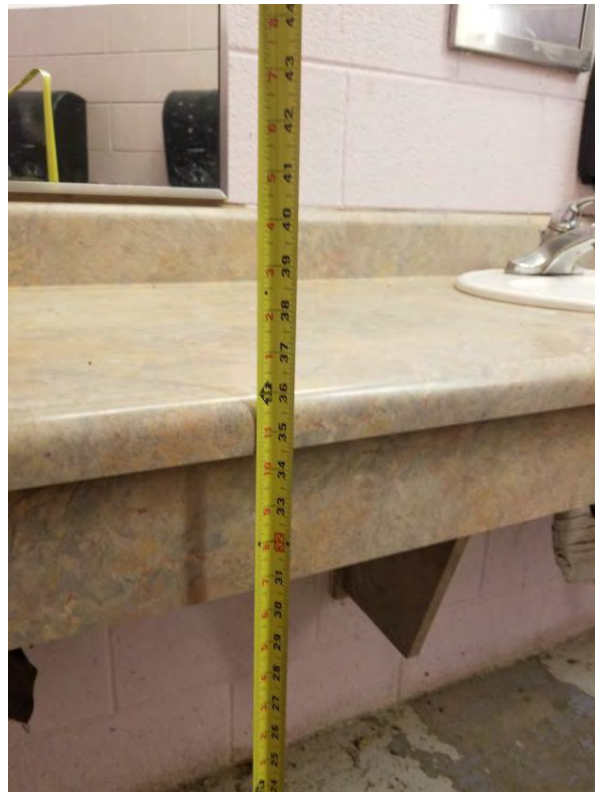
Baseball Women's Restroom**Finding: 6B****Budget: \$3,250****Recommendation:**

3 (Moderate): Should be completed as soon as possible, but there may be other items that will provide greater access to persons with disabilities. (Includes; Findings that have a high financial impact on the entity in relationship to the degree of access provided)

**As Built:**

The countertop is 36" AFF

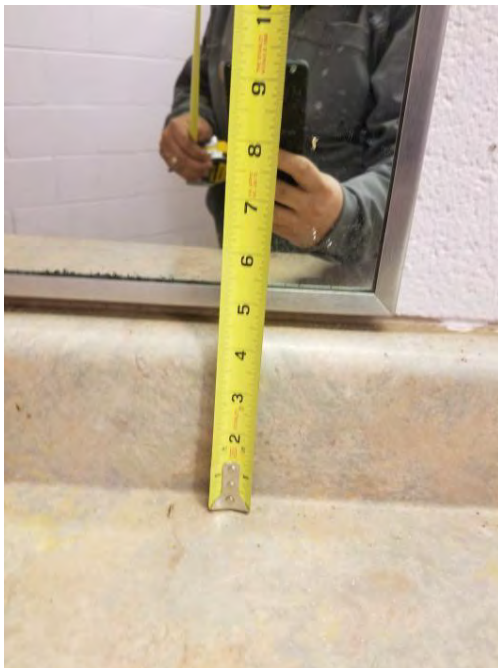
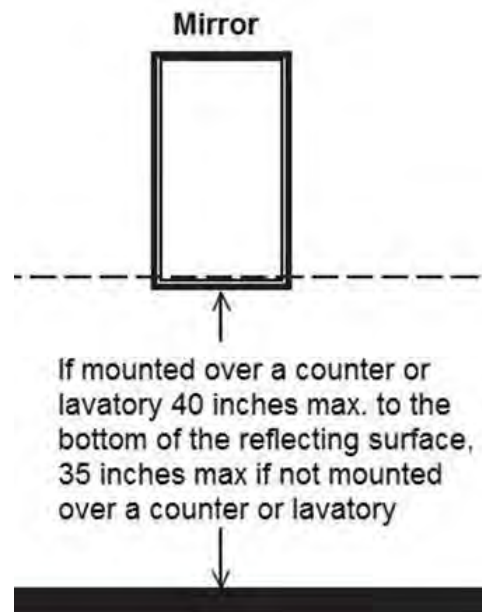
Baseball Women's Restroom**Finding: 7B****Budget: \$2,000****Recommendation:**

3 (Moderate): Should be completed as soon as possible, but there may be other items that will provide greater access to persons with disabilities. (Includes; Findings that have a high financial impact on the entity in relationship to the degree of access provided)

The reflecting surface is 41.5" AFF. The mirror is mounted too high.

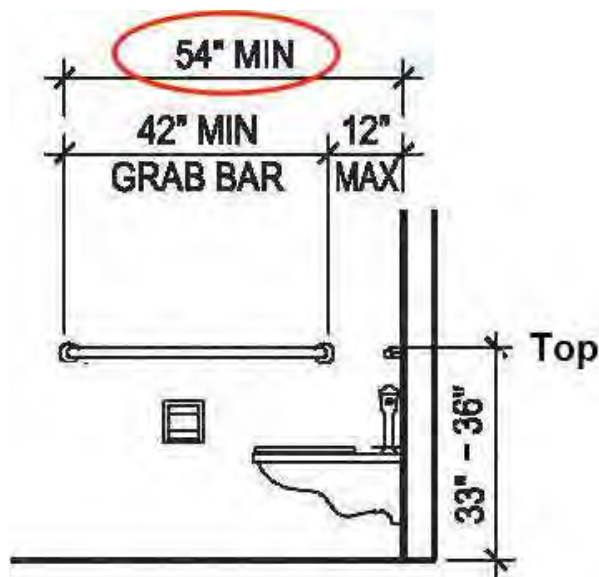
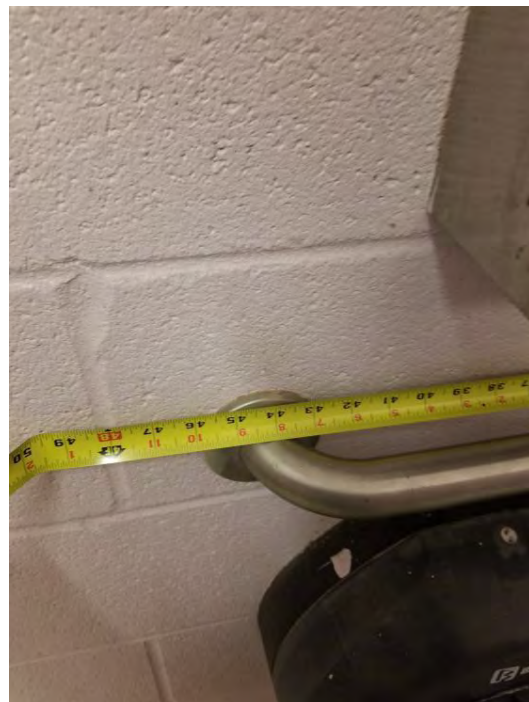
Baseball Women's Restroom**Finding: 8B****Budget: \$350****Recommendation:**

3 (Moderate): Should be completed as soon as possible, but there may be other items that will provide greater access to persons with disabilities. (Includes; Findings that have a high financial impact on the entity in relationship to the degree of access provided)

The grab bar is 45" to wall. The side grab bar does not extend far enough from the rear wall.
