ADA Self-Evaluation and Transition Plan

January 2020

Opera House
RESTAURANT

Prepared by:

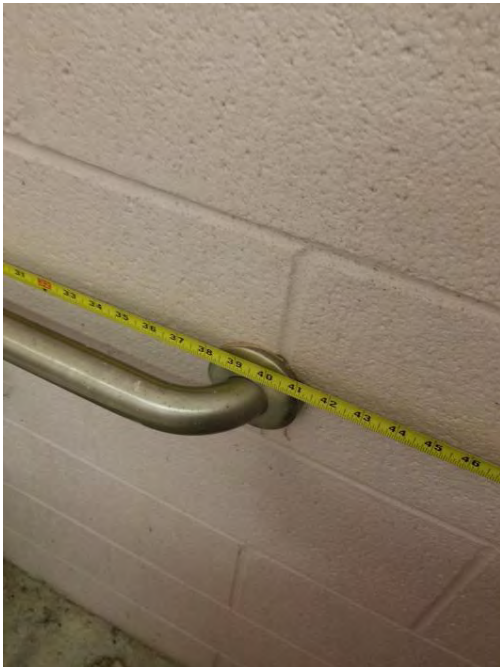
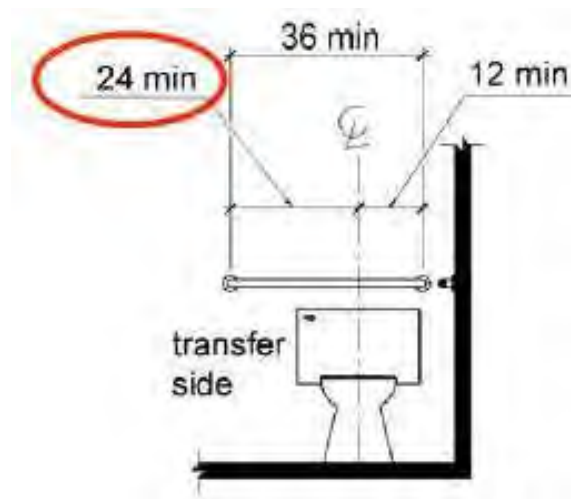
Baseball Women's Restroom**Finding: 9B****Budget: Refer to Finding 8B****Recommendation:**

3 (Moderate): Should be completed as soon as possible, but there may be other items that will provide greater access to persons with disabilities. (Includes; Findings that have a high financial impact on the entity in relationship to the degree of access provided)

The grab bar only extends 18". The rear grab bar does not extend adequately past the toilet on the wide side.

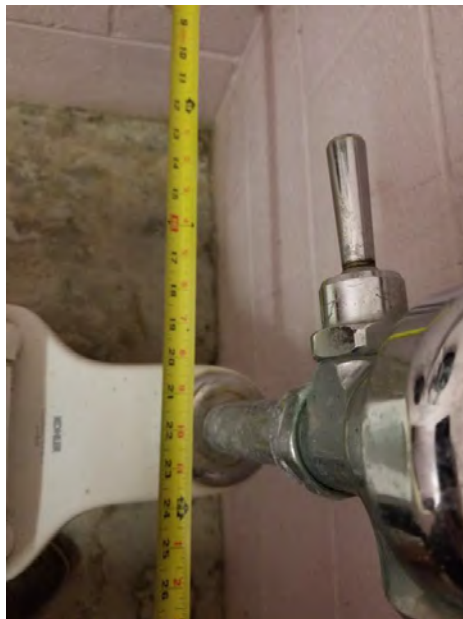
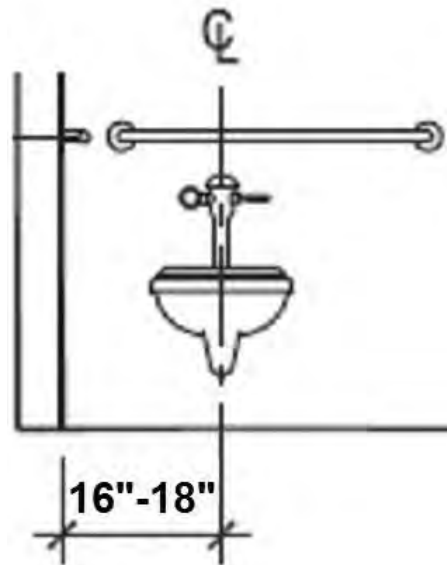
Baseball Women's Restroom**Finding: 10B****Budget: \$2,000****Recommendation:**

3 (Moderate): Should be completed as soon as possible, but there may be other items that will provide greater access to persons with disabilities. (Includes; Findings that have a high financial impact on the entity in relationship to the degree of access provided)

The toilet is 22" to wall. The toilet is not located within the range allowed from the side wall or partition. The centerline of the toilet must be 16 to 18 inches from the side wall.

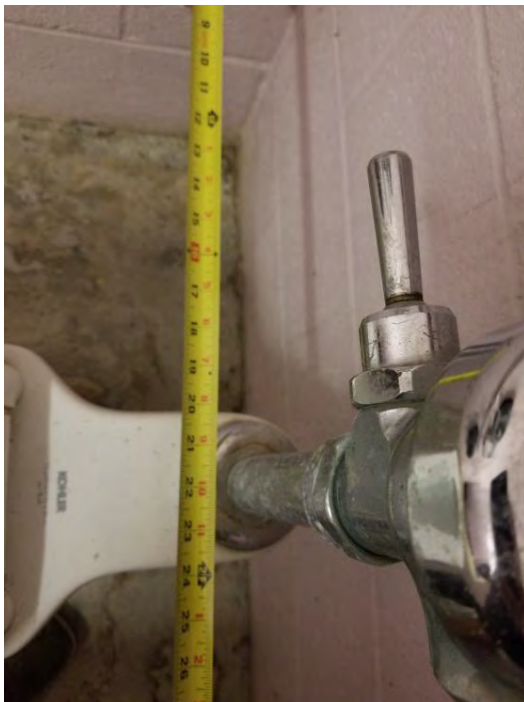
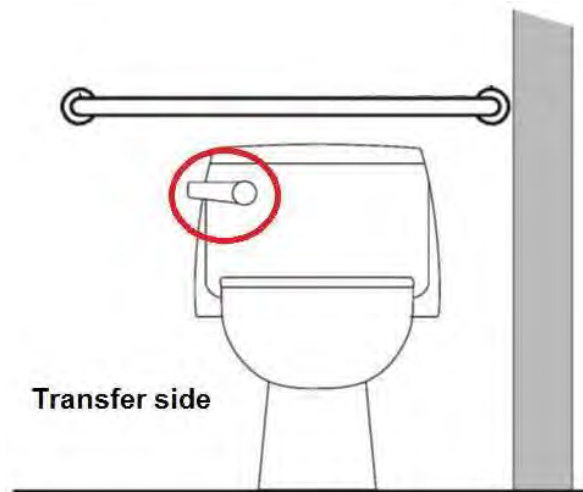
Baseball Women's Restroom**Finding: 11B****Budget: \$2,000****Recommendation:**

3 (Moderate): Should be completed as soon as possible, but there may be other items that will provide greater access to persons with disabilities. (Includes; Findings that have a high financial impact on the entity in relationship to the degree of access provided)

The flush handle is on closed side. The flush handle is located on the wrong side of the toilet.

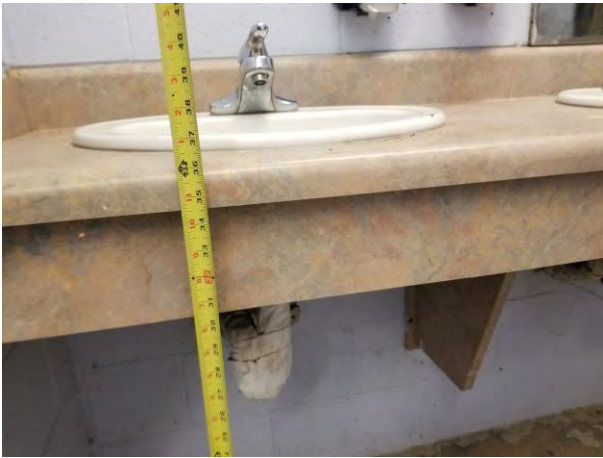
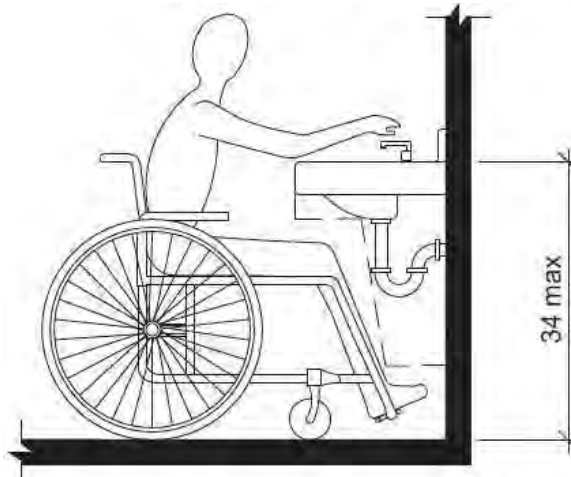
Baseball Men's Restroom**Finding: 12B****Budget: \$3,250****Recommendation:**

3 (Moderate): Should be completed as soon as possible, but there may be other items that will provide greater access to persons with disabilities. (Includes; Findings that have a high financial impact on the entity in relationship to the degree of access provided)

The lavatory is 36" AFF. The top rim of the lavatory is too high.

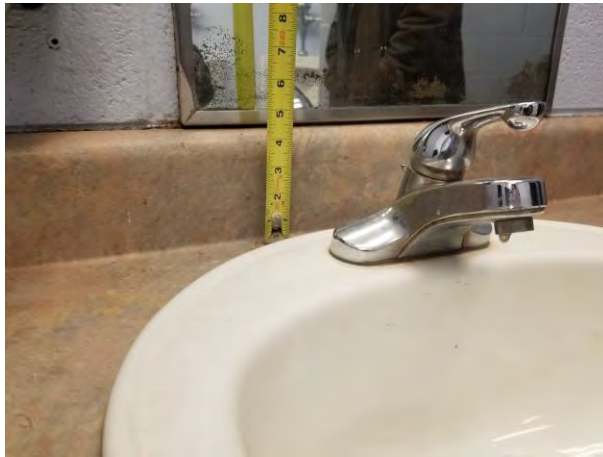
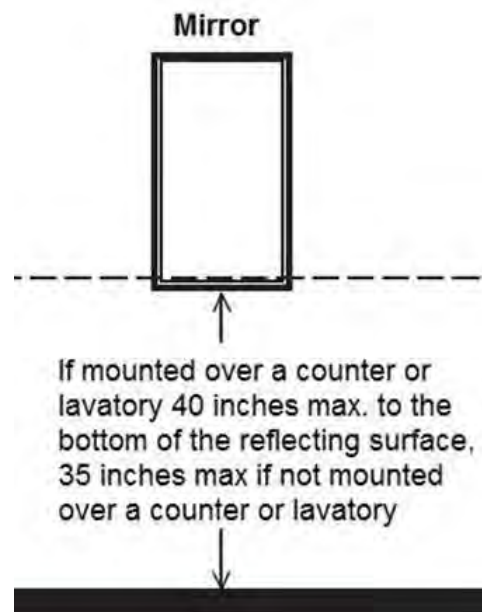
Baseball Men's Restroom**Finding: 13B****Budget: \$2,000****Recommendation:**

3 (Moderate): Should be completed as soon as possible, but there may be other items that will provide greater access to persons with disabilities. (Includes; Findings that have a high financial impact on the entity in relationship to the degree of access provided)

The reflecting surface is 41". The mirror is mounted too high.

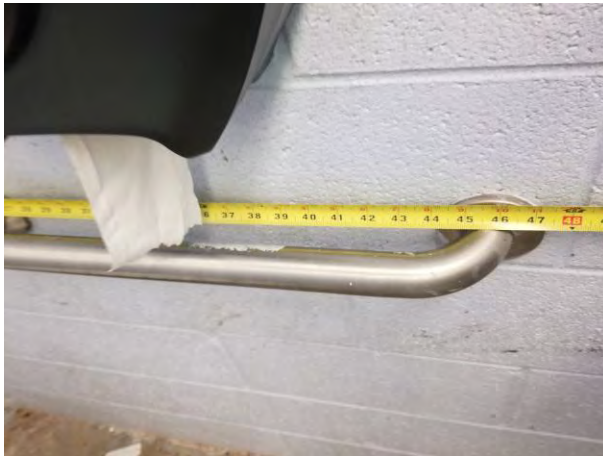
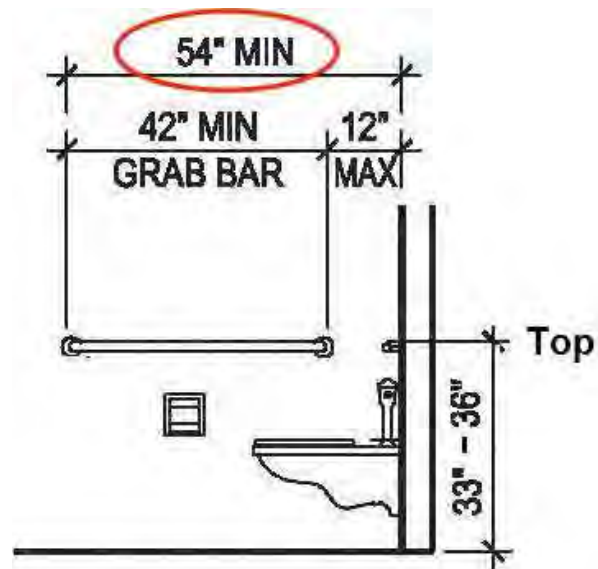
Baseball Men's Restroom**Finding: 14B****Budget: \$350****Recommendation:**

3 (Moderate): Should be completed as soon as possible, but there may be other items that will provide greater access to persons with disabilities. (Includes; Findings that have a high financial impact on the entity in relationship to the degree of access provided)

The grab bar is 46" from wall. The side grab bar does not extend far enough from the rear wall.

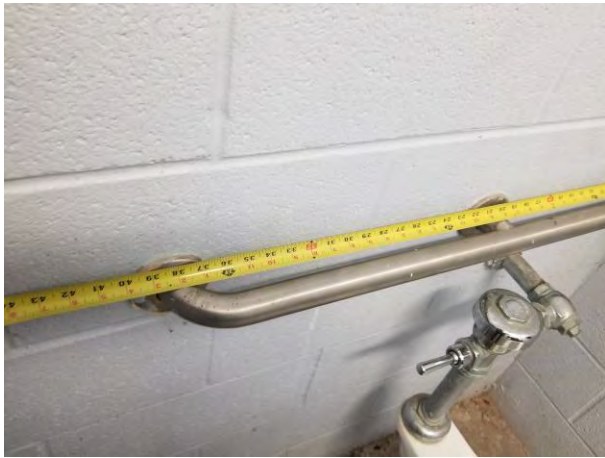
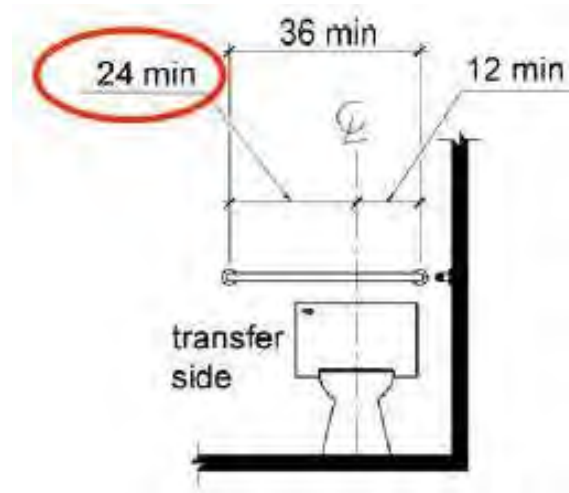
Baseball Men's Restroom**Finding: 15B****Budget: Refer to Finding 14B****Recommendation:**

3 (Moderate): Should be completed as soon as possible, but there may be other items that will provide greater access to persons with disabilities. (Includes; Findings that have a high financial impact on the entity in relationship to the degree of access provided)

The grab bar only extends 18". The rear grab bar does not extend adequately past the toilet on the wide side.

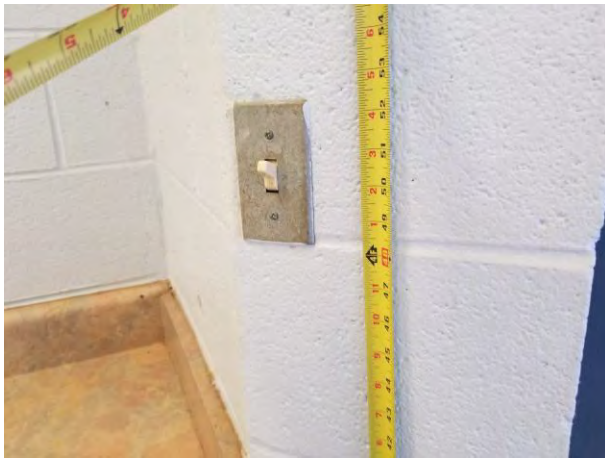
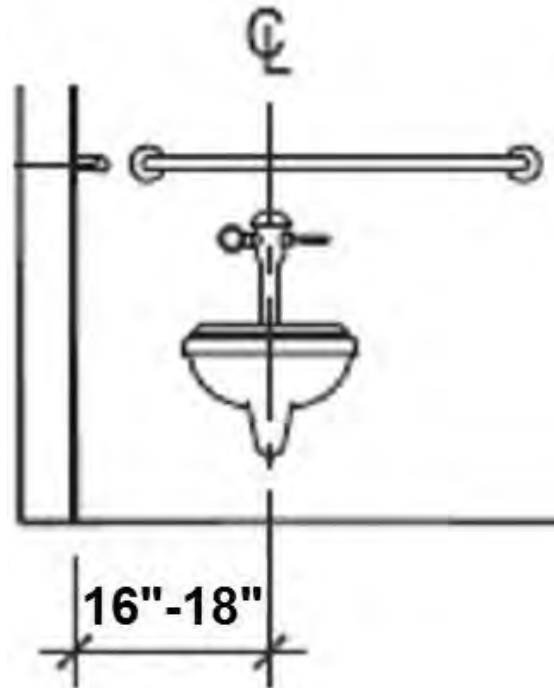
Baseball Men's Restroom**Finding: 16B****Budget: \$2,000****Recommendation:**

4 (Low): Should be completed as soon as possible due to being a technical violation, but may not result in providing greater access to persons with disabilities. (Includes; Findings that are technically violations but provide a moderate to low increase in accessibility compared to the financial impact on the entity)

The water closet is 23" to wall. The toilet is not located within the range allowed from the side wall or partition. The centerline of the toilet must be 16 to 18 inches from the side wall.

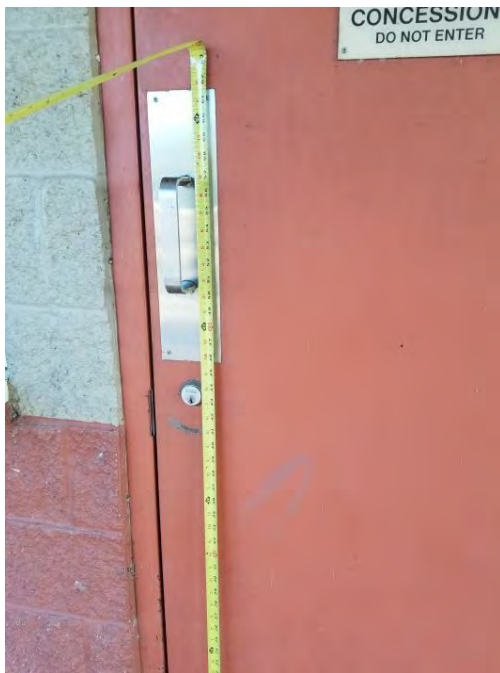
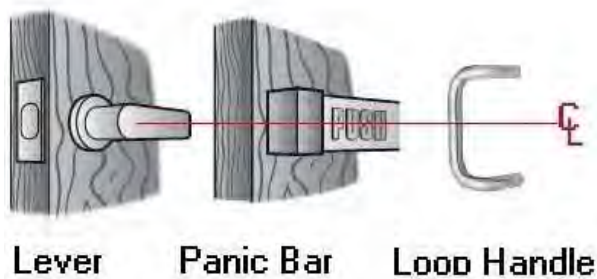
Baseball Men's Restroom**Finding: 17B****Budget: \$6,000****Recommendation:**

2 (Important): Should be completed as soon as possible. (Includes; Findings that would remove barriers to the greatest number of people to your goods and services)

Operating hardware must be centered between 34" and 48" above the floor or ground

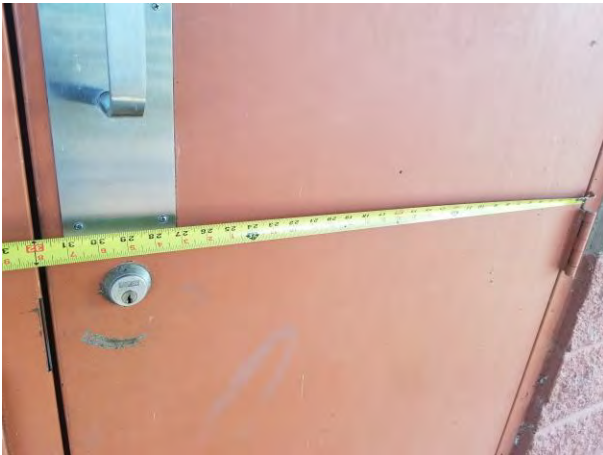
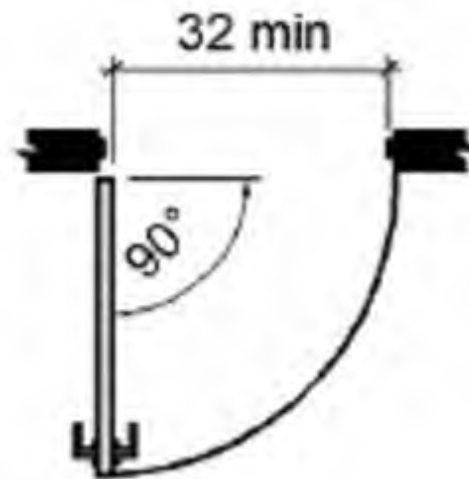
Baseball Men's Restroom**Finding: 18B****Budget: Refer to Finding 17B****Recommendation:**

2 (Important): Should be completed as soon as possible. (Includes; Findings that would remove barriers to the greatest number of people to your goods and services)

The door opening is 31.5". The door opening does not provide at least 32 inches between the face of the door and the opposite stop.

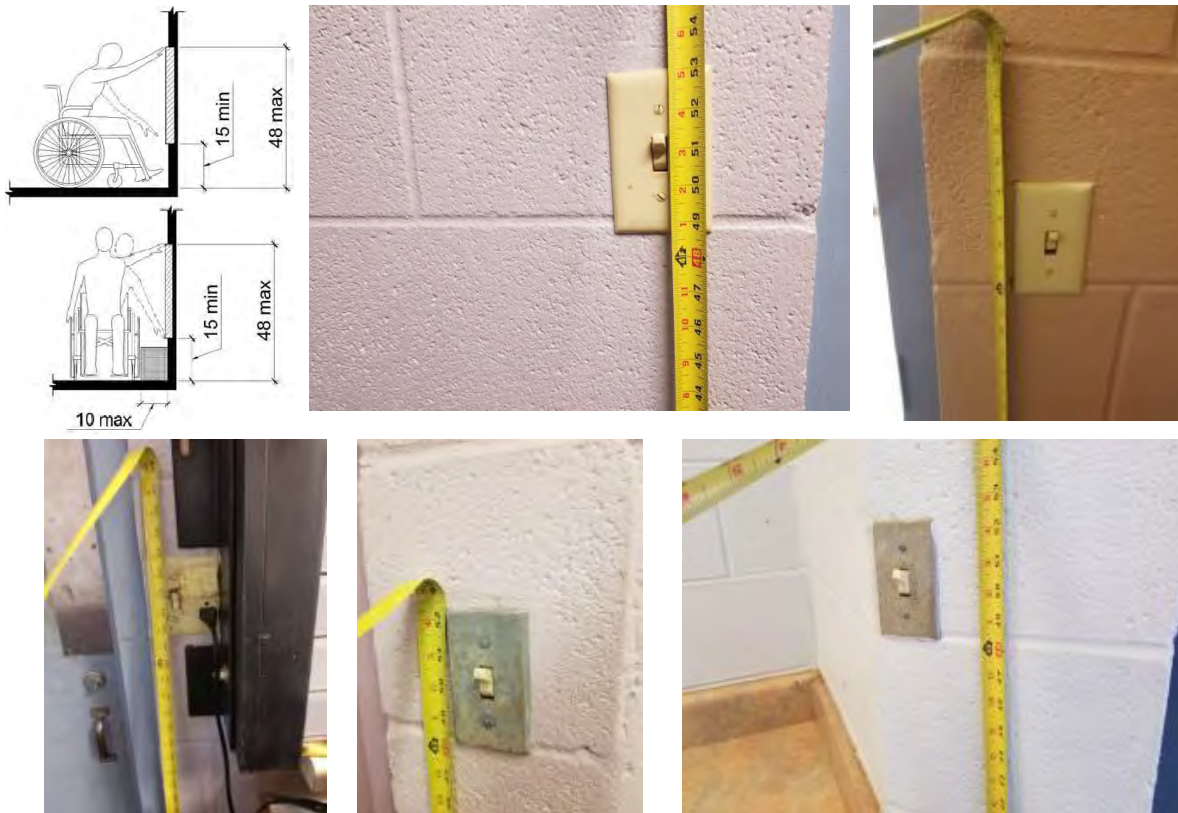
Throughout Baseball Building**Finding: 19B****Budget: \$2,800****Recommendation:**

4 (Low): Should be completed as soon as possible due to being a technical violation, but may not result in providing greater access to persons with disabilities. (Includes; Findings that are technically violations but provide a moderate to low increase in accessibility compared to the financial impact on the entity)

The switch is at 51" AFF. receptacle/switch is not positioned correctly for either a side or front approach. Where a clear floor or ground space allows a parallel or front approach to a switch or receptacle and the side reach is unobstructed, the high side reach shall be 48 inches maximum above the finish floor or ground and the low side reach shall be 15 inches minimum above the finish floor or ground.

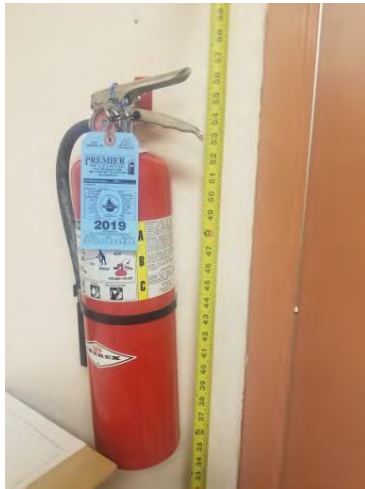
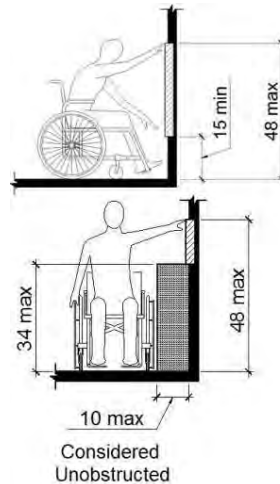
4 (Low): Should be completed as soon as possible due to being a technical violation, but may not result in providing greater access to persons with disabilities. (Includes; Findings that are technically violations but provide a moderate to low increase in accessibility compared to the financial impact on the entity)

The fire extinguisher handle is at 55". The fire extinguisher is not positioned correctly for either a side or front approach.

Soccer Complex Concessions**Finding: 1C****Budget: \$150****Recommendation:****Lower fire extinguisher for handle to be 48" max AFF.****Barrier Priority:**

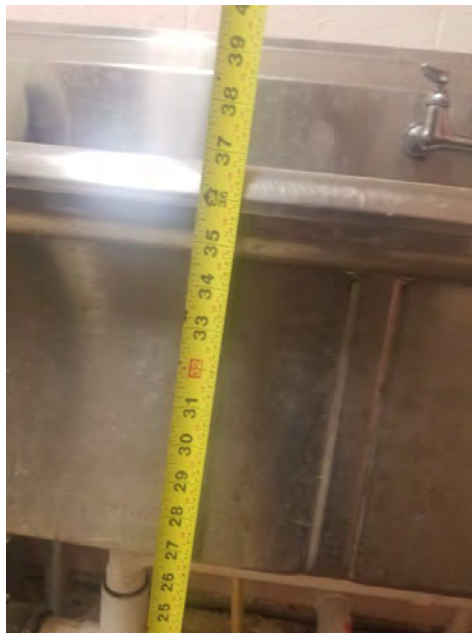
Soccer Complex Concessions**Finding: 2C****Budget: \$750****Recommendation:**

3 (Moderate): Should be completed as soon as possible, but there may be other items that will provide greater access to persons with disabilities. (Includes; Findings that have a high financial impact on the entity in relationship to the degree of access provided)

The sink is at 36.75" AFF. The top of the sink is too high.

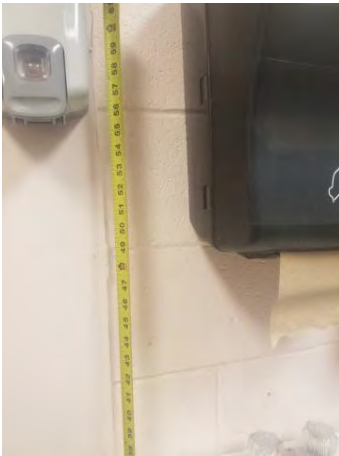
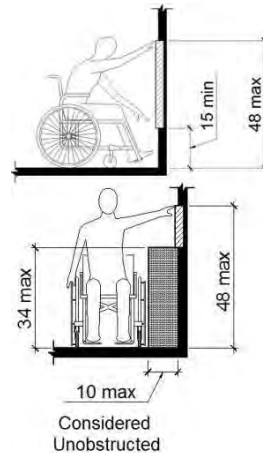
3 (Moderate): Should be completed as soon as possible, but there may be other items that will provide greater access to persons with disabilities. (Includes; Findings that have a high financial impact on the entity in relationship to the degree of access provided)

The hand sanitizer is at 54" to push release. The hand sanitizer is not positioned correctly for either a side or front approach.

Soccer Complex Concessions**Finding: 3C****Budget: \$150****Recommendation:****Lower hand sanitizer for push release to be max 48" AFF.****Barrier Priority:**

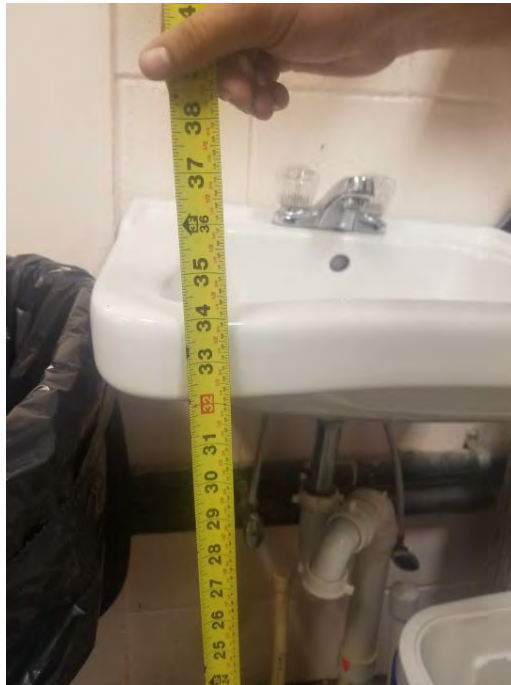
3 (Moderate): Should be completed as soon as possible, but there may be other items that will provide greater access to persons with disabilities. (Includes; Findings that have a high financial impact on the entity in relationship to the degree of access provided)

There are round turn handles at sink. The hand sink controls require tight grasping, tight pinching or twisting of the wrist to operate.

Soccer Complex Concessions**Finding: 4C****Budget: \$275****Recommendation:****Provide lever type faucet.****Barrier Priority:**

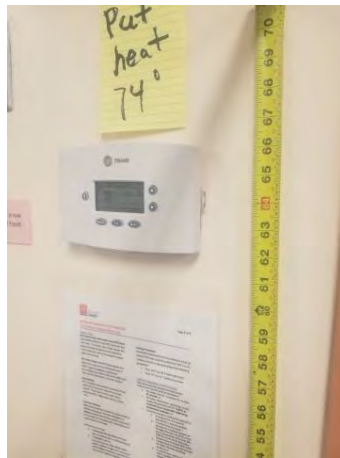
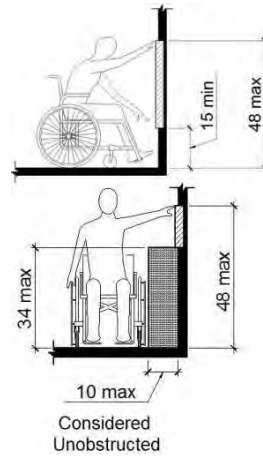
4 (Low): Should be completed as soon as possible due to being a technical violation, but may not result in providing greater access to persons with disabilities. (Includes; Findings that are technically violations but provide a moderate to low increase in accessibility compared to the financial impact on the entity)

The thermostat is 62" to bottom. The thermostat is not positioned correctly for either a side or front approach.

Soccer Complex Concessions**Finding: 5C****Budget: \$350****Recommendation:****Lower thermostat for all operable components to be 48" max AFF.****Barrier Priority:**

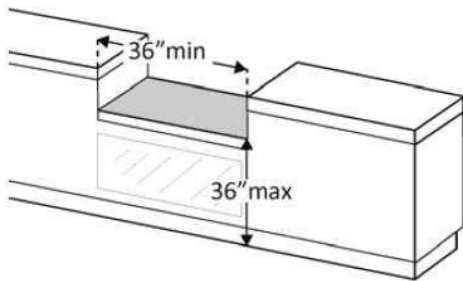
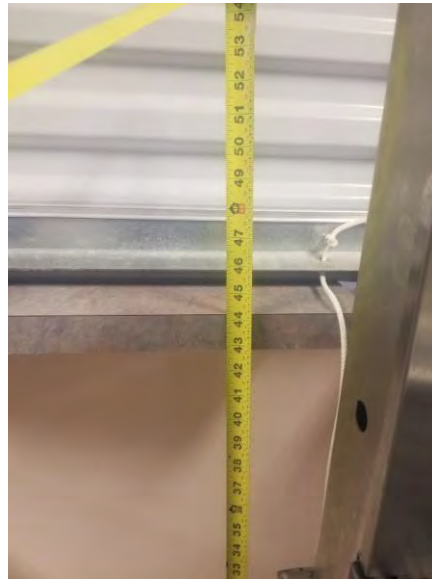
2 (Important): Should be completed as soon as possible. (Includes; Findings that would remove barriers to the greatest number of people to your goods and services)

The countertop is at 44" AFF. The transaction counter is too high.

Soccer Complex Concessions**Finding: 6C****Budget: \$18,000****Recommendation:****Lower countertop to 48" max AFF.****Barrier Priority:**

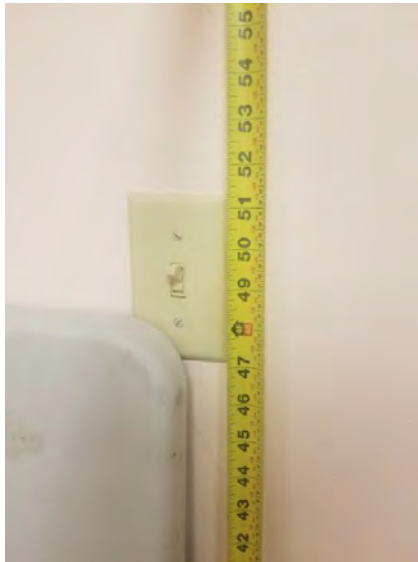
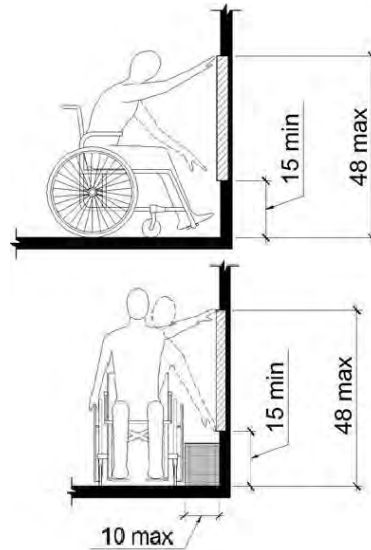
4 (Low): Should be completed as soon as possible due to being a technical violation, but may not result in providing greater access to persons with disabilities. (Includes; Findings that are technically violations but provide a moderate to low increase in accessibility compared to the financial impact on the entity)

The switches are at 49.5" AFF. The receptacle/switch is not positioned correctly for either a side or front approach.

Soccer Complex Concessions**Finding: 7C****Budget: \$650****Recommendation:****Lower switches to 48" max AFF.****Barrier Priority:**

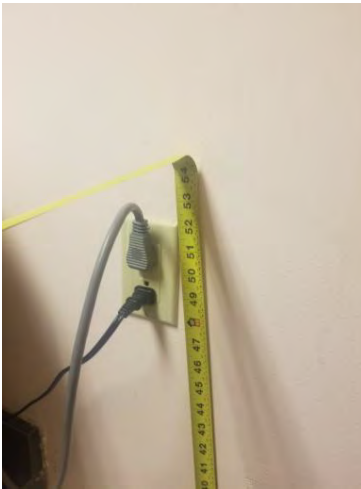
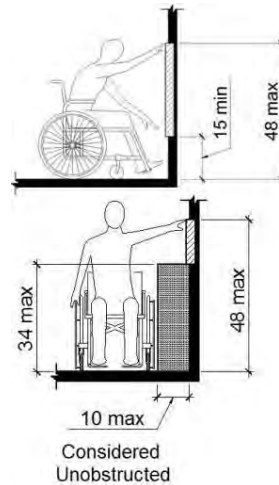
Soccer Complex Concessions**Finding: 8C****Budget: Refer to Finding 7C****Recommendation:**

**As Built:**

The receptacles are at 51". The receptacles is not positioned correctly for either a side or front approach.

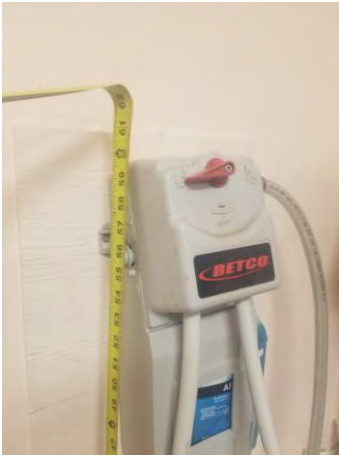
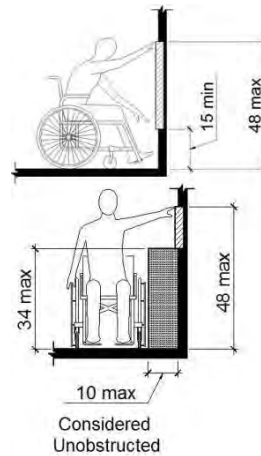
Soccer Complex Concessions**Finding: 9C****Budget: \$150****Recommendation:****Lower dispenser to 48" max AFF.****Barrier Priority:**

**As Built:**

The Chemical Cleaning Dispenser is at 59". The chemical cleaning dispenser is not positioned correctly for either a side or front approach.

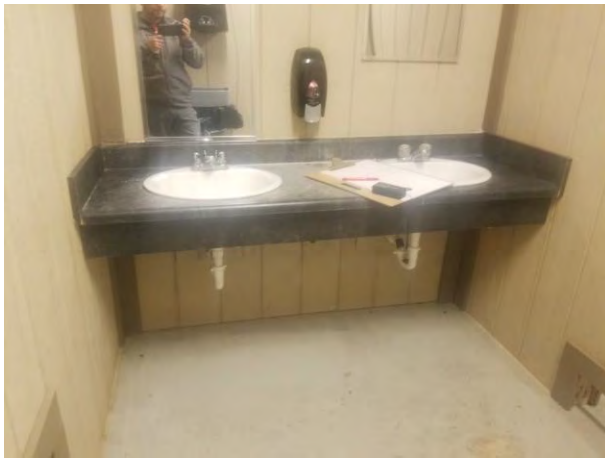
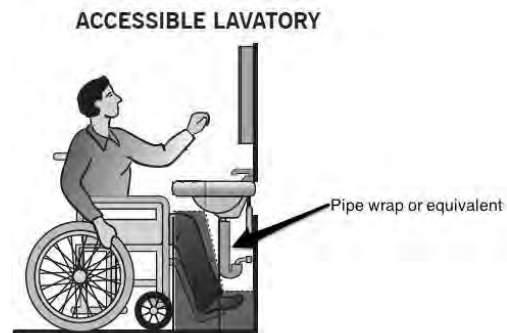
Soccer Complex Men's Restroom**Finding: 10C****Budget: \$200****Recommendation:****Provide Insulation at drain and supply pipes.****Barrier Priority:**

No insulation provided at drain and supply pipes. The water and drain pipes under the lavatory are not adequately insulated.

Water supply and drain pipes under lavatories and sinks shall be insulated or otherwise configured to protect against contact. There shall be no sharp or abrasive surfaces under lavatories and sinks.

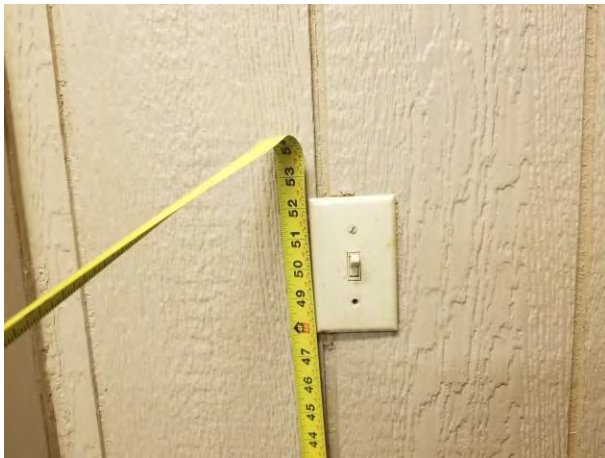
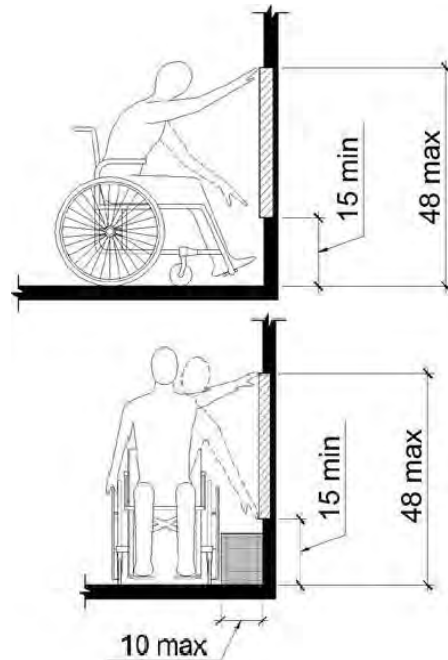
Soccer Complex Men's Restroom**Finding: 11C****Budget: \$500****Recommendation:****Lower switch to 48" max AFF.****Barrier Priority:**

The switch is at 50" AFF. The receptacle/switch is not positioned correctly for either a side or front approach.

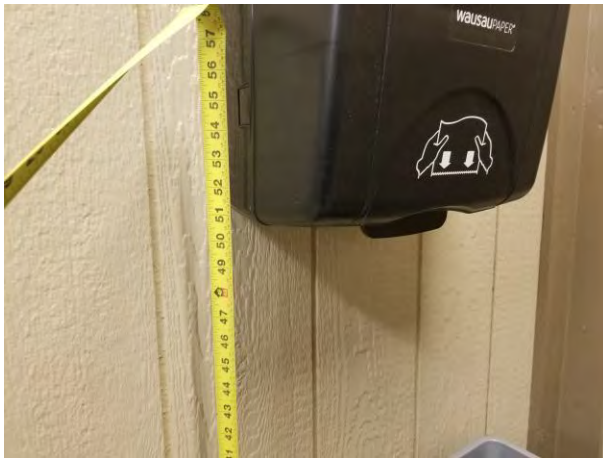
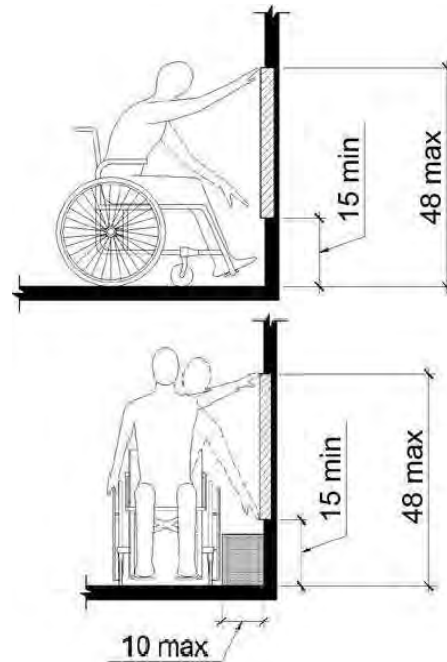
Soccer Complex Men's Restroom**Finding: 12C****Budget: \$150****Recommendation:****Lower paper towel dispenser for all operable components to be 48" max AFF.****Barrier Priority:**

The Paper Towel dispenser is at 51" to bottom. The hand sanitizer dispenser's operation mechanism is too high off the floor. Dispensers must have all operable parts a maximum of 48 inches above the floor.

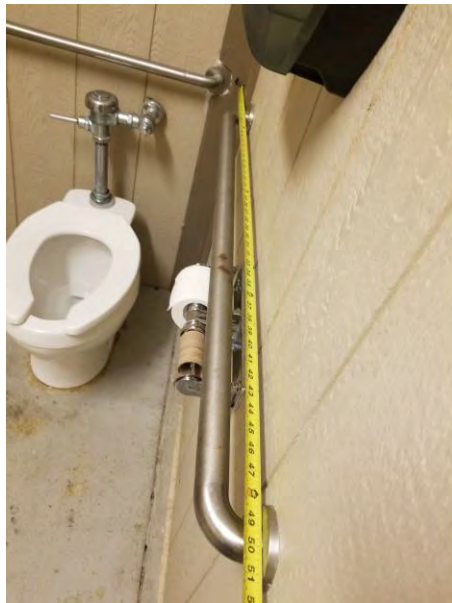
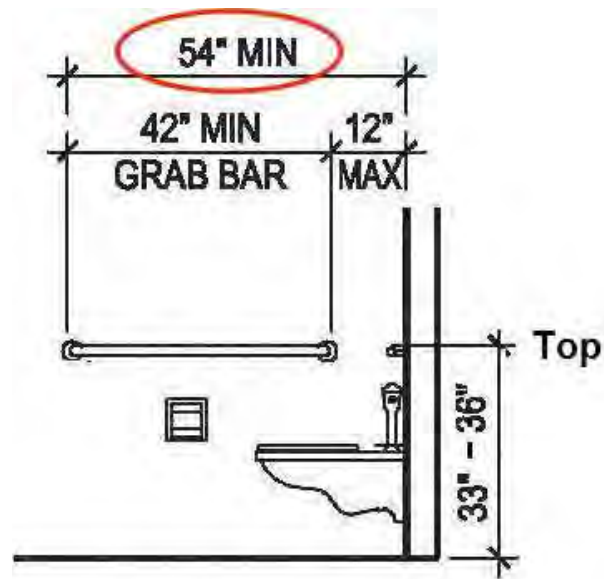
Soccer Complex Men's Restroom**Finding: 13C****Budget: \$200****Recommendation:****Install new grab bar extending 54" from wall.****Barrier Priority:**

The grab bar is 50" from wall. The side grab bar does not extend far enough from the rear wall.

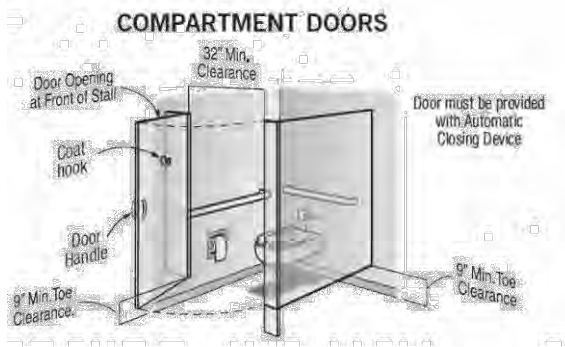
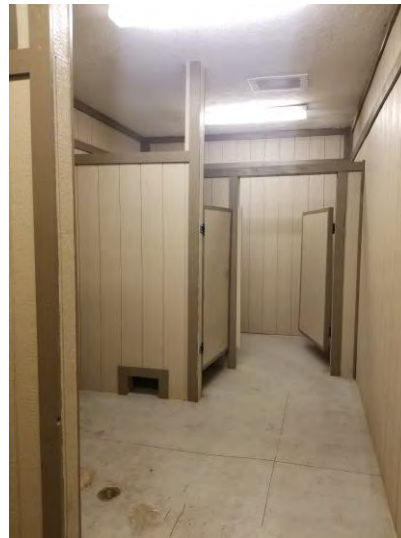
Soccer Complex Men's Restroom**Finding: 14C****Budget: \$375****Recommendation:****Provide self-closing hinges.****Barrier Priority:**

The compartment door is not self-closing. The water closet compartment shall be equipped with a door that has an automatic-closing device.

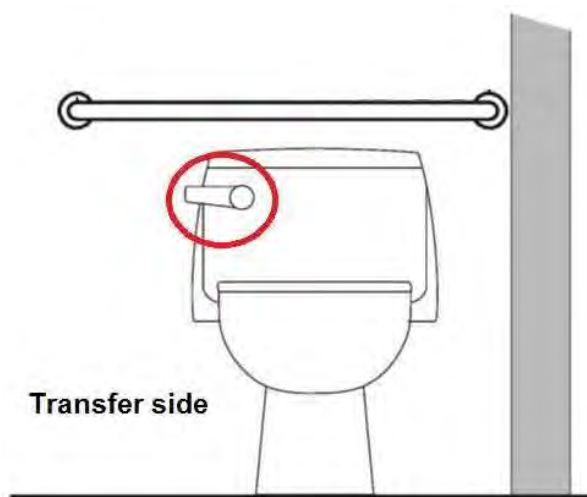
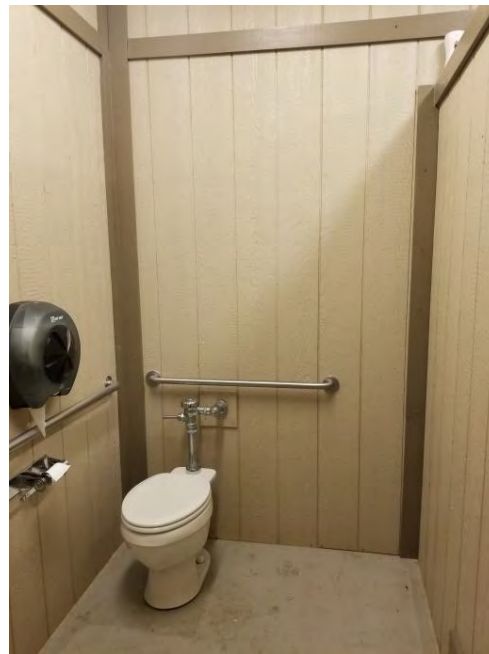
Soccer Complex Women's Restroom**Finding: 15C****Budget: \$1,600****Recommendation:**

The flush handle is located on the wrong side of the toilet.

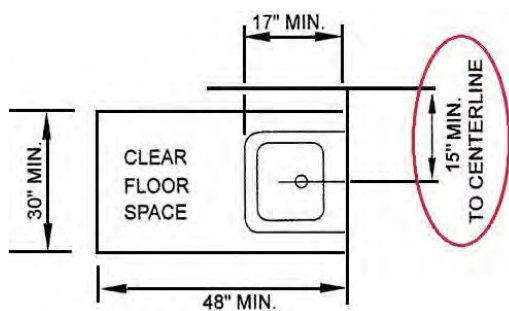
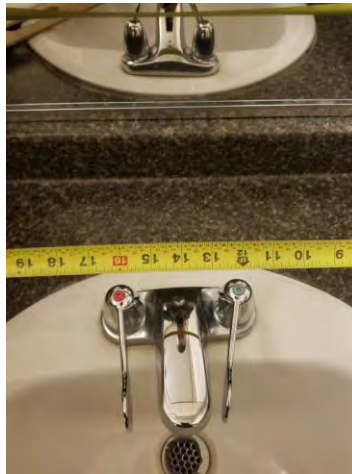
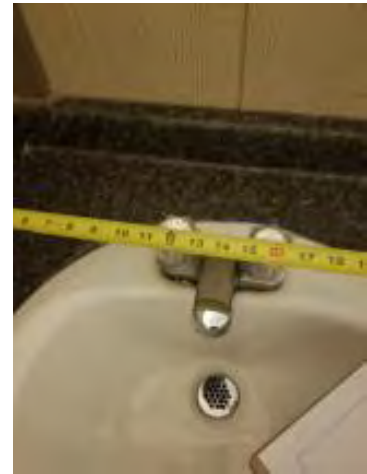
Soccer Complex Women's Restroom**Finding: 16C****Budget: \$2,400****Recommendation:**

The lavatory is 14" from wall. The lavatory is too close to the side wall.

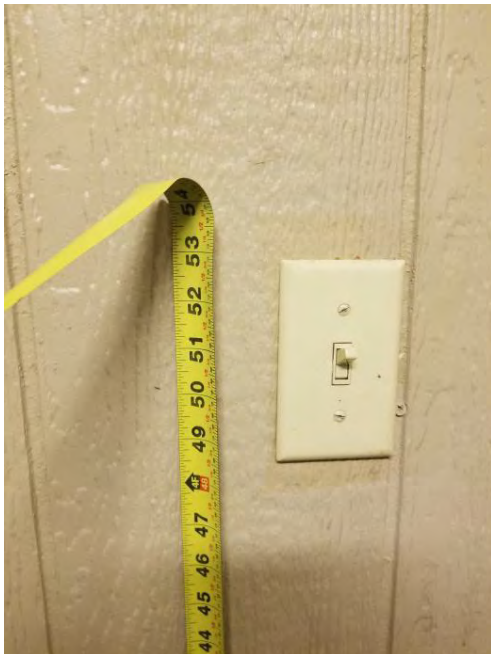
Soccer Complex Women's Restroom**Finding: 18C****Budget: \$475****Recommendation:****Lower switch to 48" max AFF.****Barrier Priority:**

The switch is at 51". The receptacle/switch is not positioned correctly for either a side or front approach.

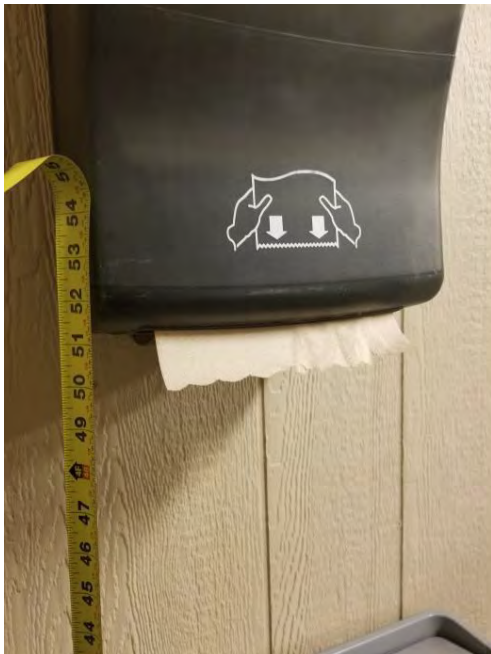
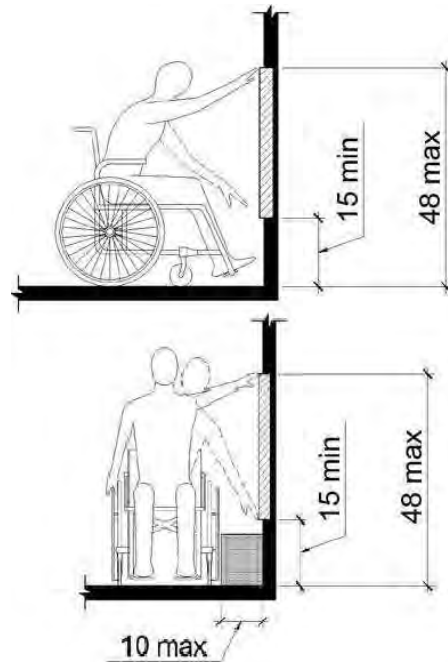
Soccer Complex Women's Restroom**Finding: 19C****Budget: \$150****Recommendation:****Lower paper towel dispenser for all operable components to be 48" max AFF****Barrier Priority:**

Paper Towel dispenser 51" to bottom. The paper towel dispenser's operation mechanism is too high off the floor. Dispensers must have all operable parts a maximum of 48 inches above the floor.

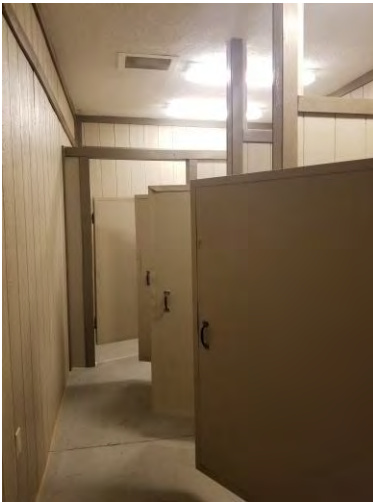
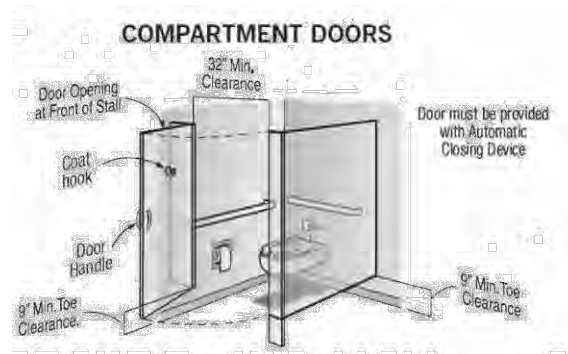
Soccer Complex Women's Restroom**Finding: 20C****Budget: \$375****Recommendation:**

The compartment door is not self closing.

The water closet compartment shall be equipped with a door that has an automatic-closing device.

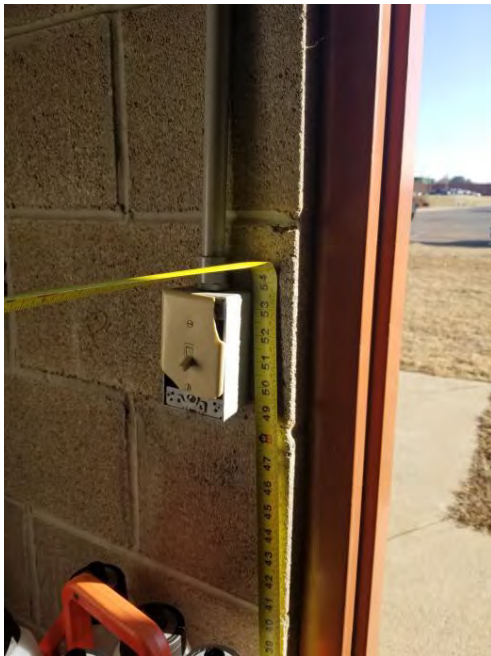
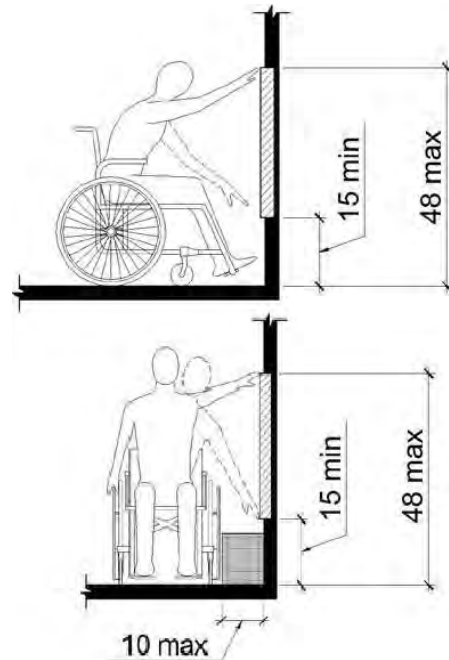
Soccer Complex Equipment Storage**Finding: 21C****Budget: \$250****Recommendation:****Lower switch to 48" AFF.****Barrier Priority:**

The switch is at 51". The receptacle/switch is not positioned correctly for either a side or front approach.

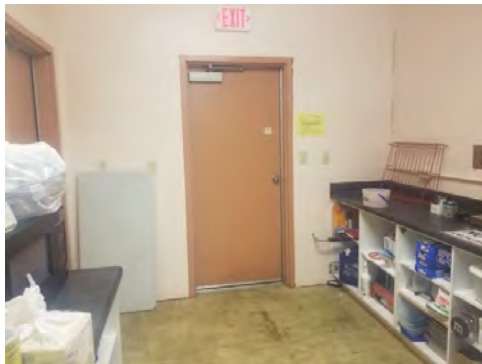
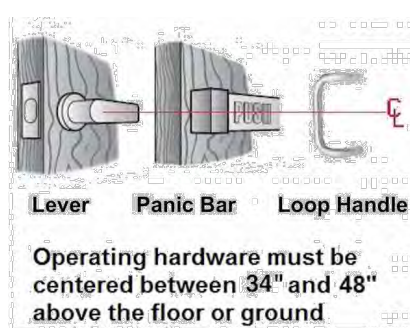
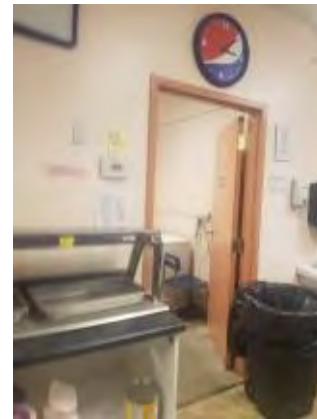
Soccer Complex Throughout**Finding: 22C****Budget: \$1,375****Recommendation:**

The door/gate operating hardware is not accessible due to round knobs.

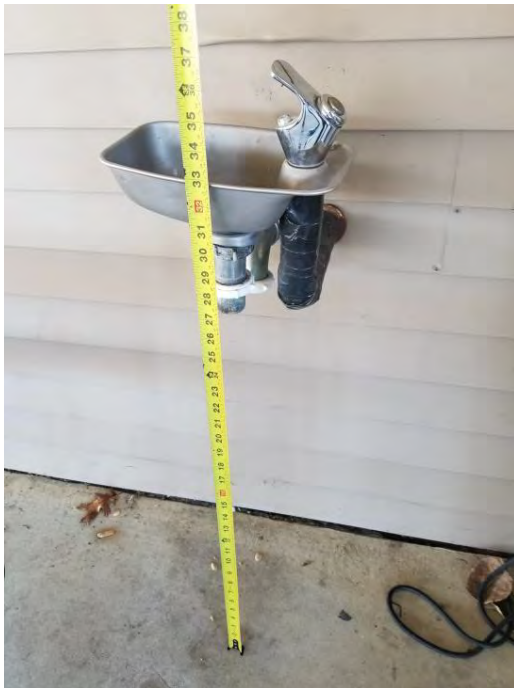
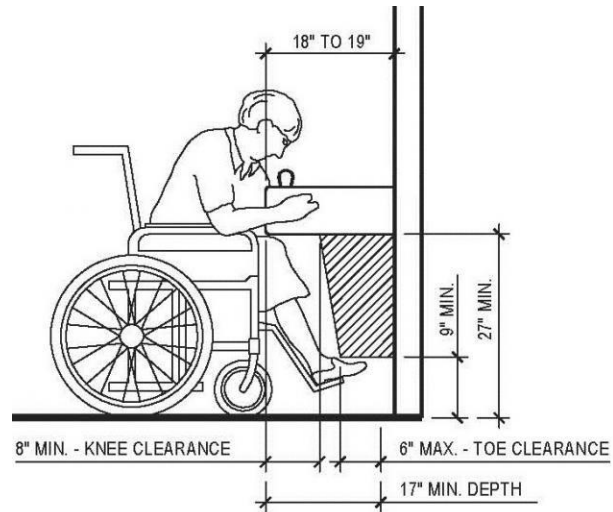
Soccer Complex Water Fountain**Finding: 23C****Budget: \$2,400****Recommendation:****Install new Drinking Fountains to meet standing and ADA requirements.****Barrier Priority:**

It is 13" to wall. There is not enough knee clearance under the drinking fountain.

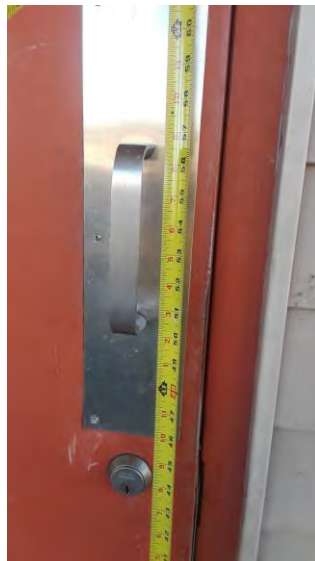
Softball Women's Restroom**Finding: 1D****Budget: \$900****Recommendation:**

The door operating hardware is too high.

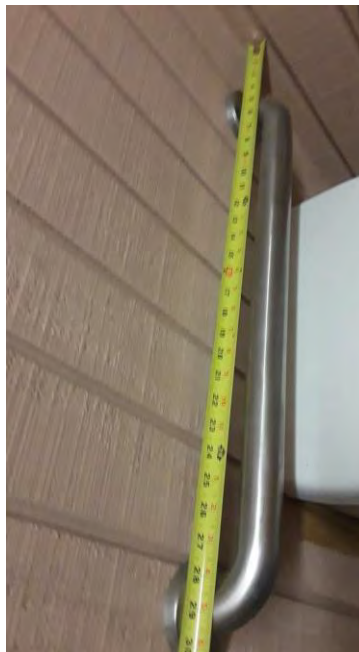
Softball Women's Restroom**Finding: 2D****Budget: \$350****Recommendation:**

The rear grab bar does not extend adequately past the toilet on the wide side.

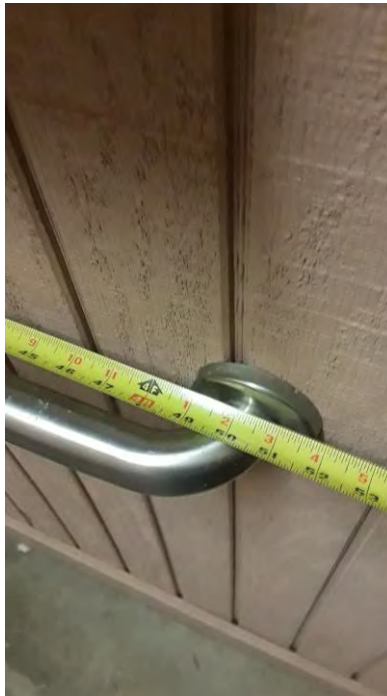
Softball Women's Restroom**Finding: 3D****Budget: Refer to Finding 2D****Recommendation:**

The side grab bar does not extend far enough from the rear wall.

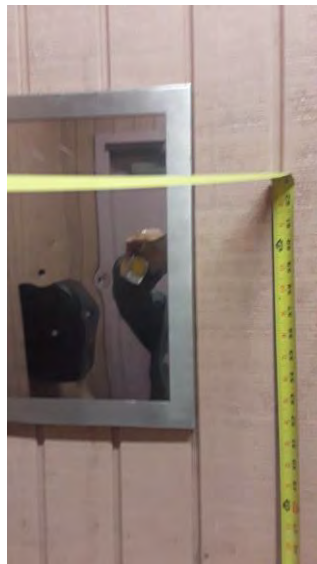
Softball Women's Restroom**Finding: 4D****Budget: \$475****Recommendation:**

The mirror is mounted too high.

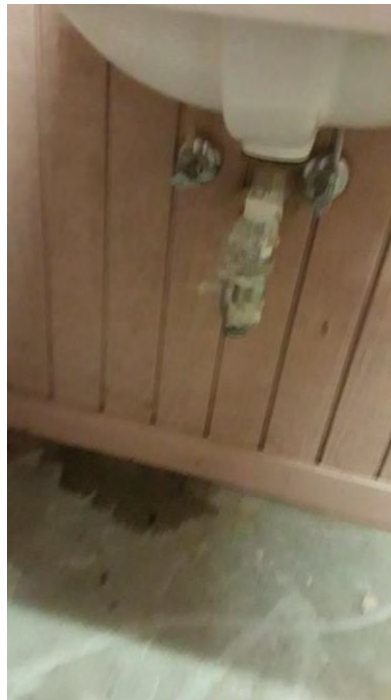
Softball Women's Restroom**Finding: 5D****Budget: \$100****Recommendation:**

The water and drain pipes under the lavatory are not adequately insulated.

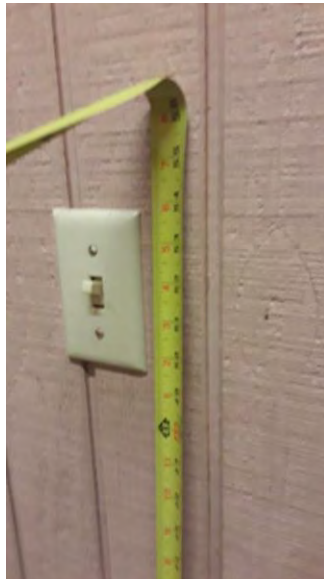
Softball Women's Restroom**Finding: 6D****Budget: \$800****Recommendation:**

The receptacle/switch is not positioned correctly for either a side or front approach.

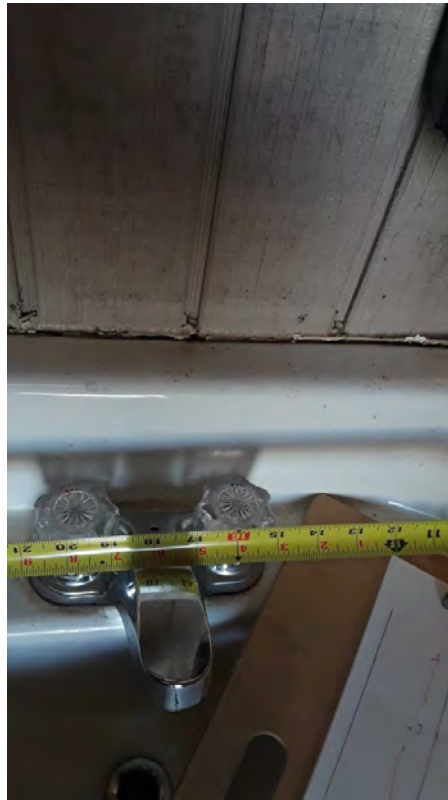
Softball Men's Restroom**Finding: 7D****Budget: \$275****Recommendation:**

The faucet controls require twisting of the wrist.

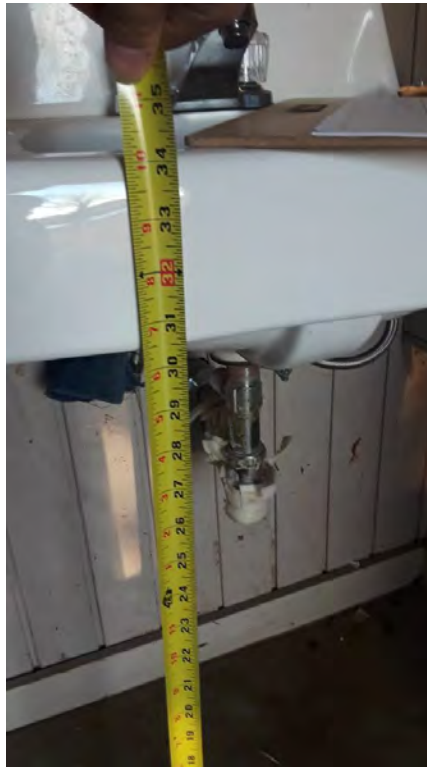
Softball Men's Restroom**Finding: 8D****Budget: \$100****Recommendation:**

The water and drain pipes under the lavatory are not adequately insulated.

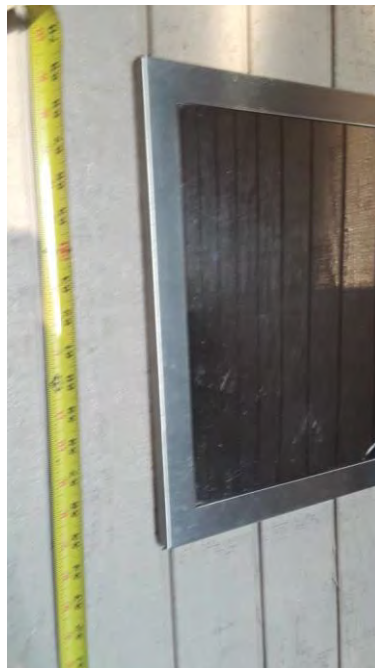
Softball Men's Restroom**Finding: 9D****Budget: \$475****Recommendation:**

The mirror is mounted too high.

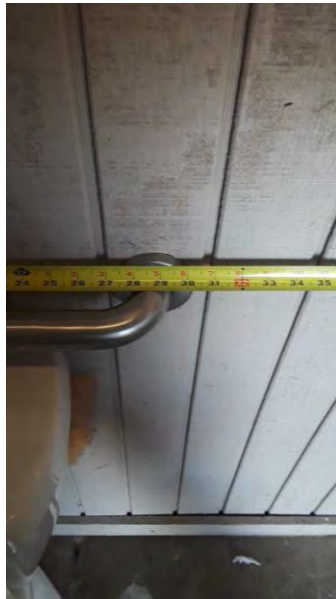
Softball Men's Restroom**Finding: 10D****Budget: \$350****Recommendation:**

The rear grab bar does not extend adequately past the toilet on the wide side.
