ADA Self-Evaluation and Transition Plan

January 2020

Opera House
RESTAURANT

Prepared by:

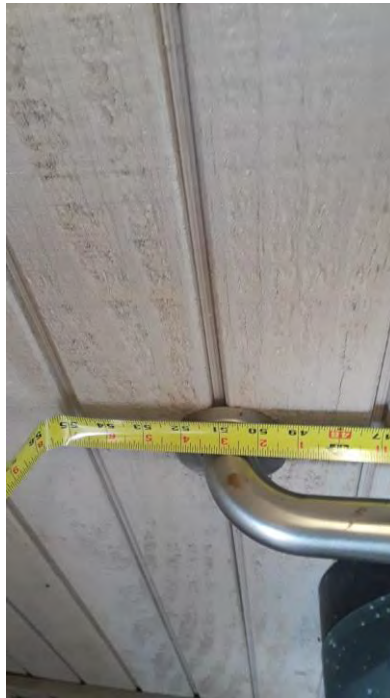
Softball Men's Restroom**Finding: 11D****Budget: Refer to Finding 10D****Recommendation:**

The side grab bar does not extend far enough from the rear wall.

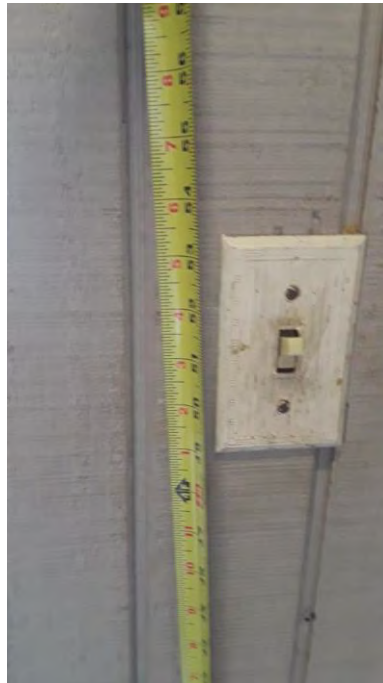
Softball Men's Restroom**Finding: 12D****Budget: \$800****Recommendation:**

The receptacle/switch is not positioned correctly for either a side or front approach.

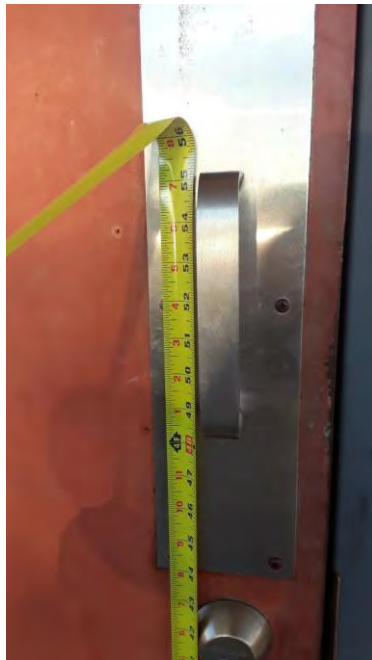
Softball Men's Restroom**Finding: 13D****Budget: \$900****Recommendation:**

The door operating hardware is not located within the compliant range.

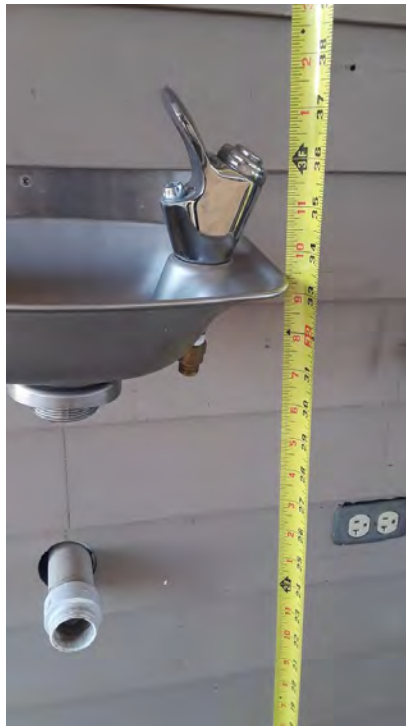
Softball Water Fountain**Finding: 14D****Budget: \$2,500****Recommendation:**

There is not enough knee clearance under the drinking fountain.

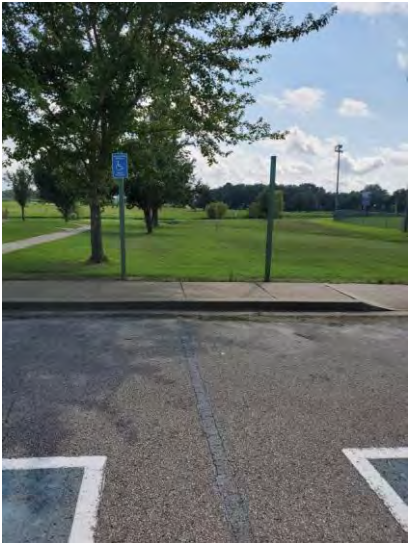
There are no van accessible parking stalls. Three are marked, none for van, and one is missing a sign.

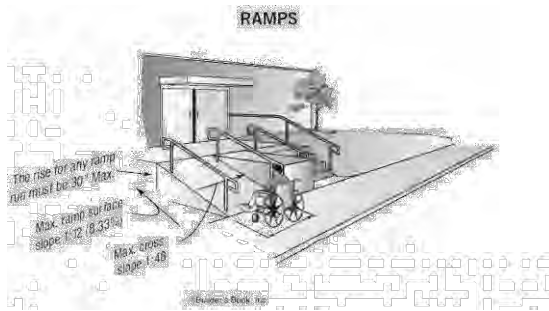
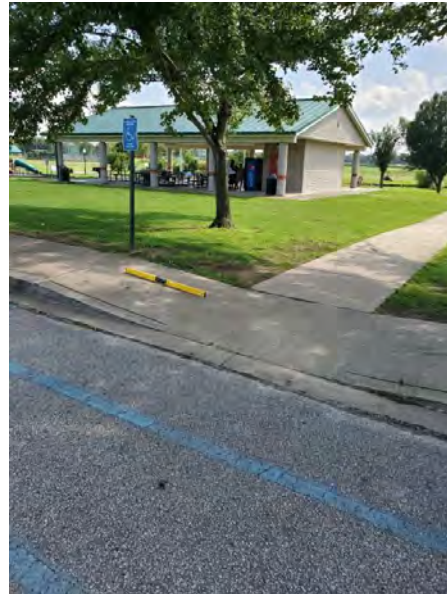
Pavilion, Monument & Parking**Finding: 2****Budget: \$4,000****Recommendation:**

The ramp slope is 9.8%. The ramps slope exceeds the maximum running slope (direction of travel) allowable of 8.33%. Ramps should have the least possible slope but in no case more than 8.3% (1:12).

Replace ramp and curb from parking to pavilion sidewalk and sidewalk as necessary to tie back to existing.

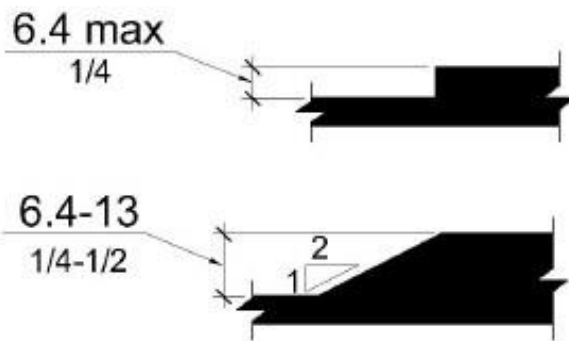
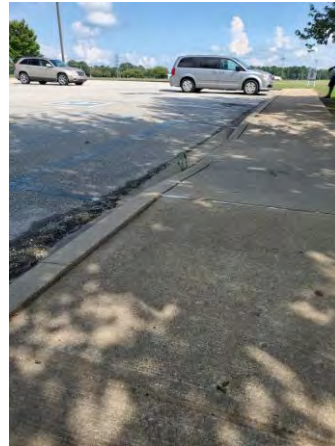
Pavilion, Monument & Parking**Finding: 3****Budget: \$500****Recommendation:**

There is over 1/2" discontinuity, perpendicular to pedestrian route, which is a trip hazard. The surface of the pedestrian access route has vertical discontinuities greater than 1/2 inch or between 1/4 inch and 1/2 inch that are not beveled.

Replace 1 panel to create flush transition.

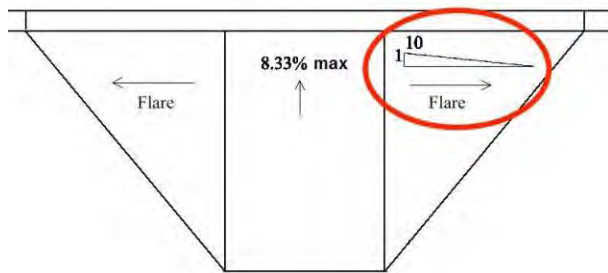
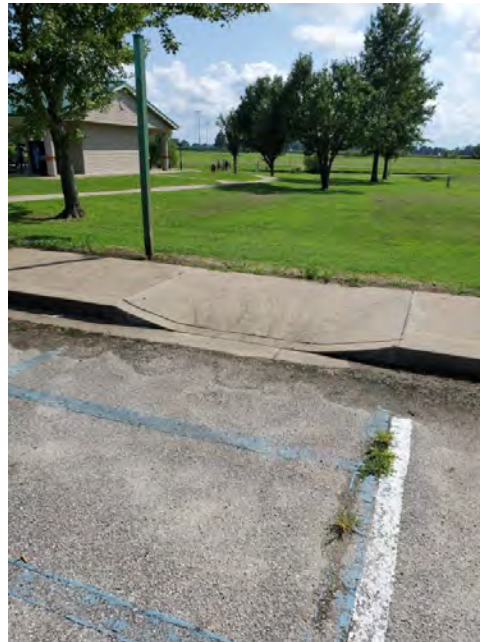
Pavilion, Monument & Parking**Finding: 4****Budget: \$4,000****Recommendation:**

The curb ramp side flares are too steep, at 25.2%

Replace entire curb ramp, flares, curb landing, and sidewalk as necessary.

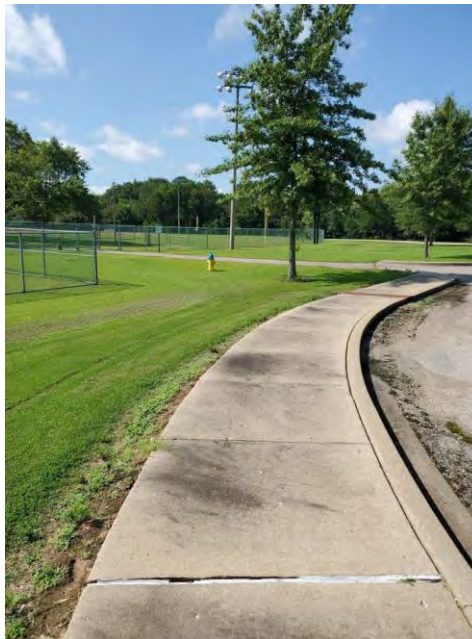
Pavilion, Monument & Parking**Finding: 5****Budget: \$4,000****Recommendation:**

The sidewalk varies up to 3.1%. The cross slope of the pedestrian access route is excessive.

Replace panels from "service entry only" dead end of sidewalk to 8 panels past tread plate when walking toward the pavilion.

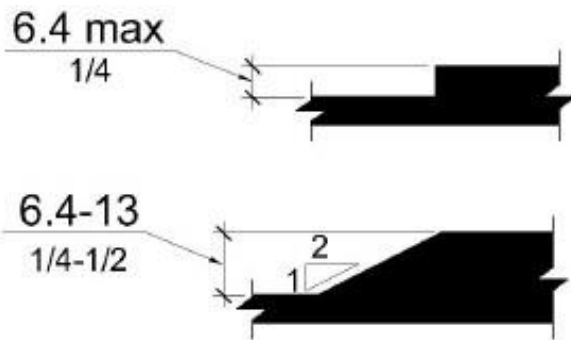
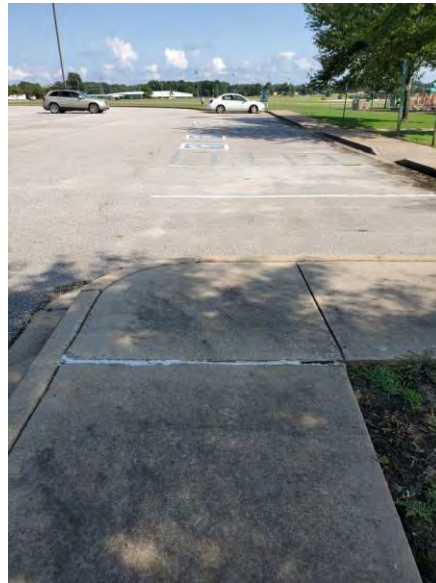
Pavilion, Monument & Parking**Finding: 6****Budget: \$400****Recommendation:**

The surface of the pedestrian access route has vertical discontinuities of 3/4" which is greater than 1/2 inch or between 1/4 inch and 1/2 inch that are not beveled. Vertical surface discontinuities shall be 0.5 inch maximum. Vertical surface discontinuities between 0.25 inch and 0.5 inch shall be beveled with a slope not steeper than 50 percent. The bevel shall be applied across the entire vertical surface discontinuity.

Replace 1 panel to provide flush transition.

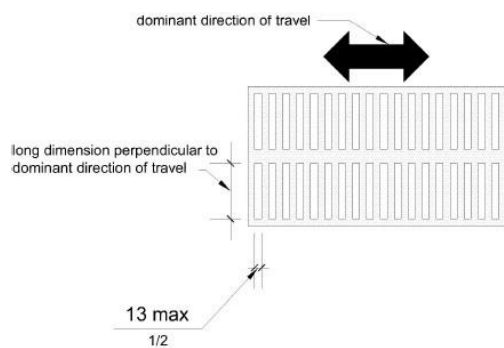
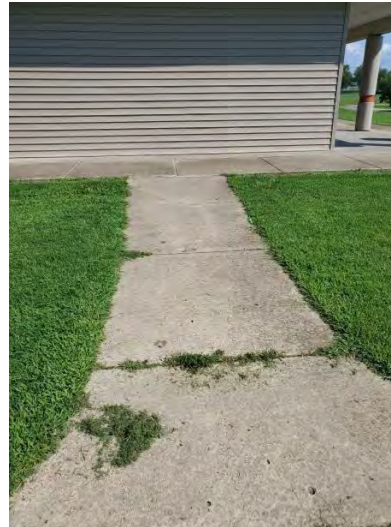
Pavilion, Monument & Parking**Finding: 7****Budget: \$500****Recommendation:**

The surface of the pedestrian access route has openings greater than 1/2 inch. Horizontal openings in gratings and joints shall not permit passage of a sphere more than 13 mm (0.5 in) in diameter.

Replace 1 panel.

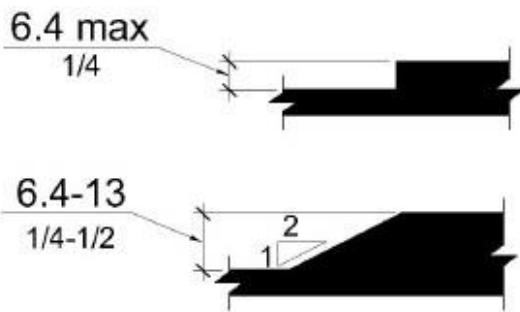
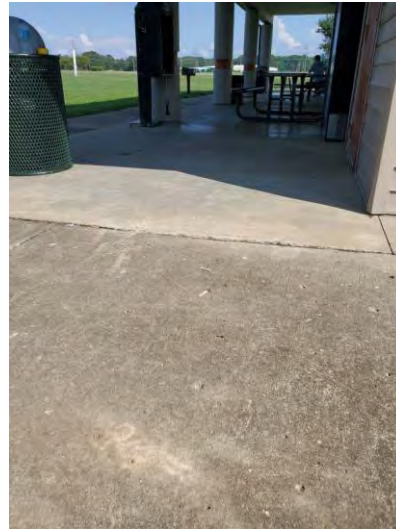
Pavilion, Monument & Parking**Finding: 8****Budget: \$3,000****Recommendation:**

Multiple locations are greater than 1/2" transition from exterior sidewalk path to pavilion pad. The surface of the pedestrian access route has vertical discontinuities greater than 1/2 inch or between 1/4 inch and 1/2 inch that are not beveled.

Bevel areas that are between 1/4 and 1/2", replace sections that exceed 1/2".

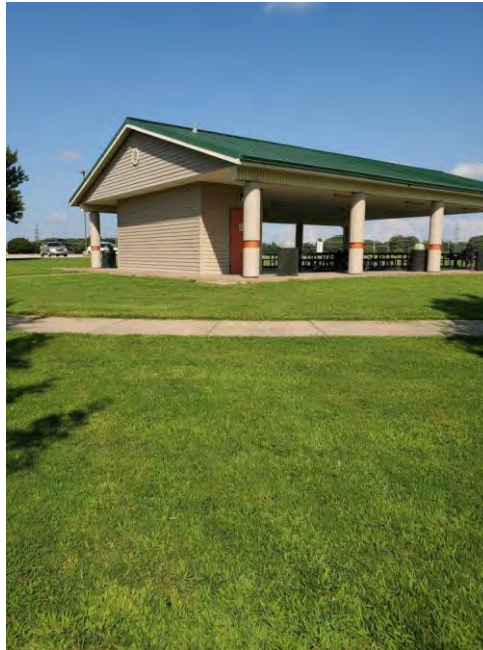
Pavilion, Monument & Parking**Finding: 9****Budget: \$1,800****Recommendation:**

The radiused section directly off of corner of pavilion closest to men's restroom has 6 panels in radius leading to trail over 2%. The cross slope of the pedestrian access route is excessive. The cross slope of pedestrian access routes shall be 2 percent maximum.

Replace from expansion joint to expansion joint, 28'x5'.

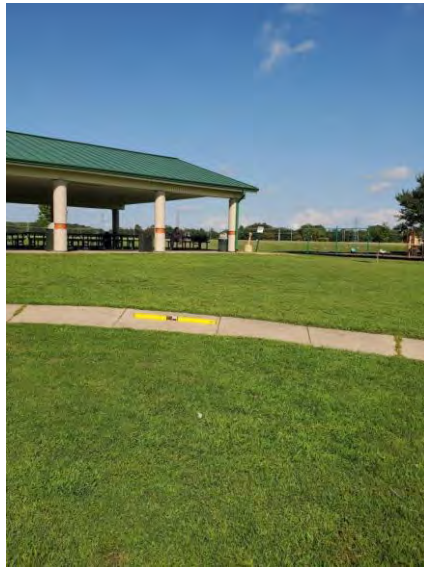
Pavilion, Monument & Parking**Finding: 10****Budget: \$2,000****Recommendation:**

The sidewalk varies up to 7.4% for approximately 20'. The grade of the pedestrian access route is too steep.

Replace approximately 30' of sidewalk to flatten grade to less than 5%.

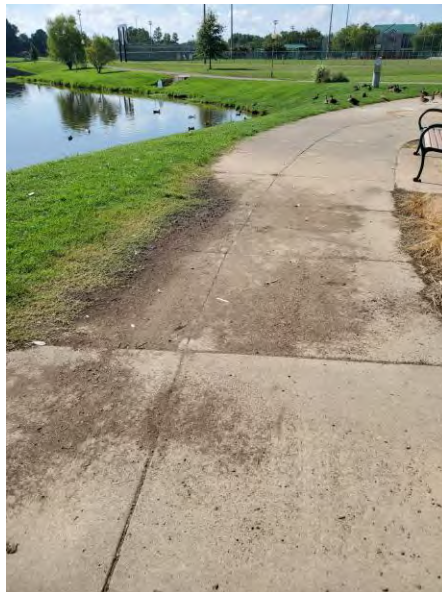
Pavilion, Monument & Parking**Finding: 11****Budget: \$100****Recommendation:**

The sidewalk has ponding water and sediment build up. The surface of the pedestrian access route is not firm, stable and slip resistant. The surfaces of pedestrian access routes and elements and spaces along the pedestrian access route that are required to be accessible that connect to pedestrian access routes shall be firm, stable, and slip resistant.

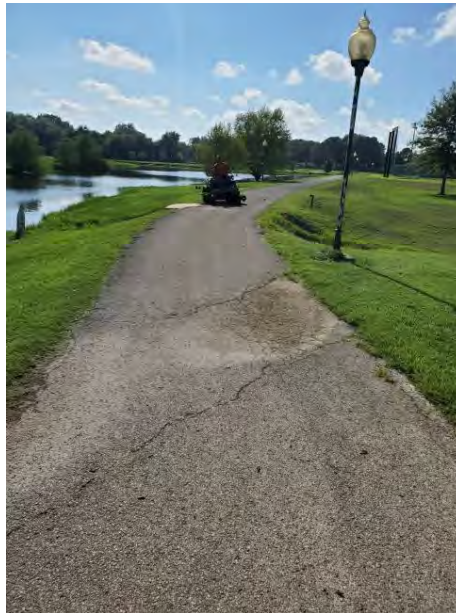
Trail**Finding: 12****Budget: \$1,800****Recommendation:**

The surface of the pedestrian access route is not firm, stable and slip resistant. The surfaces of pedestrian access routes and elements and spaces along the pedestrian access route that are required to be accessible that connect to pedestrian access routes shall be firm, stable, and slip resistant.

Replace 9x18' sunken area with excessive cross slope and ponding water.

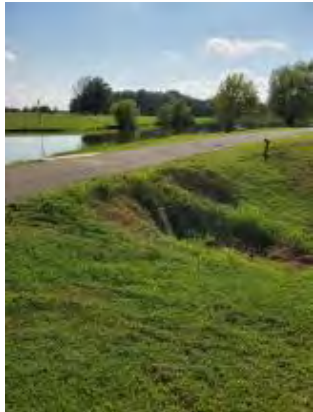
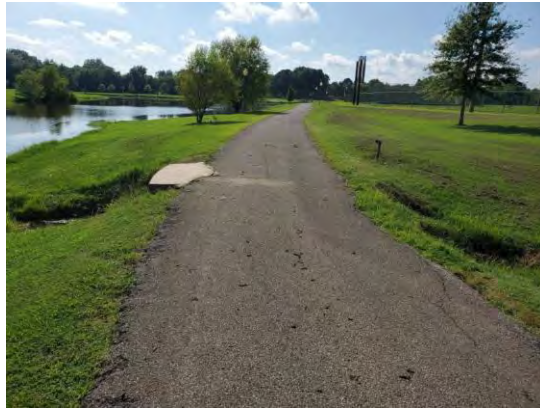
Trail**Finding: 13****Budget: \$4,000****Recommendation:**

There are no handrails on the trail. Pedestrians should be protected by safety rail from the slope and drop off at this location.

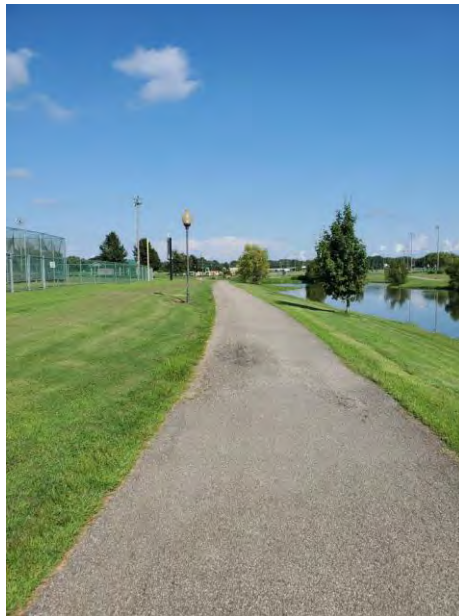
Trail**Finding: 14****Budget: \$10,000****Recommendation:**

Approximately 300' of trail on north side of water, adjacent to field 3 outfield fencing drastically exceeds 2% in some areas. The cross slope of the pedestrian access route is excessive. The cross slope of pedestrian access routes shall be 2 percent maximum.

Resurface or replace 300' x 9'.

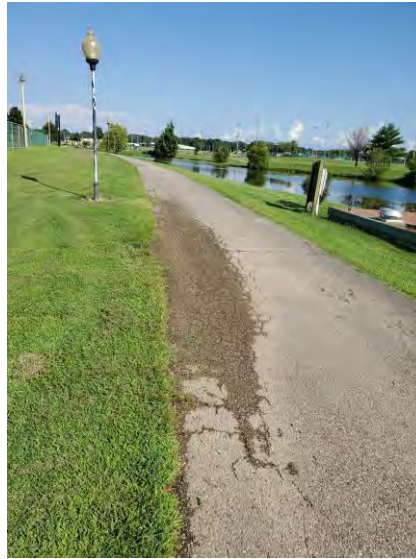
Trail**Finding: 15****Budget: \$2,200****Recommendation:**

Approximately 50' of the trails are damaged and uneven. The surface of the pedestrian access route is not firm, stable and slip resistant. The surfaces of pedestrian access routes and elements and spaces along the pedestrian access route that are required to be accessible that connect to pedestrian access routes shall be firm, stable, and slip resistant.

Replace or resurface 50x9'. Portion of trail passable in this location. Lower priority.

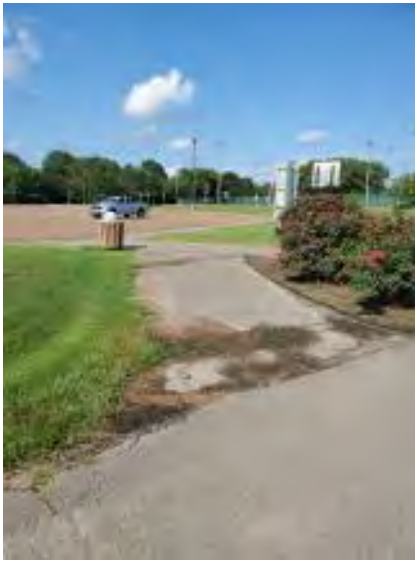
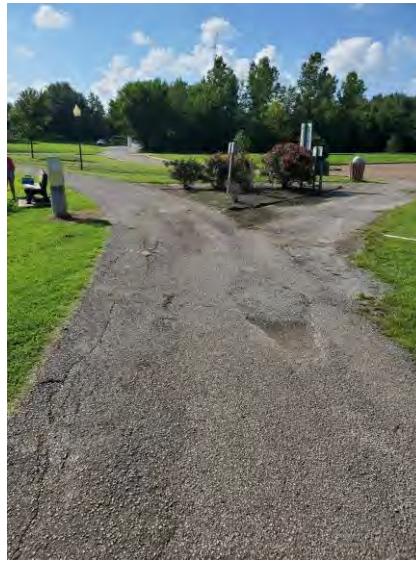
Trail**Finding: 16****Budget: \$8,000****Recommendation:**

There is broken asphalt, ponding water, sediment build up and loose rocks. The surface of the pedestrian access route is not firm, stable and slip resistant. The surfaces of pedestrian access routes and elements and spaces along the pedestrian access route that are required to be accessible that connect to pedestrian access routes shall be firm, stable, and slip resistant.

Replace asphalt from parking entrance, around planter, approximately 100 linear feet.

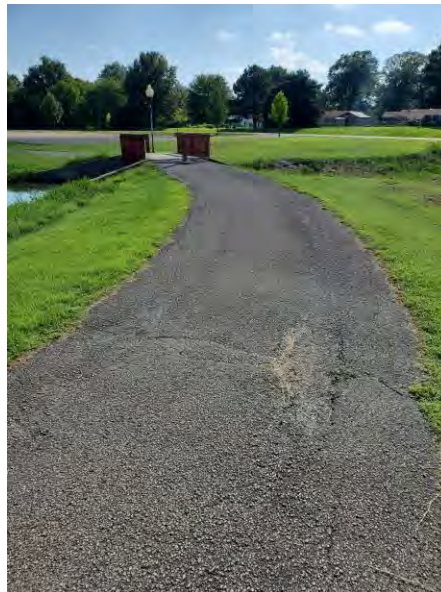
Trail**Finding: 17****Budget: \$400****Recommendation:**

The surface of the pedestrian access route is not firm, stable and slip resistant.

Replace or resurface 8'.

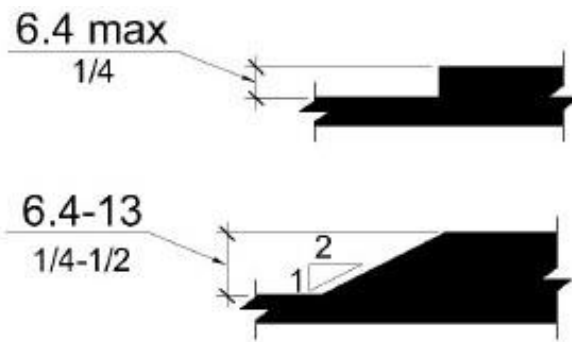
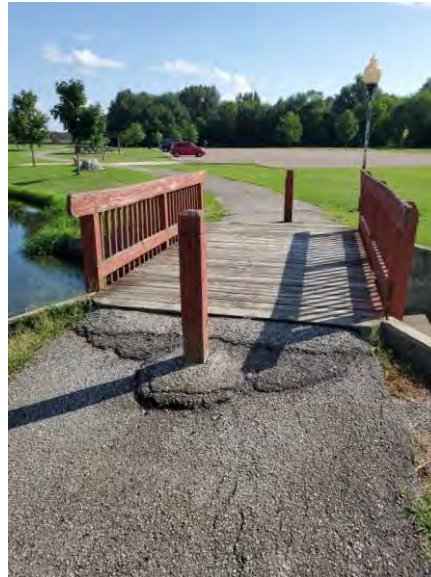
Trail**Finding: 18****Budget: \$4,000****Recommendation:**

Both sides of bridge are over 1" above asphalt surface.

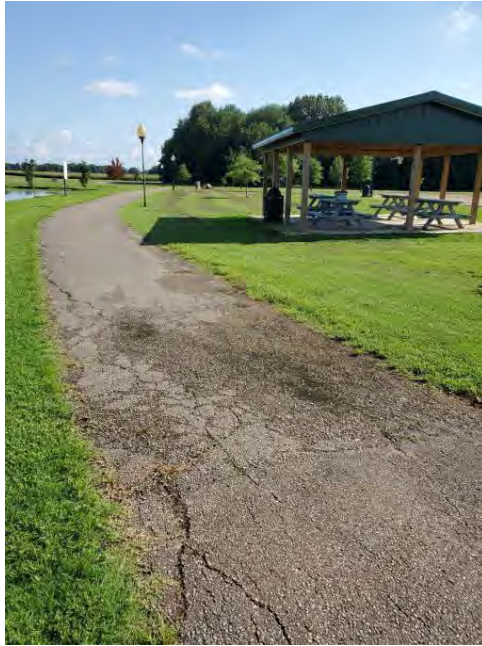
Trail**Finding: 19****Budget: \$1,000****Recommendation:**

The surface of the pedestrian access route is not firm, stable and slip resistant. The surfaces of pedestrian access routes and elements and spaces along the pedestrian access route that are required to be accessible that connect to pedestrian access routes shall be firm, stable, and slip resistant.

Replace or resurface approximately 12'.

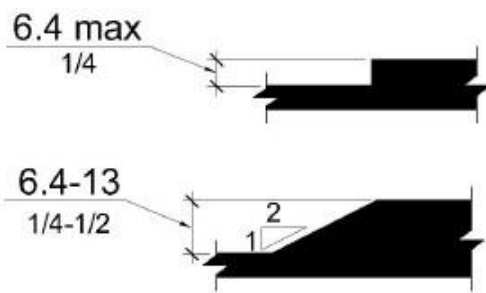
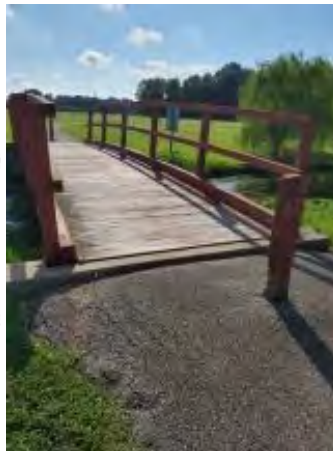
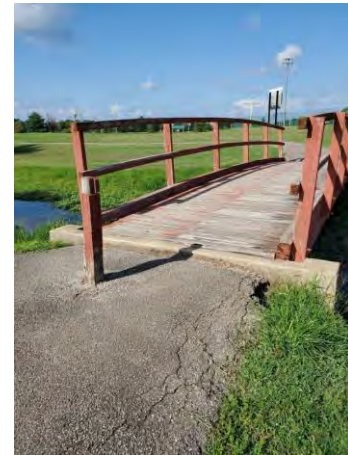
Trail**Finding: 20****Budget: \$5,000****Recommendation:**

The surface of the pedestrian access route has vertical discontinuities greater than 1/2 inch or between 1/4 inch and 1/2 inch that are not beveled. Vertical surface discontinuities shall be 0.5 inch maximum. Vertical surface discontinuities between 0.25 inch and 0.5 inch shall be beveled with a slope not steeper than 50 percent. The bevel shall be applied across the entire vertical surface discontinuity.

Replace asphalt both sides of bridge to provide smooth transition.

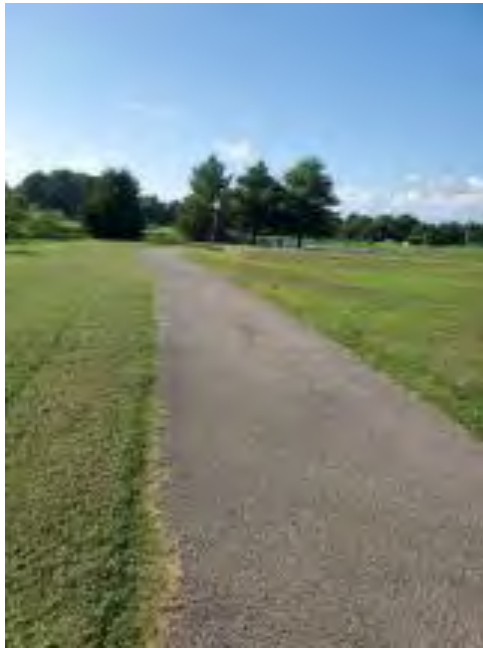
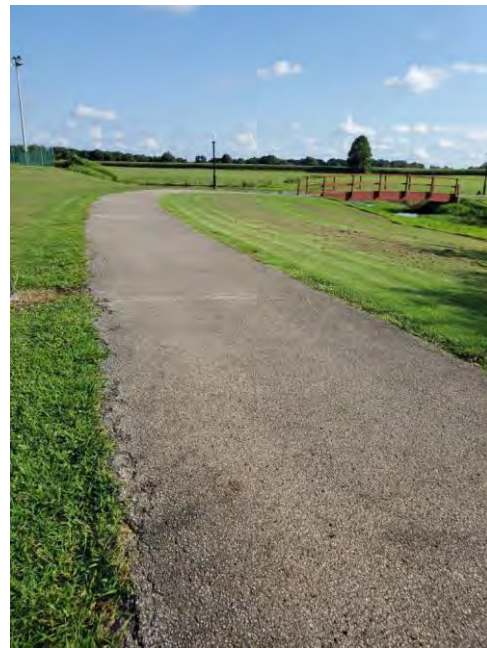
Trail**Finding: 21****Budget: \$10,000****Recommendation:**

Approximately 300' of trail exceeds 2%, up to 4.8%, varies from compliant to non-compliant. The cross slope of the pedestrian access route is excessive.

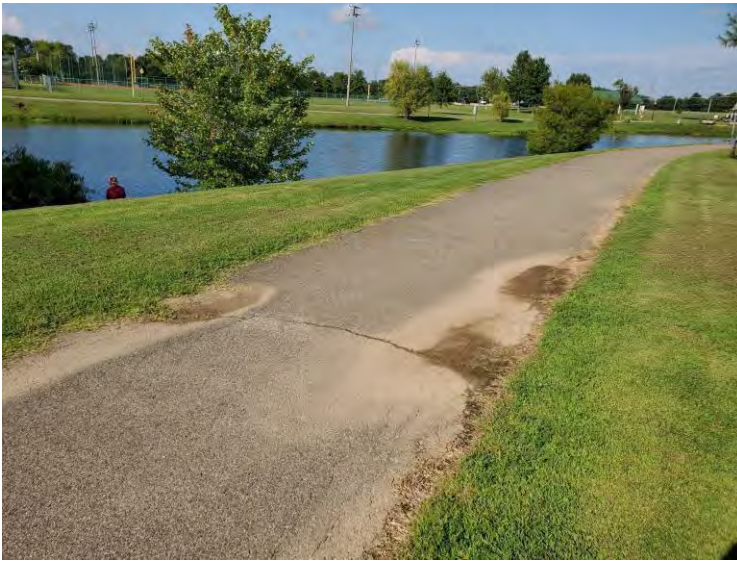
Trail**Finding: 22****Budget: \$1,000****Recommendation:**

Approximately 15' of the surfaces is damaged and uneven and ponding water. The surface of the pedestrian access route is not firm, stable and slip resistant.

Replace or resurface 15x9'.

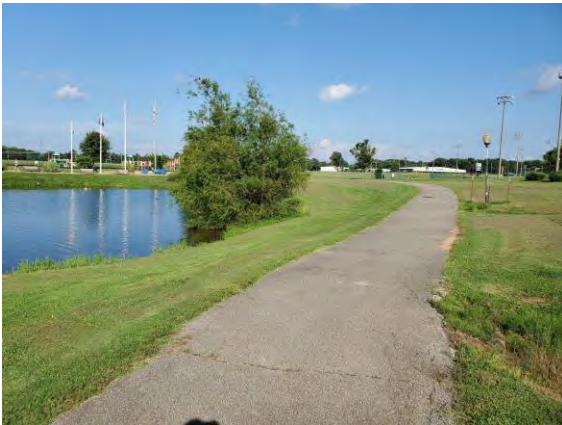
Trail**Finding: 23****Budget: \$5,500****Recommendation:**

Approximately 160' of trail exceeds 2%, up to 6%. The cross slope of the pedestrian access route is excessive. The cross slope of pedestrian access routes shall be 2 percent maximum.

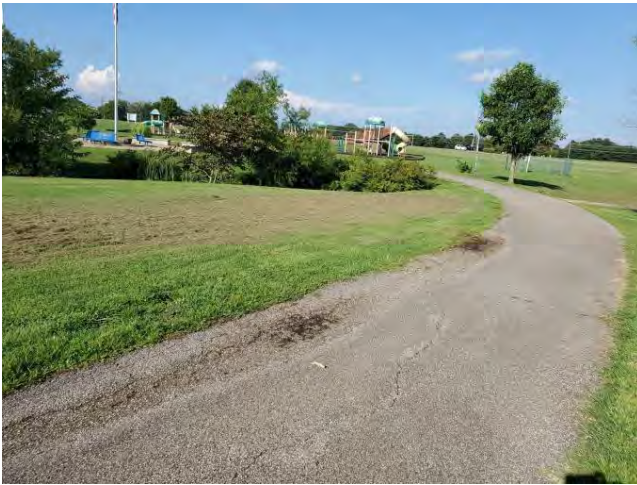
Trail**Finding: 24****Budget: \$1,500****Recommendation:**

Approximately 35' damaged and uneven, ponding water, excessive cross slope. The surface of the pedestrian access route is not firm, stable and slip resistant.

Replace or resurface 35x9'.

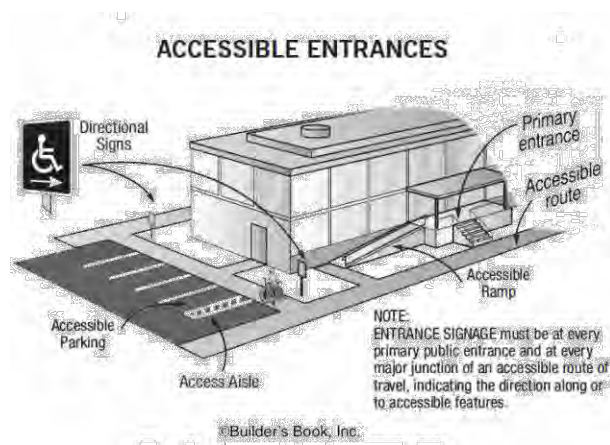
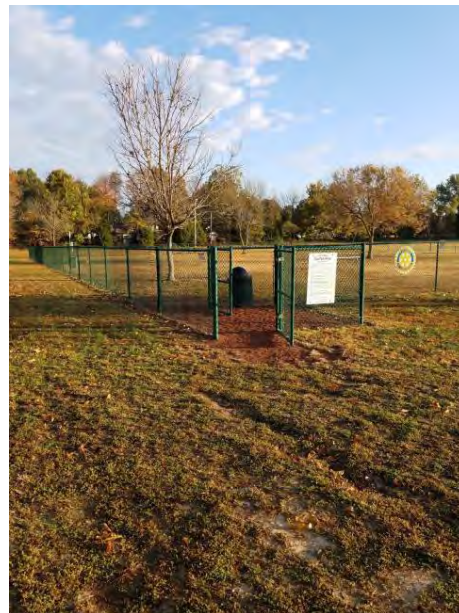
Dog Park**Finding: 25****Budget: \$3,000****Recommendation:**

There is no accessible route to the dog park.

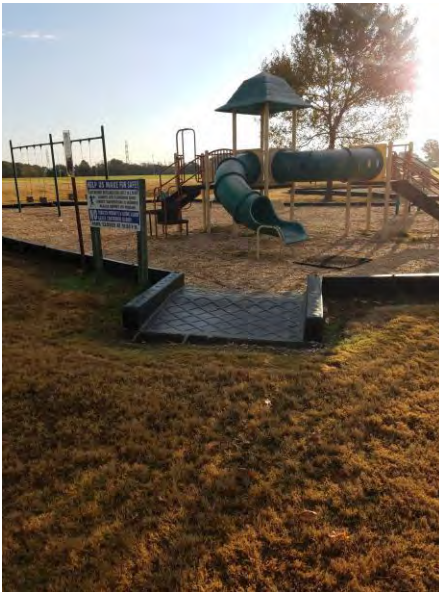
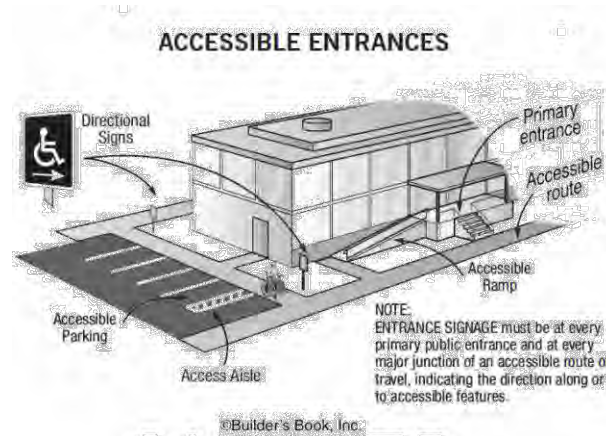
Small Composite Playground**Finding: 26****Budget: \$5,000****Recommendation:**

There is no accessible route to the small composite playground.

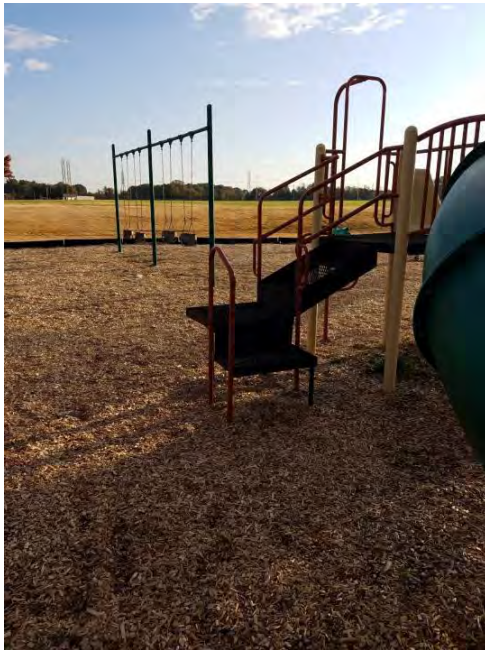
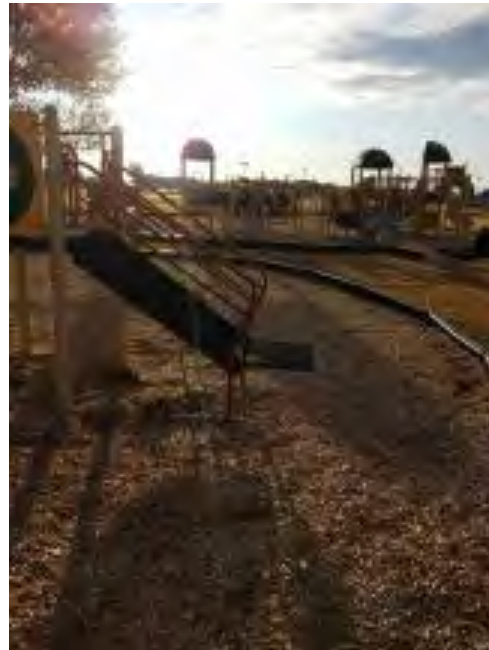
Small Composite Playground**Finding: 27****Budget: \$10,000****Recommendation:**

The small composite structure is not accessible due to lack of adequate transfer system or ramp onto structure.

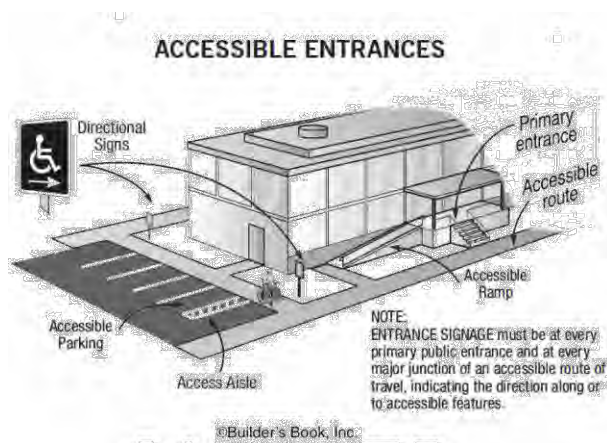
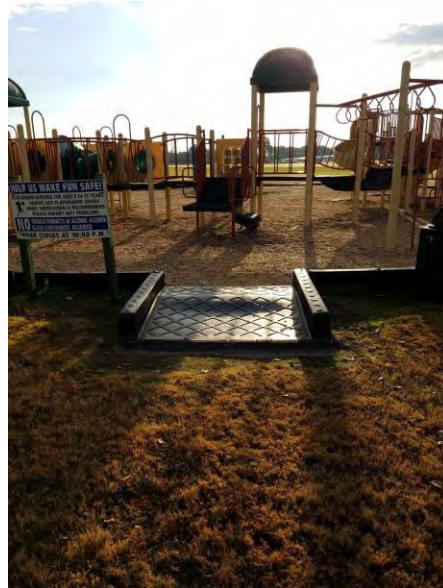
Large Composite Playground**Finding: 28****Budget: \$5,000****Recommendation:**

There is no accessible route to the large composite playground.

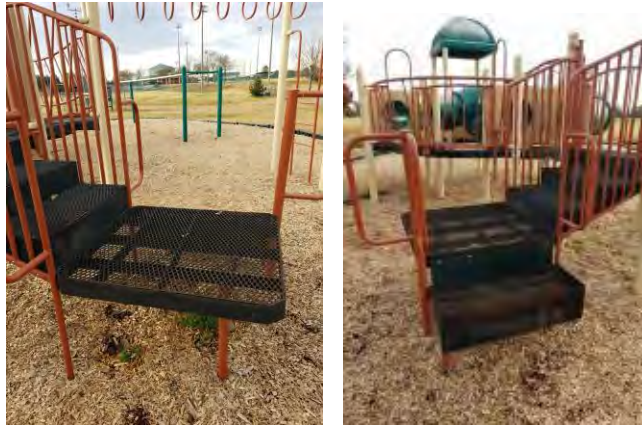
Large Composite Playground**Finding: 29****Budget: \$600****Recommendation:**

Transfer platform is provided, but it is less than 48". An unobstructed transfer space to the platform has not been provided.

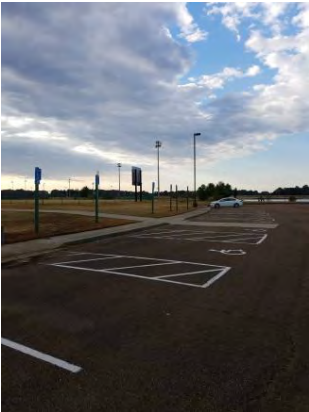
Parking stall and access aisle on north side of concrete walk needs to be flipped and the van accessible sign needs relocated.

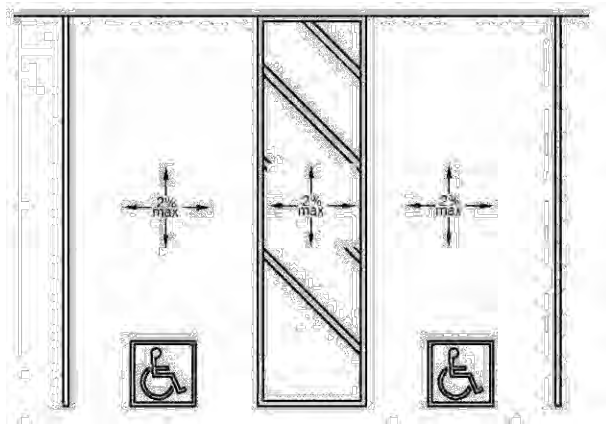
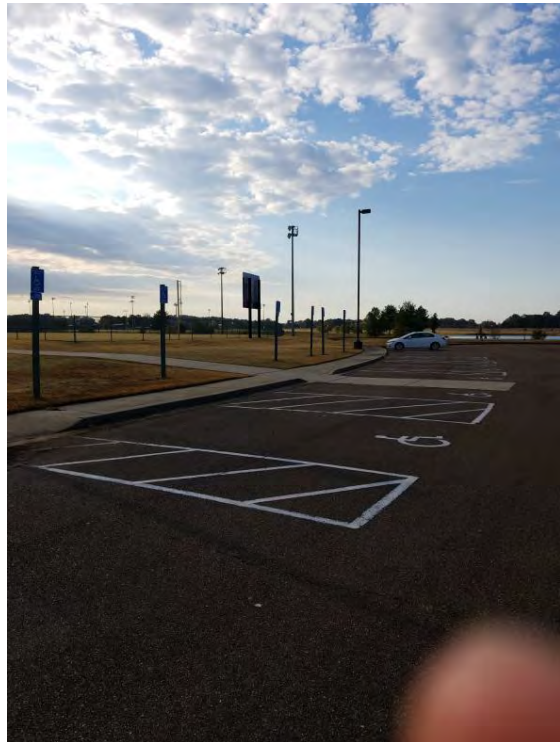
Northwest Parking**Finding: 31****Budget: \$7,000****Recommendation:**

The accessible parking stall's access aisle contains a curb without a ramp.

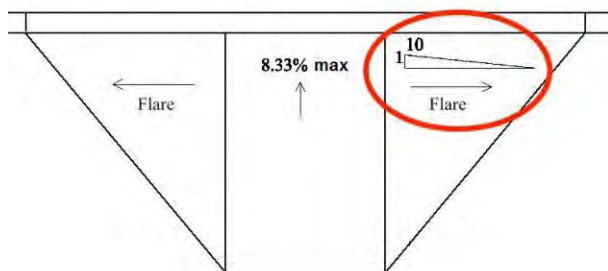
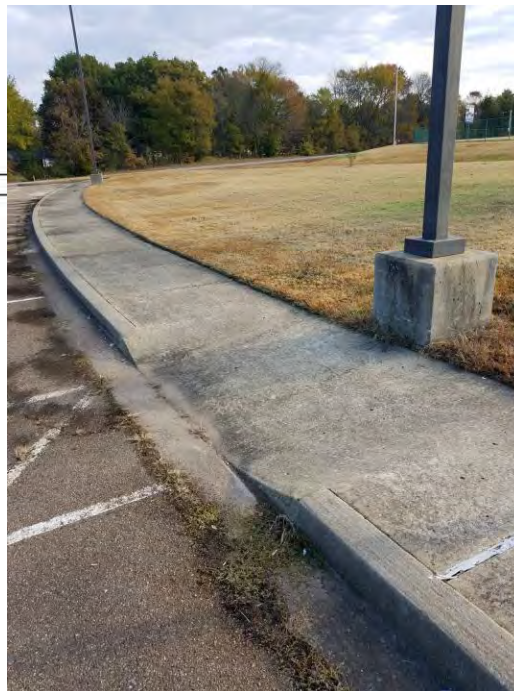
Northwest Parking**Finding: 32****Budget: \$7,000****Recommendation:**

The curb ramp side flares are too steep, at 30% and there is no landing.

Replace existing ramps.

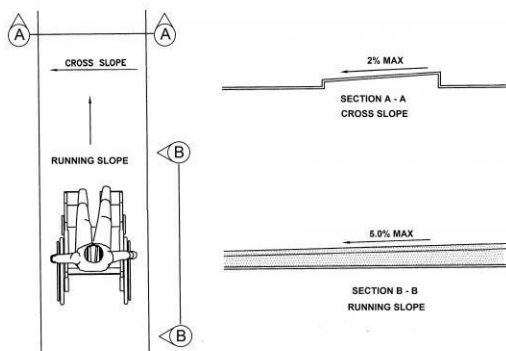
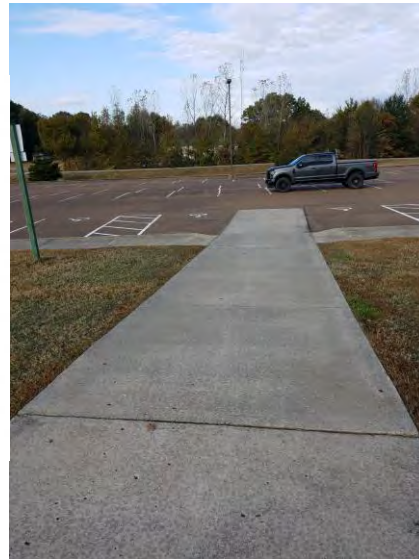
Northwest Parking**Finding: 33****Budget: \$3,500****Recommendation:**

The slope varies up to 6.9%. The accessible route on the site contains running slopes greater than 5% and has not been constructed as a ramp (i.e. handrails, wheel guides, etc.).

Install handrails or replace section with shorter ramps and landings.

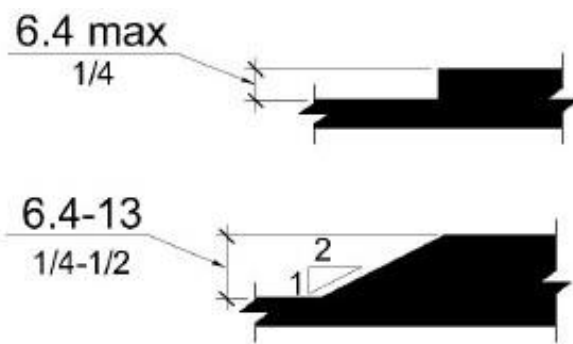
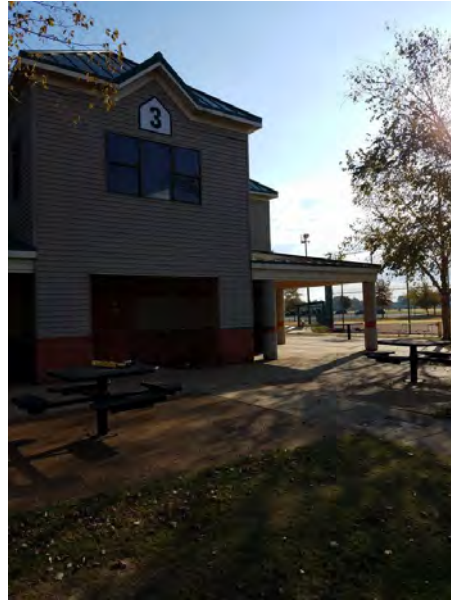
Baseball Fields 1-4, plus pavilion**Finding: 34****Budget: \$20,000****Recommendation:**

This finding is typical and should be corrected in multiple locations.

Replace concrete.

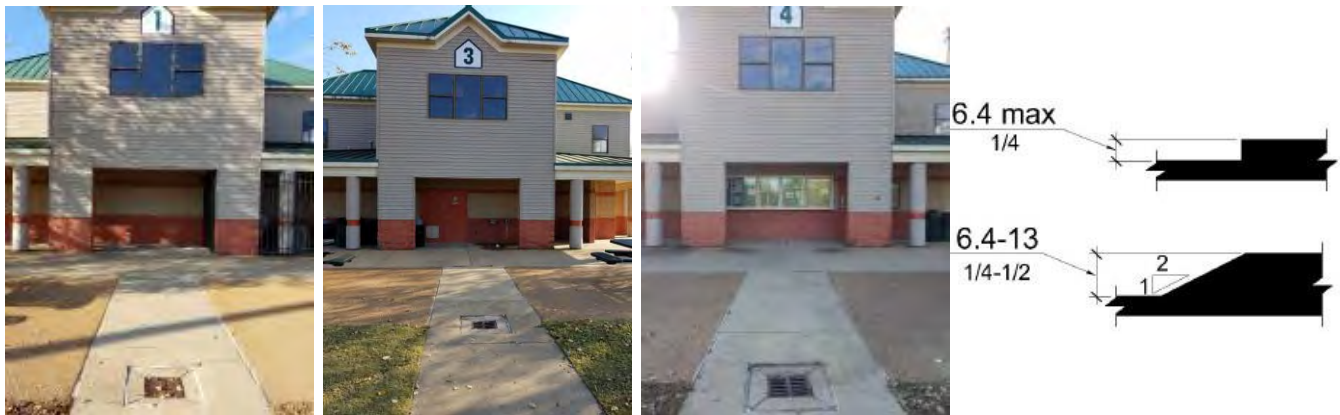
Baseball Fields 1-4, plus pavilion**Finding: 35****Budget: \$2,000****Recommendation:**

The sidewalk panel around storm inlet is not flush. This is typical at fields 1,3,4.

Replace concrete to provide flush surface.

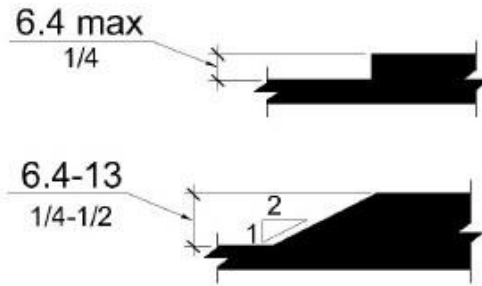
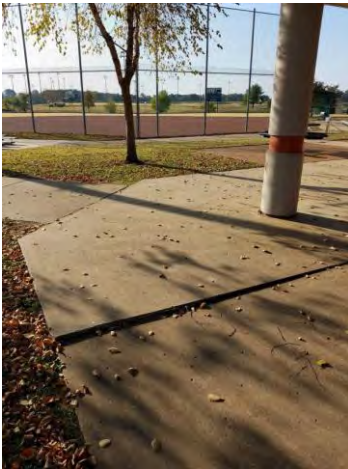
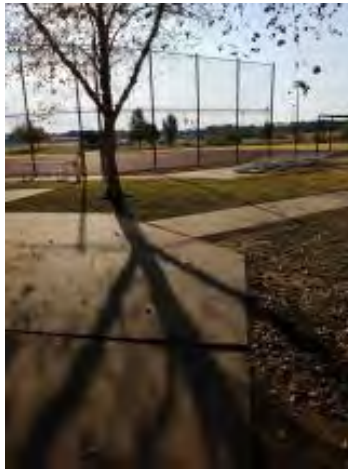
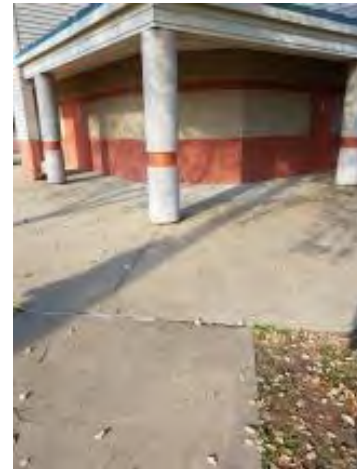
Baseball Fields 1-4, plus pavilion**Finding: 36****Budget: \$3,000****Recommendation:**

Due to tree the (2) 10ft x 10 ft. Panels at northeast and southeast corner of pavilion at field 2 varies up to 1.5". The surface of the pedestrian access route has vertical discontinuities greater than 1/2 inch or between 1/4 inch and 1/2 inch that are not beveled. Vertical surface discontinuities shall be 0.5 inch maximum. Vertical surface discontinuities between 0.25 inch and 0.5 inch shall be beveled with a slope not steeper than 50 percent. The bevel shall be applied across the entire vertical surface discontinuity.

Replace concrete to provide flush surface.

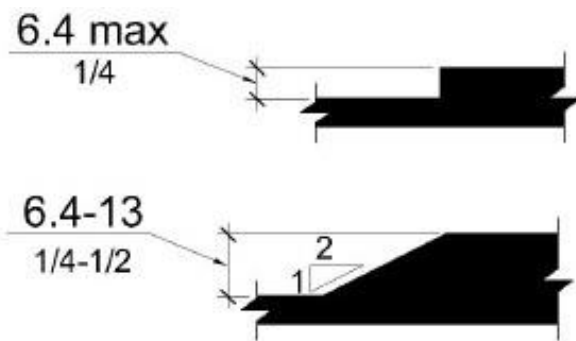
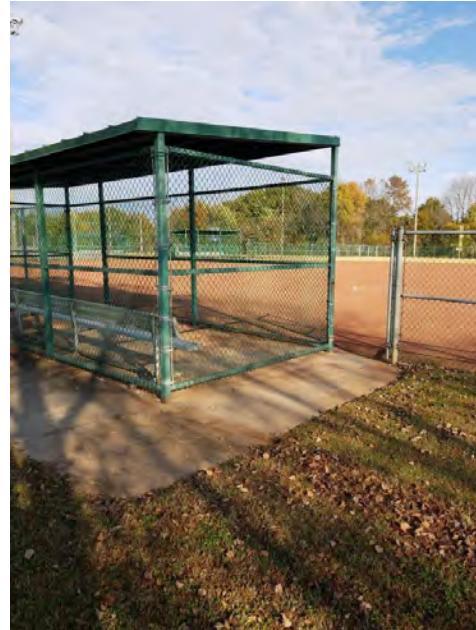
Baseball Fields 1-4, plus pavilion**Finding: 37****Budget: \$500****Recommendation:**

The 5x5 concrete panel near dugout entrance at field 1 is not flush.

Replace concrete to provide flush surface.

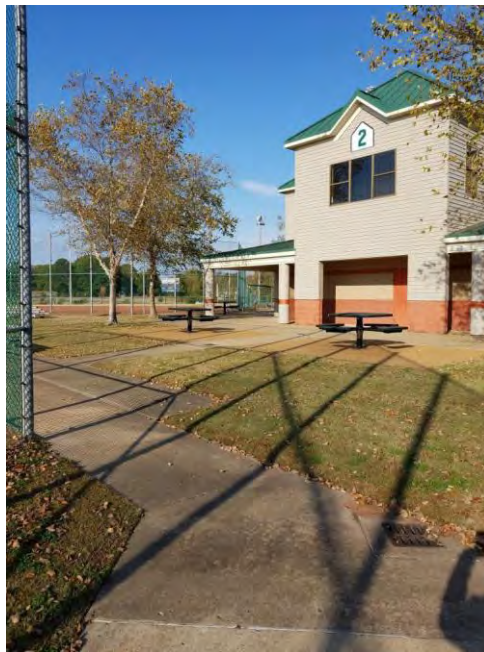
Baseball Fields 1-4, plus pavilion**Finding: 38****Budget: \$1,200****Recommendation:**

The 18ft x 5 ft. panel varies up to 3.6% along back stop of field 2.

Replace concrete.

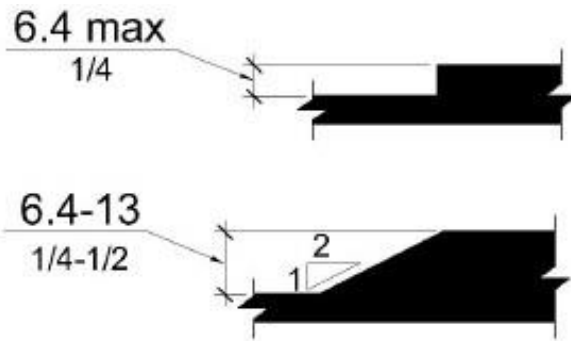
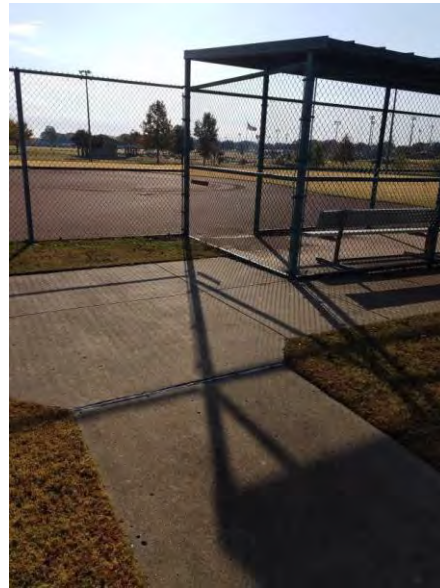
Baseball Fields 1-4, plus pavilion**Finding: 39****Budget: \$500****Recommendation:**

The 5x5 panel at the West dugout for field 2 needs replaced. The surface of the pedestrian access route has vertical discontinuities greater than 1/2 inch or between 1/4 inch and 1/2 inch that are not beveled. Vertical surface discontinuities shall be 0.5 inch maximum. Vertical surface discontinuities between 0.25 inch and 0.5 inch shall be beveled with a slope not steeper than 50 percent. The bevel shall be applied across the entire vertical surface discontinuity.

Replace concrete panel.

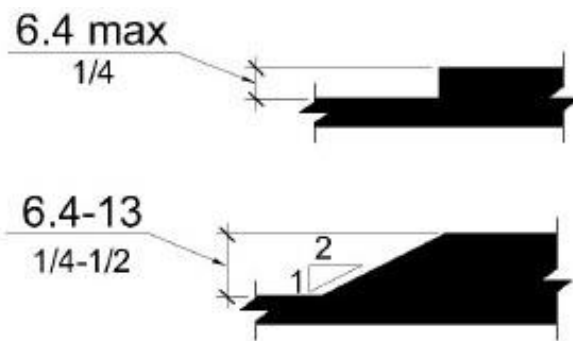
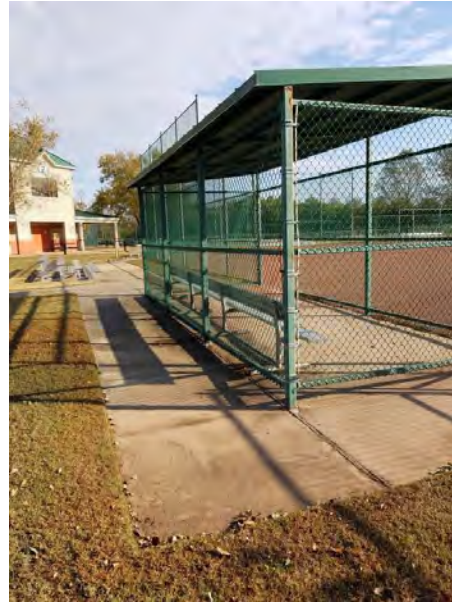
Baseball Fields 1-4, plus pavilion**Finding: 40****Budget: \$500****Recommendation:**

The 5x5 panel at west dugout of field 2 needs replaced.

Replace concrete panels.

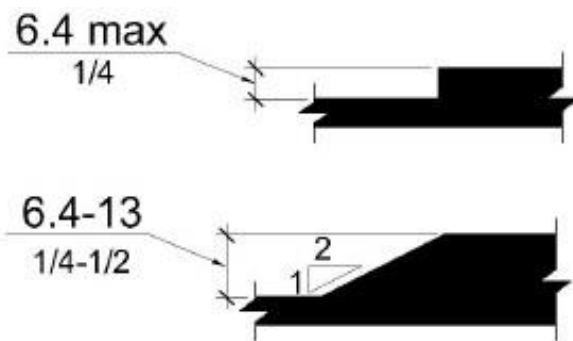
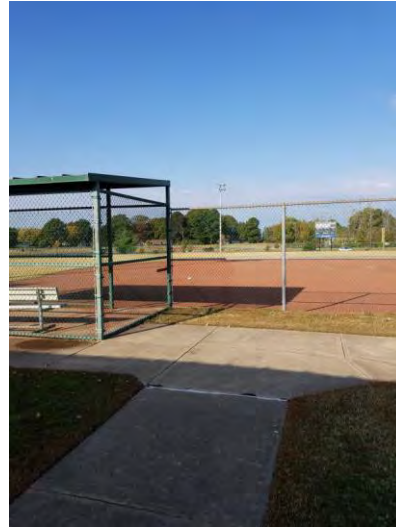
Baseball Fields 1-4, plus pavilion**Finding: 41****Budget: \$500****Recommendation:**

The 5x5 panel at east dugout for field 3 needs replaced.

Replace concrete panels.

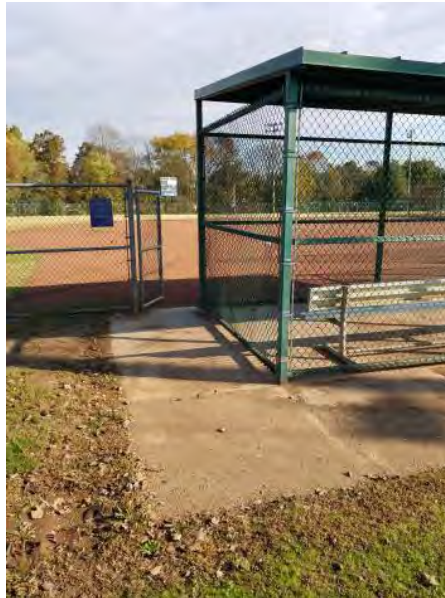
Baseball Fields 1-4, plus pavilion**Finding: 42****Budget: \$1,000****Recommendation:**

The 5x5 panels at the entrance to both dugouts at field 4 holds water and sediment at entrance.

Replace concrete panels.

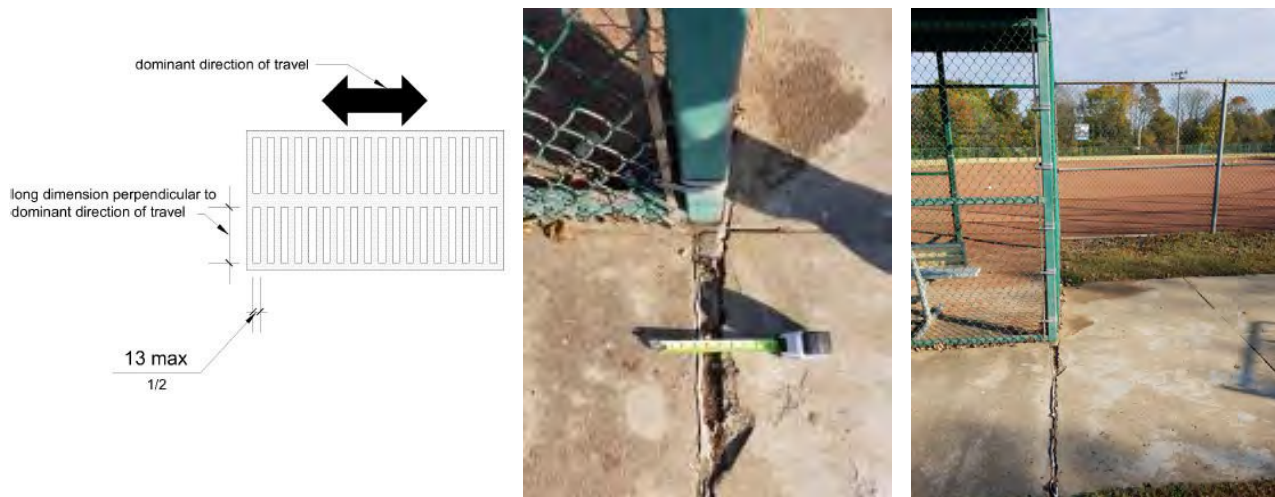
Baseball Fields 1-4, plus pavilion**Finding: 43****Budget: \$1,000****Recommendation:**

The 5x5 panels have a 2" gap along walks behind both dugouts at field 4.

Replace concrete panels.

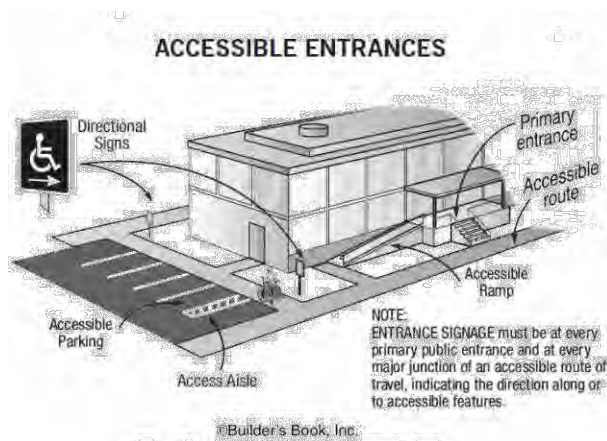
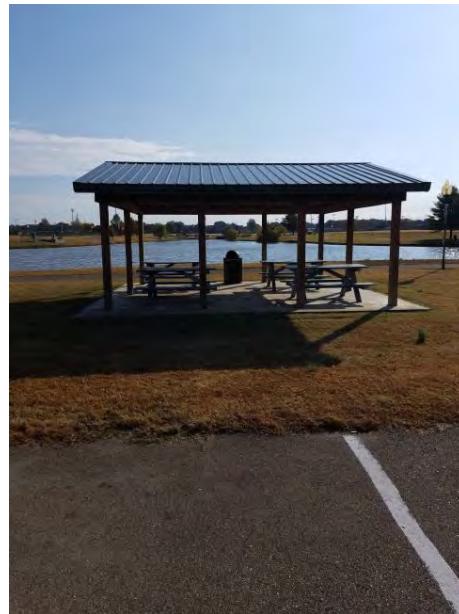
Lake Parking Lot**Finding: 44****Budget: \$1,200****Recommendation:**

There is no accessible route to the lake pavilion.
