ADA Self-Evaluation and Transition Plan

January 2020

Opera House
RESTAURANT

Prepared by:

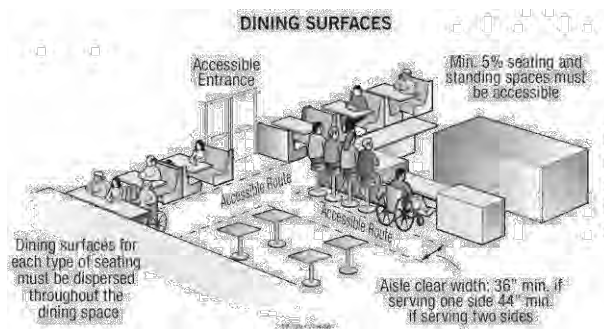
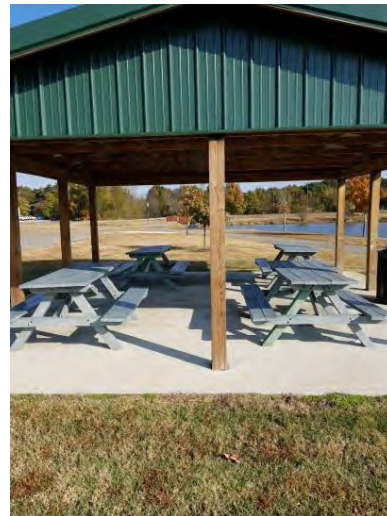
Lake Parking Lot**Finding: 46****Budget: \$4,000****Recommendation:**

There are 4 picnic tables and no accessible dining surfaces.

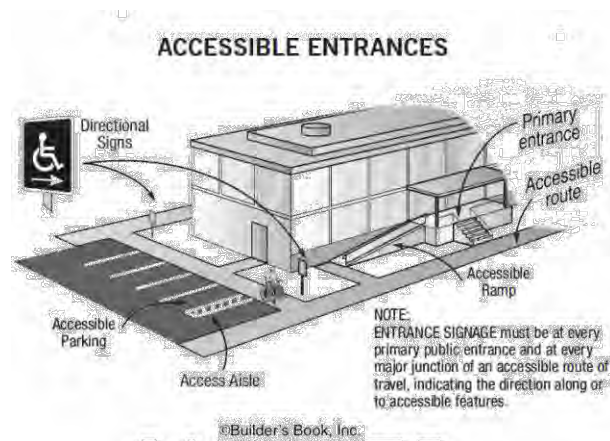
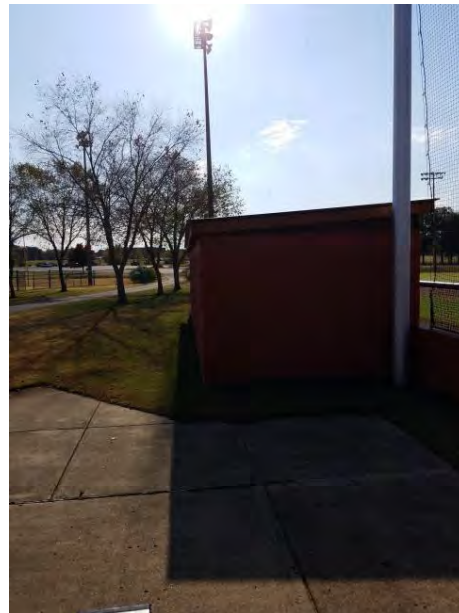
Baseball Fields 5-9, plus pavilion**Finding: 47****Budget: \$1,600****Recommendation:**

There is no accessible route provided to either dugout at field 6.

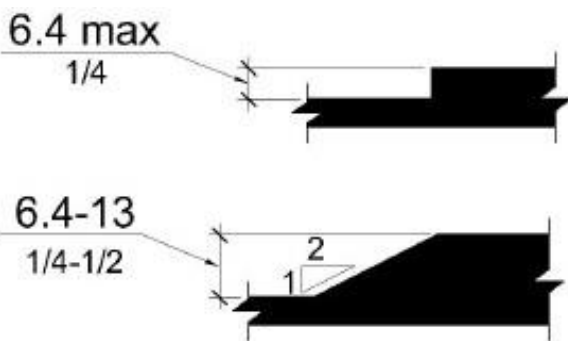
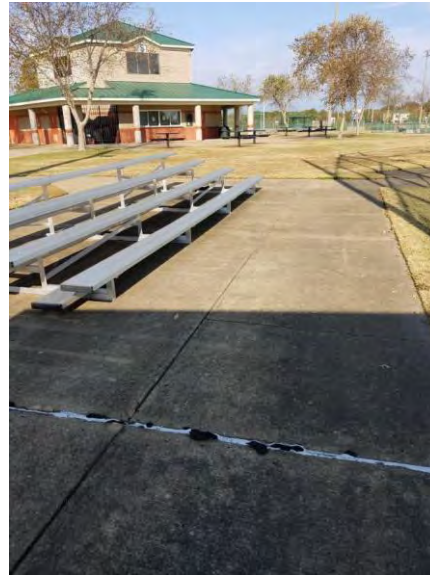
Baseball Fields 5-9, plus pavilion**Finding: 48****Budget: \$2,000****Recommendation:**

The expansion joint exceeds 1/4" in multiple locations at the complex. The surface of the pedestrian access route has vertical discontinuities greater than 1/2 inch or between 1/4 inch and 1/2 inch that are not beveled. Vertical surface discontinuities shall be 0.5 inch maximum. Vertical surface discontinuities between 0.25 inch and 0.5 inch shall be beveled with a slope not steeper than 50 percent. The bevel shall be applied across the entire vertical surface discontinuity.

Repair or replace expansion joints around entire facility. Multiple exceed maximums for accessibility.

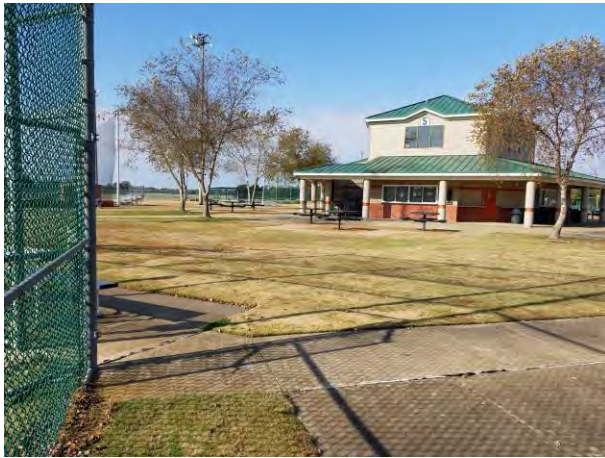
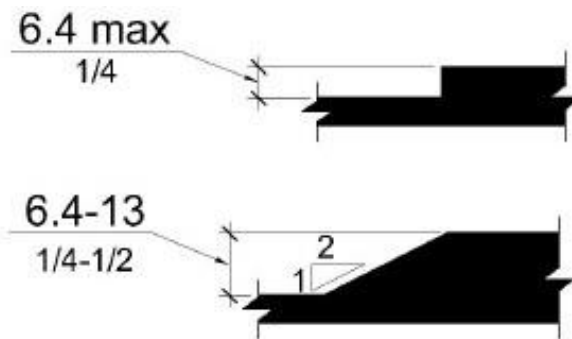
Baseball Fields 5-9, plus pavilion**Finding: 49****Budget: \$1,000****Recommendation:**

There are 3 panels that exceed 1/4" at back stop entrance to field 5. The surface of the pedestrian access route has vertical discontinuities greater than 1/2 inch or between 1/4 inch and 1/2 inch that are not beveled. Vertical surface discontinuities shall be 0.5 inch maximum. Vertical surface discontinuities between 0.25 inch and 0.5 inch shall be beveled with a slope not steeper than 50 percent. The bevel shall be applied across the entire vertical surface discontinuity.

Replace concrete panels.

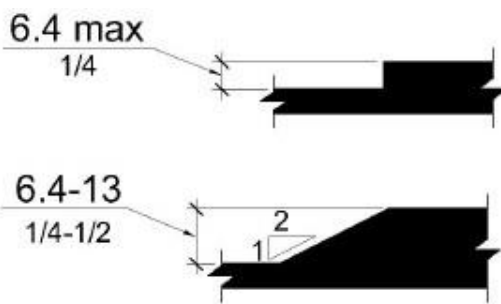
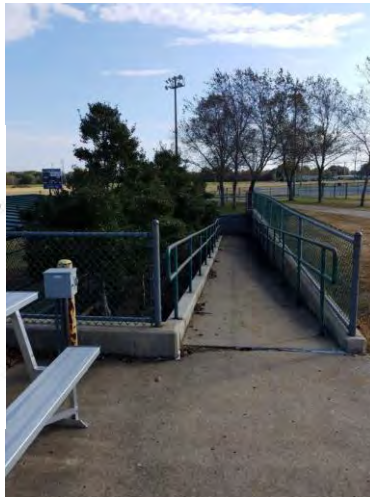
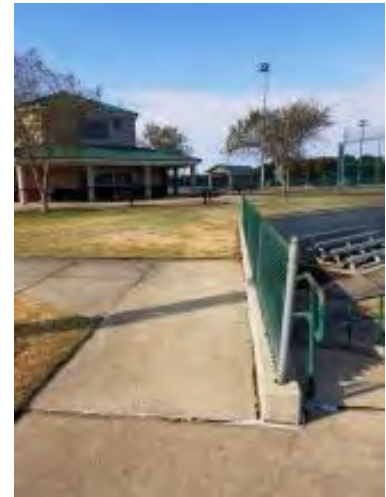
Baseball Fields 5-9, plus pavilion**Finding: 50****Budget: \$1,500****Recommendation:**

There are 2 panels that exceed 1/2" at field 9. The surface of the pedestrian access route has vertical discontinuities greater than 1/2 inch or between 1/4 inch and 1/2 inch that are not beveled.

Replace concrete panels.

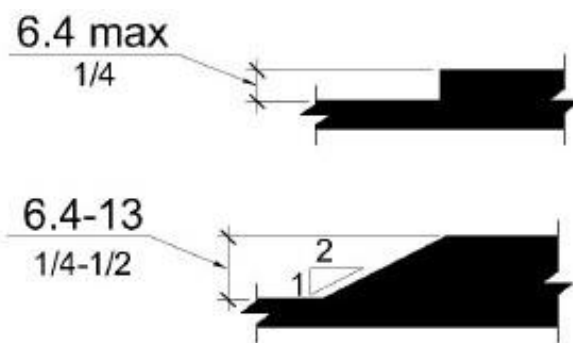
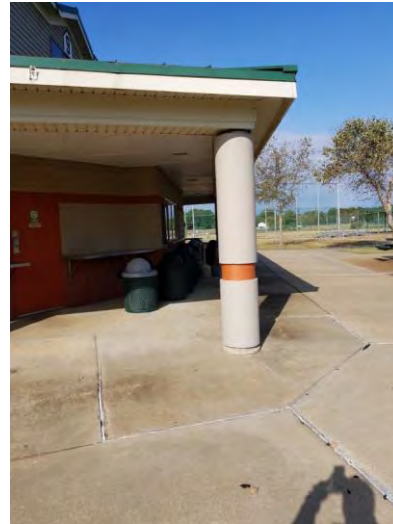
Baseball Fields 5-9, plus pavilion**Finding: 51****Budget: \$700****Recommendation:**

The 10 ft x 5 ft Northeast corner pedestrian access route surface between fields 5 & 9 has vertical discontinuities greater than 1/2 inch or between 1/4 inch and 1/2 inch that are not beveled.

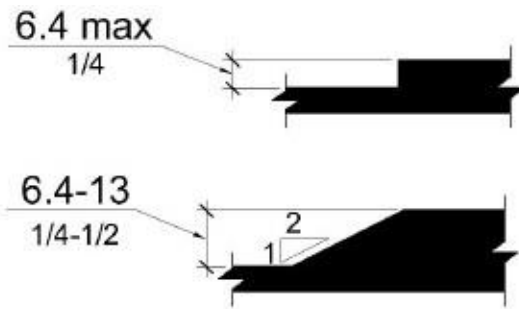
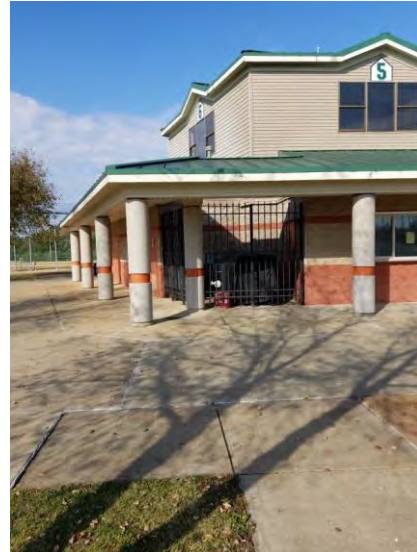
Baseball Fields 5-9, plus pavilion**Finding: 52****Budget: \$700****Recommendation:**

The 10 ft x 5 ft surface in front of field 5 has panels in bad condition.

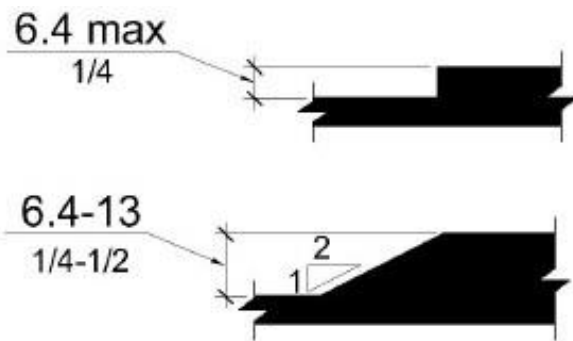
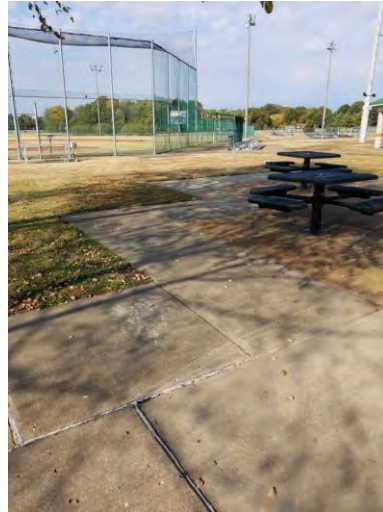
Baseball Fields 5-9, plus pavilion**Finding: 53****Budget: \$1,200****Recommendation:**

The 10 ft x 10 ft pedestrian access route surface in front of field 7 has vertical discontinuities greater than 1/2 inch or between 1/4 inch and 1/2 inch that are not beveled.

Replace concrete panels.

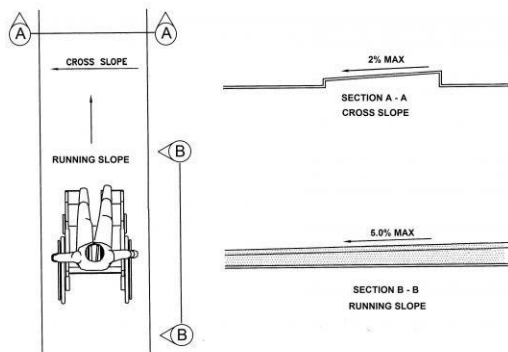
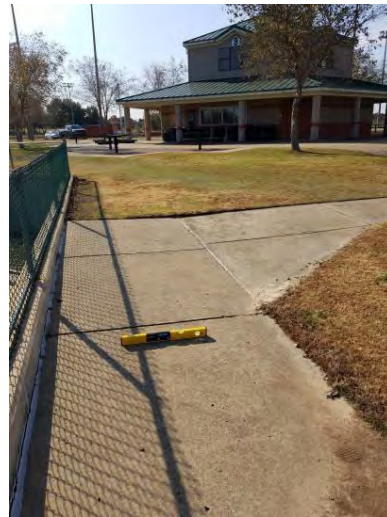
Baseball Fields 5-9, plus pavilion**Finding: 54****Budget: \$950****Recommendation:**

The 15ft x 5 ft surface varies up to 3.7% along walk leading to north dugout of field 9. The accessible path of travel contains cross slopes greater than 2%.

Replace concrete panels.

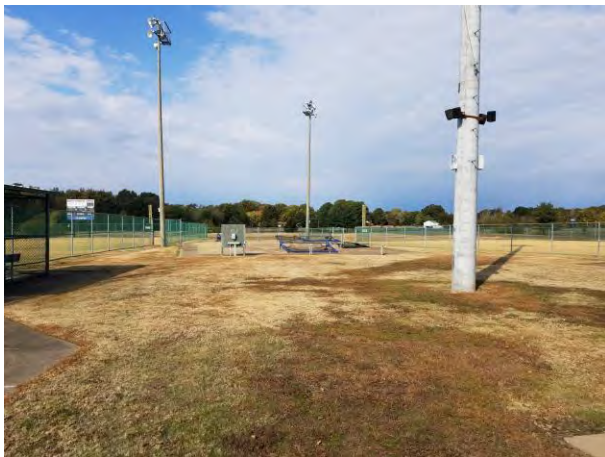
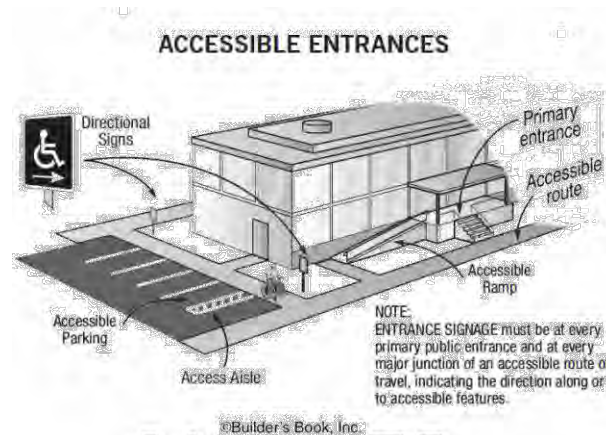
Baseball Fields 5-9, plus pavilion**Finding: 55****Budget: \$2,500****Recommendation:**

No accessible route provided to pitching cages between fields 7&8.

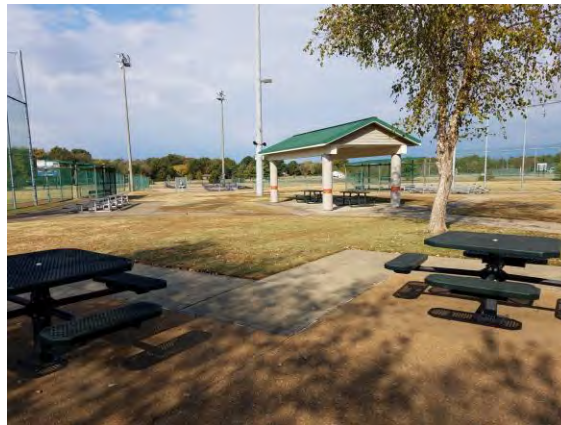
Baseball Fields 5-9, plus pavilion**Finding: 56****Budget: \$10,000****Recommendation:**

There are 15 square picnic tables and 2 rectangle picnic tables provided, and no accessible tables. There are no accessible tables.

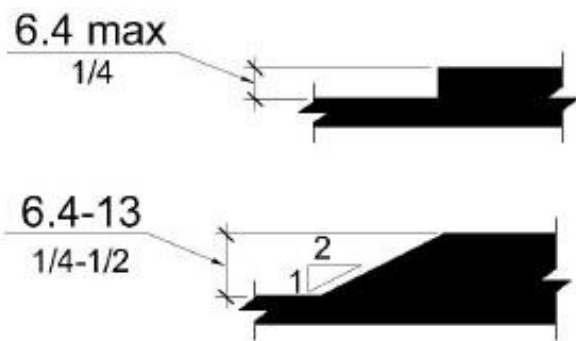
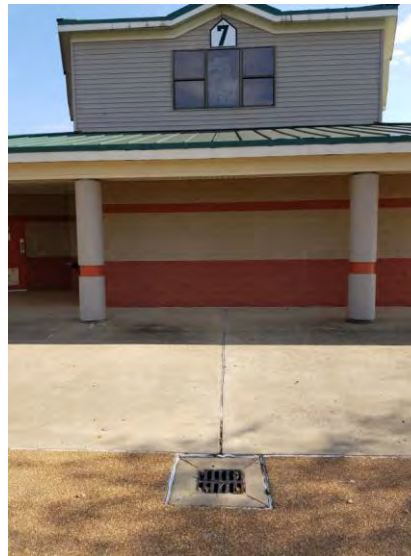
Baseball Fields 5-9, plus pavilion**Finding: 57****Budget: \$500****Recommendation:**

Panel around storm drain inlet in front of field 7 has vertical discontinuities greater than 1/2 inch or between 1/4 inch and 1/2 inch that are not beveled.

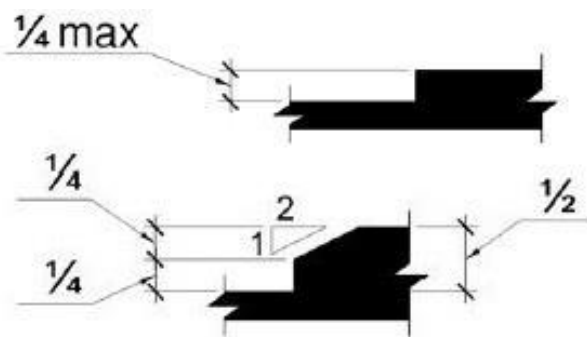
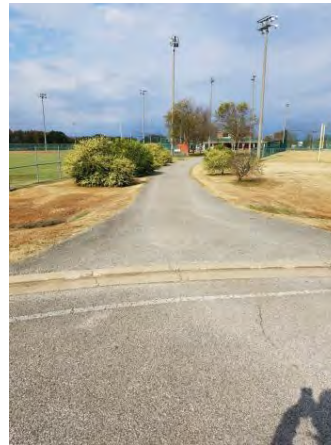
Baseball Fields 5-9, plus pavilion**Finding: 58****Budget: \$1,500****Recommendation:**

There is a 1" lip at curb and gutter. The walkway contains abrupt vertical edges and/or variations over a 1/4 inch.

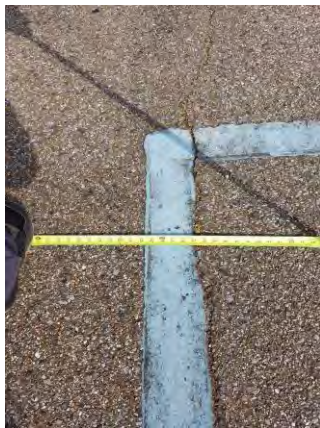
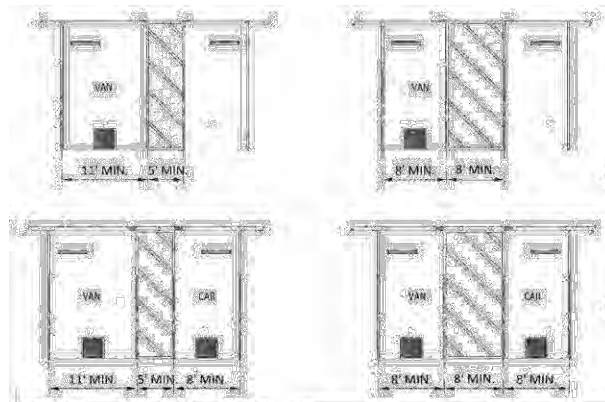
Baseball Fields 5-9, plus pavilion**Finding: 60****Budget: \$2,500****Recommendation:**

The surface varies from 7' to less than 8' and is typical of all spaces. The accessible parking stall is not wide enough.

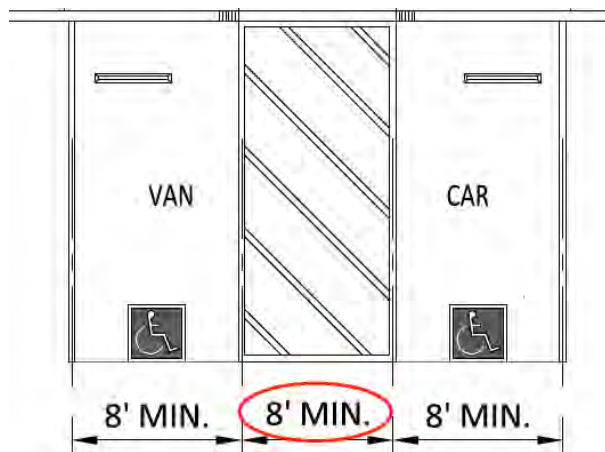
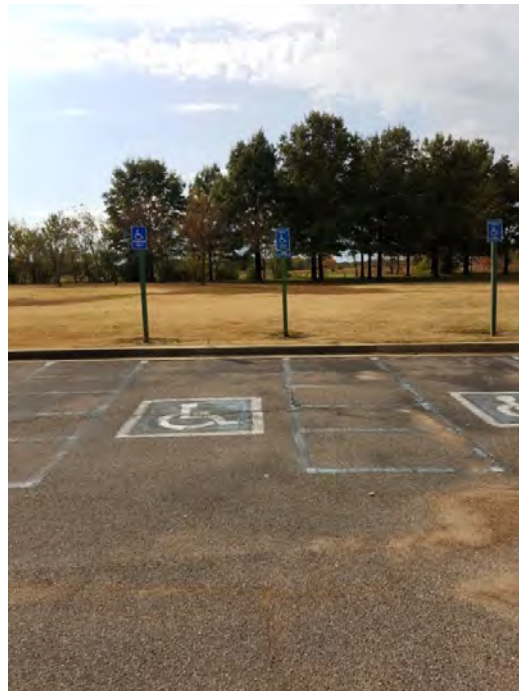
Baseball Fields 5-9, plus pavilion**Finding: 61****Budget: \$2,000****Recommendation:**

The access aisle plus parking stall measures 13 ft. Restripe parking after resurfacing. Ensure dimension meet requirements. Provide 6 spaces total, 1 being van accessible. The access aisle is not a minimum 8 feet to the centerline of the stripe.

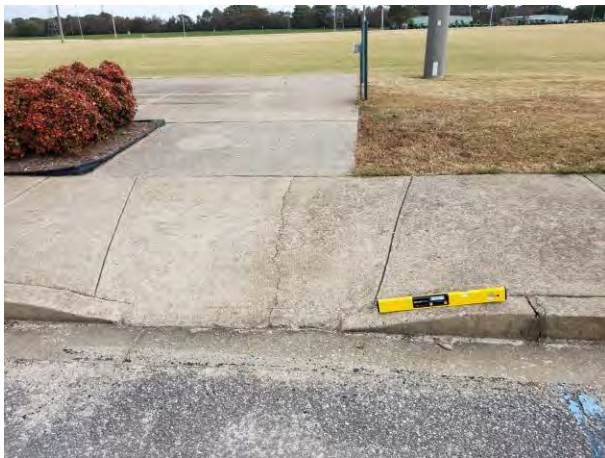
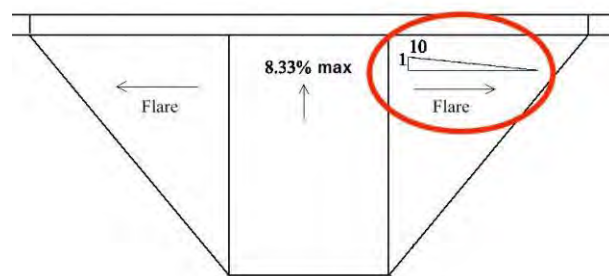
Soccer Pavilion and Small Parking Lot**Finding: 62****Budget: \$2,500****Recommendation:**

The 35 ft x 6ft. ramp varies up to 16.5% and there is no landing provided. This is typical in 2 places. The curb ramp side flares are too steep.

Replace curb ramps.

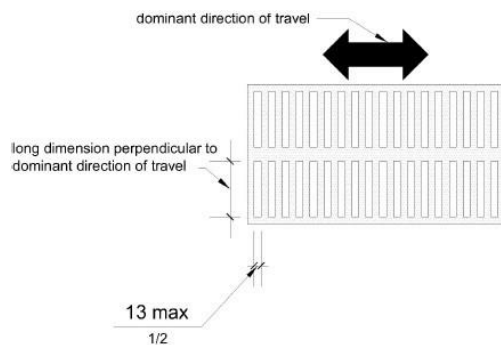
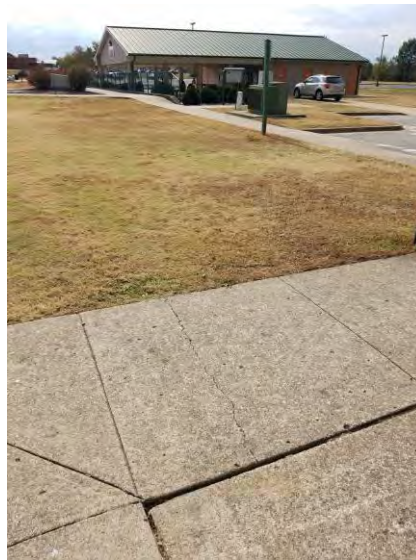
Soccer Pavilion and Small Parking Lot**Finding: 63****Budget: \$200****Recommendation:**

Both viewing pads at field north of pavilion has a gap of 3/4". The surface of the pedestrian access route has openings greater than 1/2 inch. Horizontal openings in gratings and joints shall not permit passage of a sphere more than 13 mm (0.5 in) in diameter.

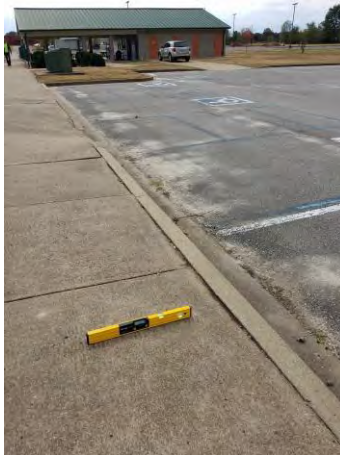
Soccer Pavilion and Small Parking Lot**Finding: 64****Budget: \$12,000****Recommendation:**

The sidewalk slope varies up to 5.7%. The cross slope of the pedestrian access route is excessive. The cross slope of pedestrian access routes shall be 2 percent maximum.

Replace sidewalk ensuring slope does not exceed 5%.

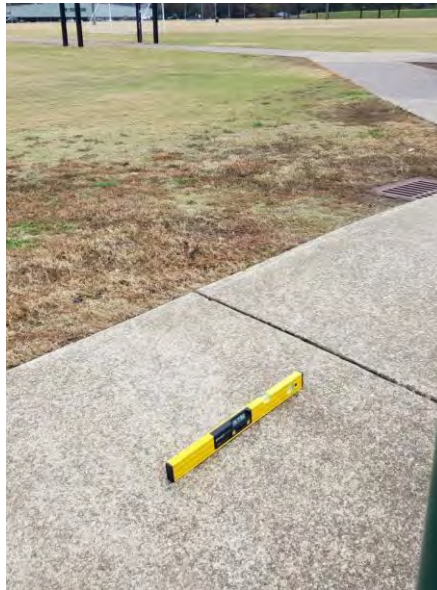
Soccer Pavilion and Small Parking Lot**Finding: 65****Budget: Refer to Finding 64****Recommendation:**

The sidewalk slope varies up to 9.3% north of pavilion along walk at wall. The grade of the pedestrian access route is too steep.

Replace sidewalk ensuring slope does not exceed 5%.

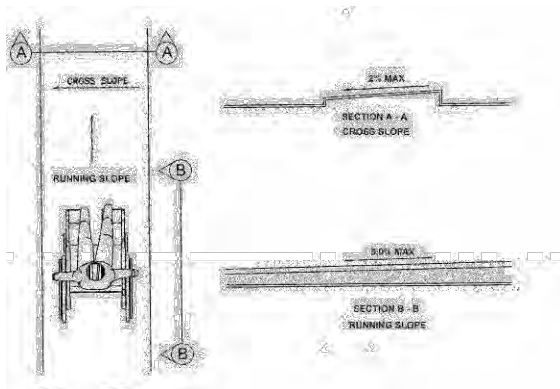
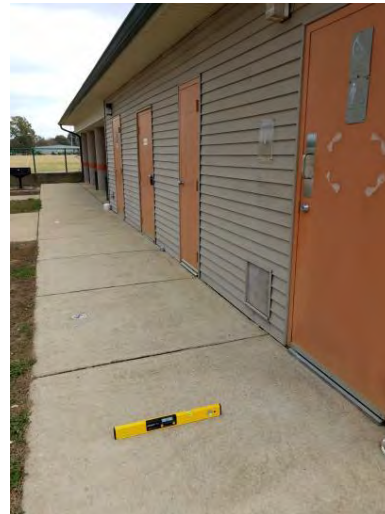
Soccer Pavilion and Small Parking Lot**Finding: 66****Budget: \$1,600****Recommendation:**

The sidewalk slope varies up to 3.3% along north side of soccer concessions. The accessible path of travel between building entrances contains cross slopes greater than 2%.

Replace sidewalk.

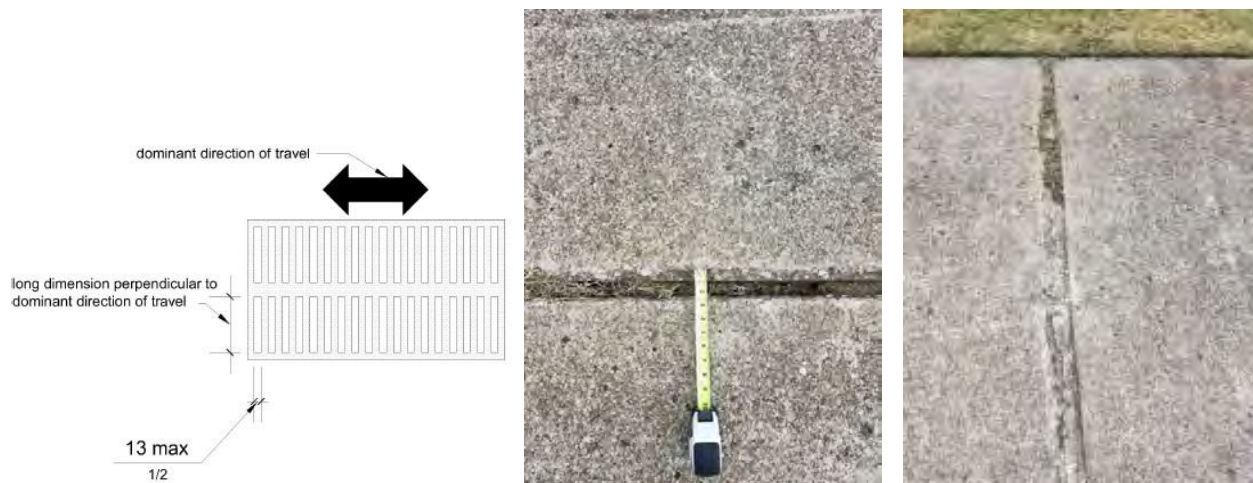
Soccer Pavilion and Small Parking Lot**Finding: 67****Budget: \$2,500****Recommendation:**

The sidewalk, which is typical along 5 places between fields, varies up to 2". The surface of the pedestrian access route has openings greater than 1/2 inch.

Replace panel adjacent to excessive gap. 8 ft x 5 ft typical each location. (200SF).

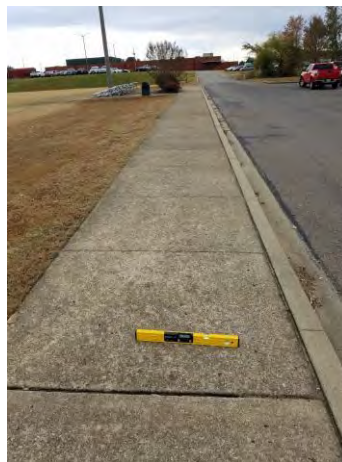
Soccer Pavilion and Small Parking Lot**Finding: 68****Budget: \$12,000****Recommendation:**

The sidewalk 200 ft x 6 ft south of soccer concessions varies up to 5.1%

Replace sidewalk.

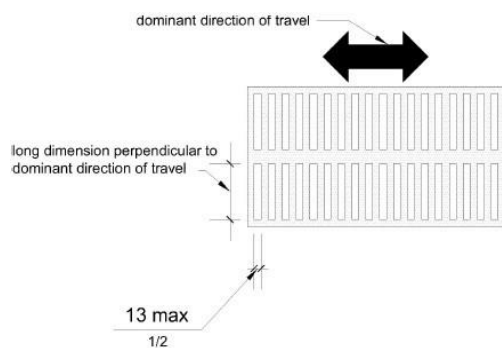
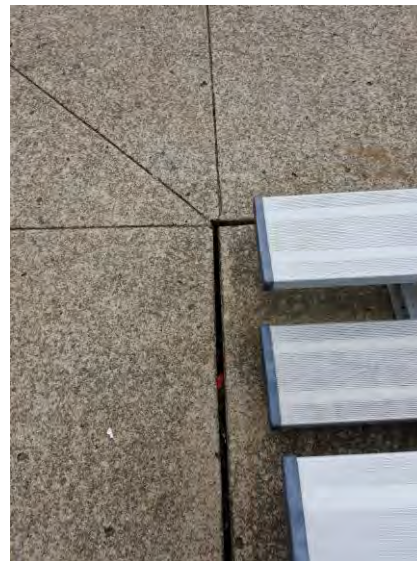
Soccer Pavilion and Small Parking Lot**Finding: 69****Budget: \$200****Recommendation:**

The viewing pad surface directly south of the soccer concessions and the pedestrian access route has openings greater than 1/2 inch.

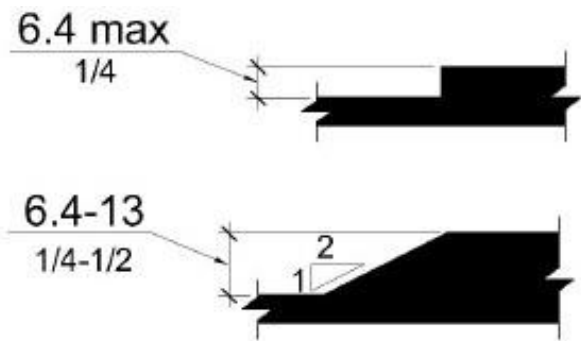
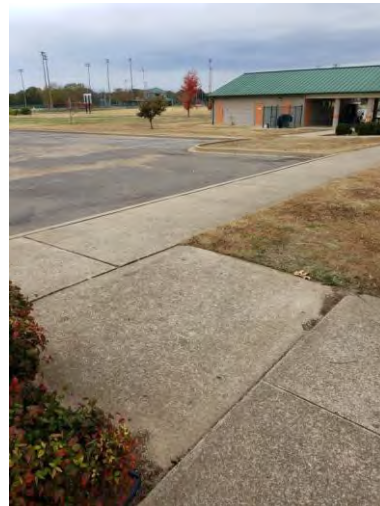
Soccer Pavilion and Small Parking Lot**Finding: 70****Budget: \$600****Recommendation:**

The panel connecting to viewing pad directly south of soccer concessions and the surface of the pedestrian access route has vertical discontinuities greater than 1/2 inch or between 1/4 inch and 1/2 inch that are not beveled.

Replace 8ft x 6ft.

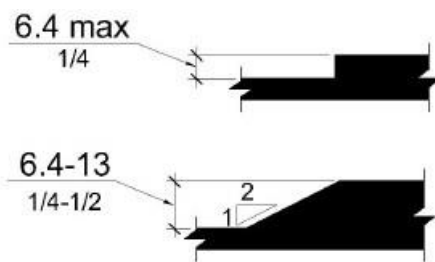
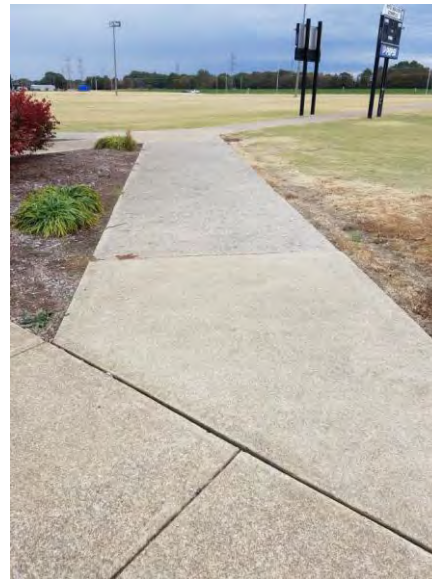
Soccer Pavilion and Small Parking Lot**Finding: 71****Budget: \$1,500****Recommendation:**

The first panel of each diagonal walk leading to walk between fields.

Replace ~8 ft x 8 ft x 2.

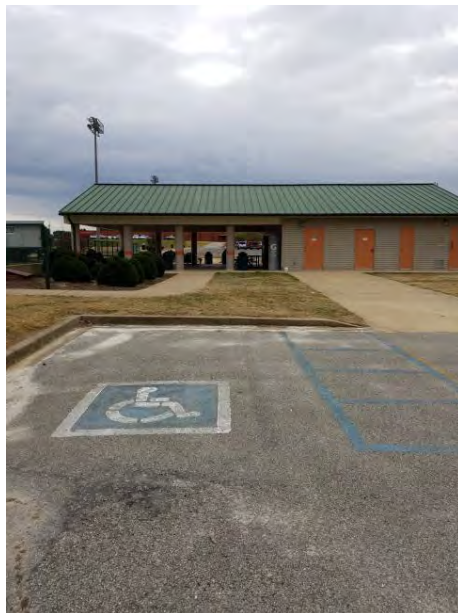
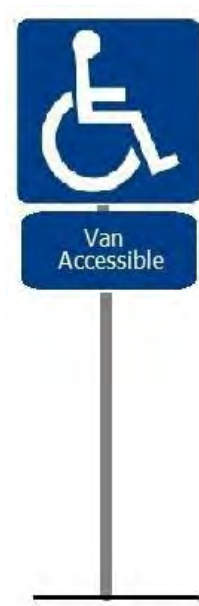
Soccer Pavilion and Small Parking Lot**Finding: 72****Budget: \$150****Recommendation:**

The van stall is missing a sign identifying it as a van accessible stall.

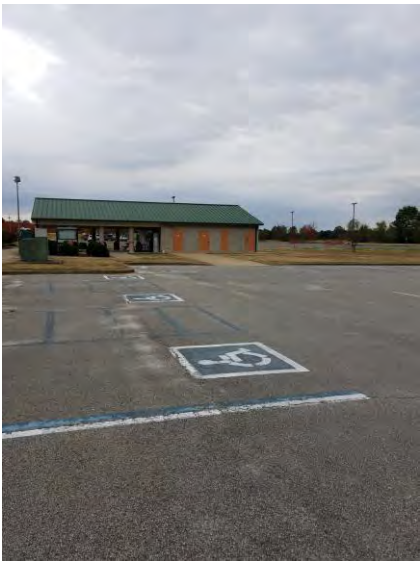
There are not enough accessible stalls

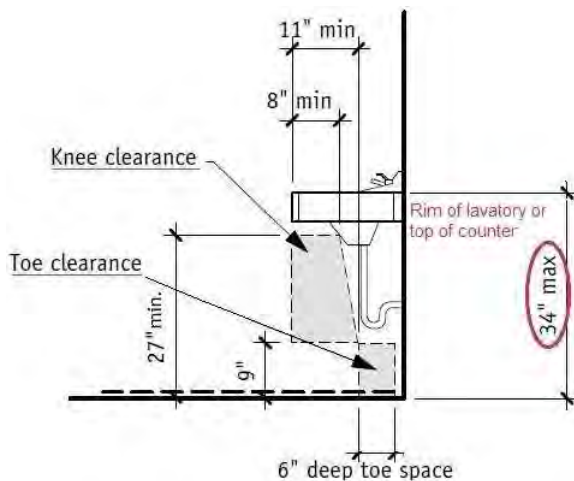
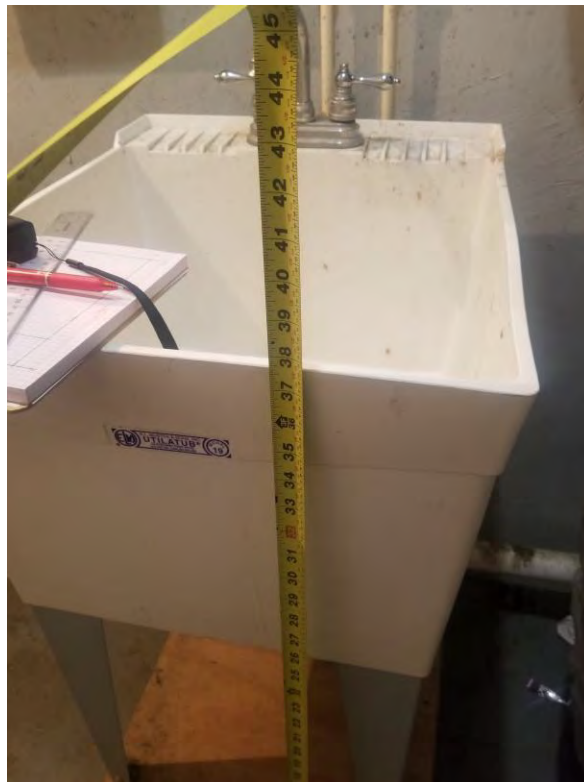
First Floor Restroom

The utility sink is too high.

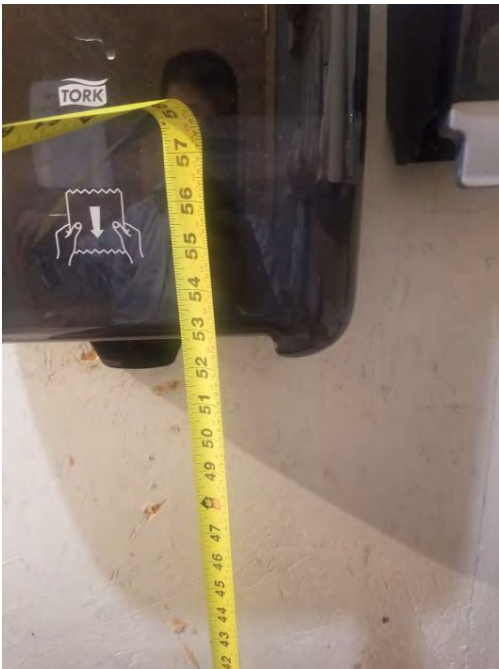
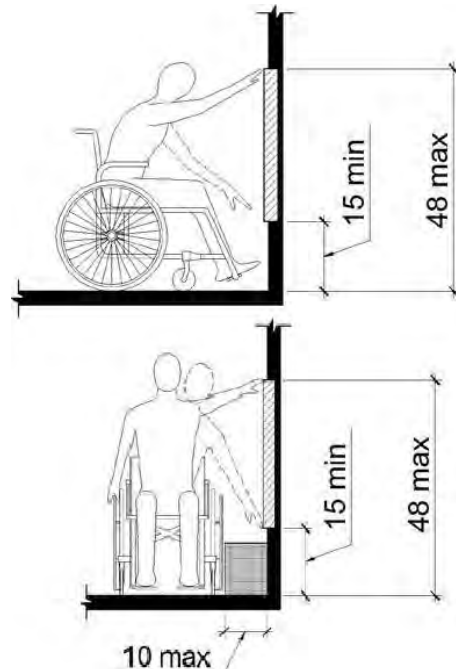
First Floor Restroom**Finding: 2****Budget: Refer to Finding 1****Recommendation:**

The paper towel dispenser is 53" to bottom.

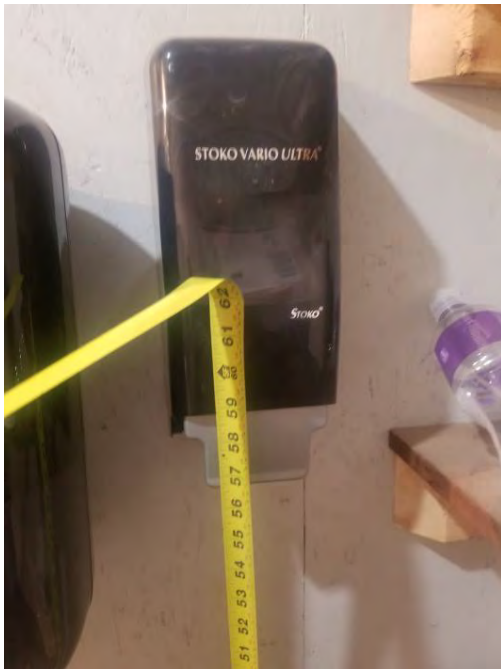
First Floor Restroom**Finding: 3****Budget: \$ Refer to Finding 1****Recommendation:**

The soap dispenser at 58" to push button

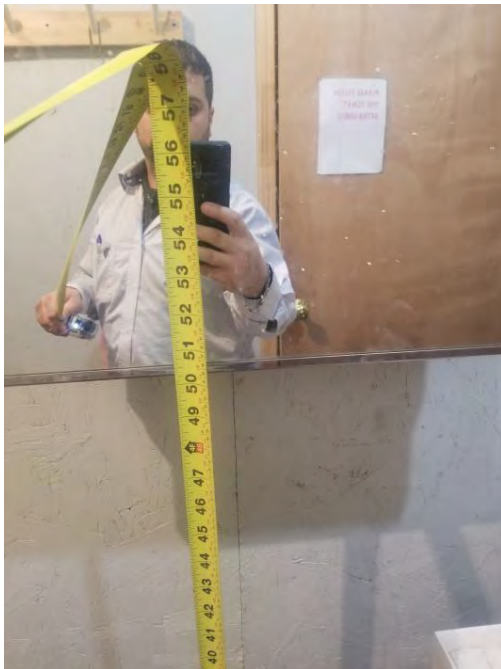
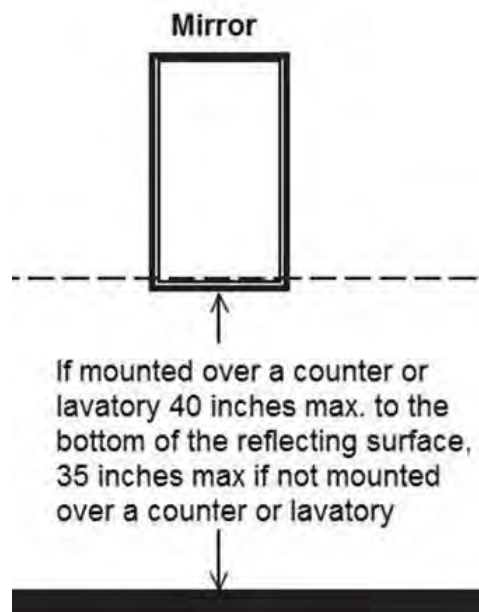
First Floor Restroom**Finding: 4****Budget: \$ Refer to Finding 1****Recommendation:**

The mirror is 50.5" high. The mirror is mounted too high.

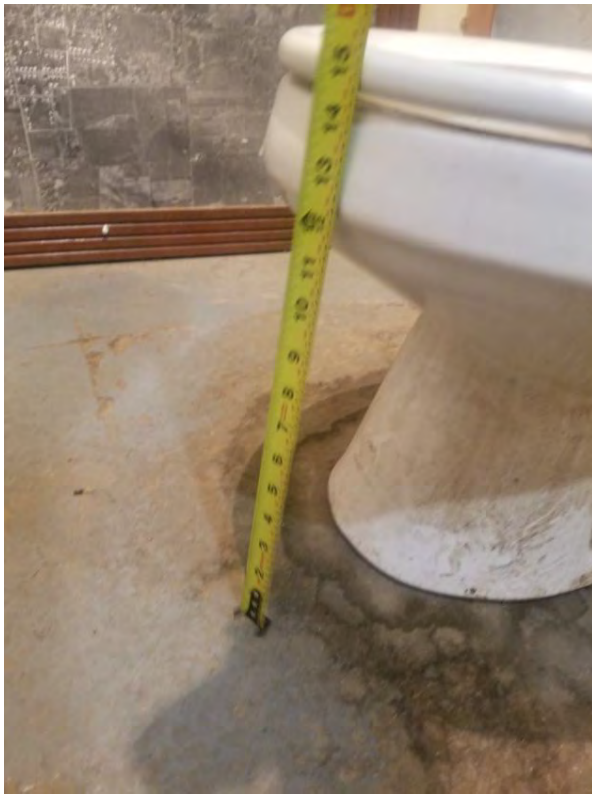
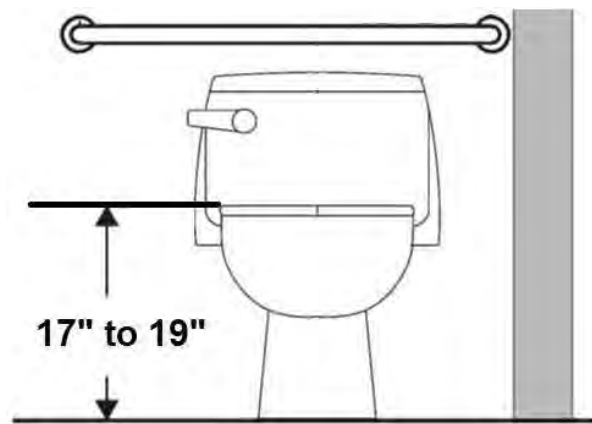
First Floor Restroom**Finding: 5****Budget: \$ Refer to Finding 1****Recommendation:**

There is 15.5" to seat.

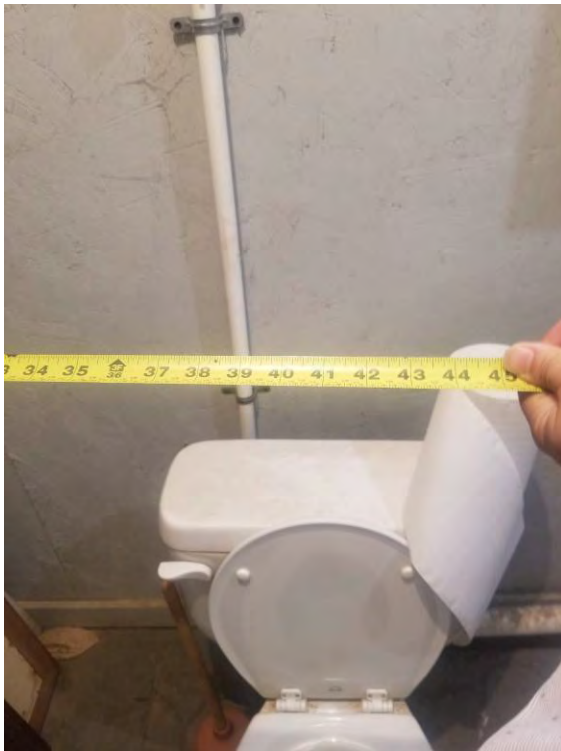
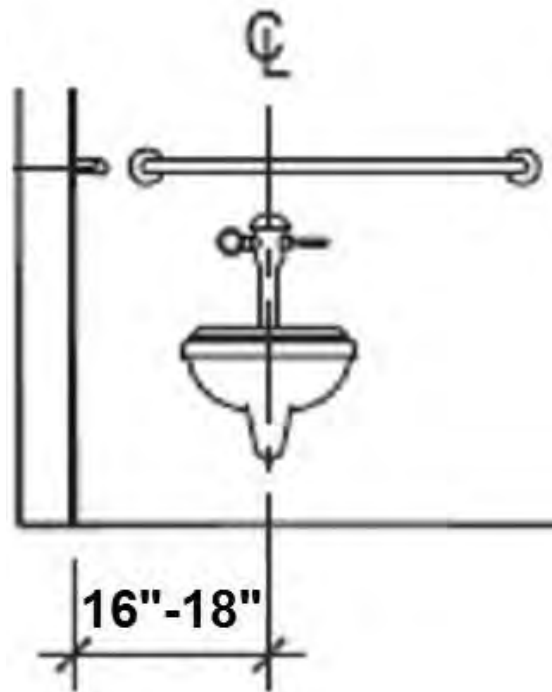
First Floor Restroom**Finding: 6****Budget: \$ Refer to Finding 1****Recommendation:**

There is 41" to wall. The toilet is not located within the range allowed from the side wall or partition. The centerline of the toilet must be 16 to 18 inches from the side wall.

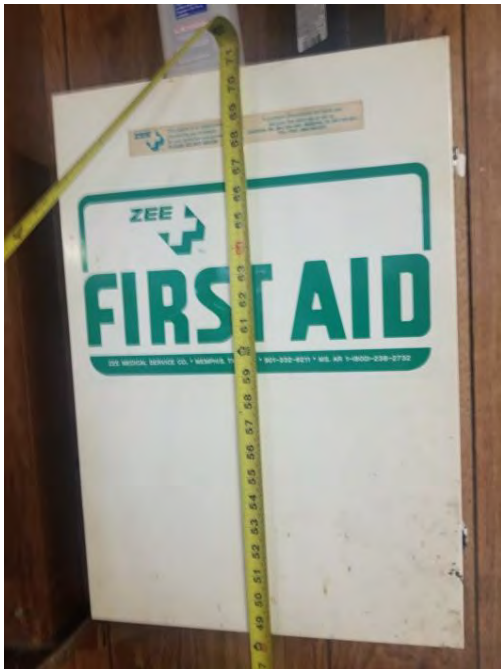
First Floor Breakroom**Finding: 7****Budget: \$400****Recommendation:**

The first aid kit 48" to bottom of Cabinet. The first aid kit is positioned too high for either a side or front approach.

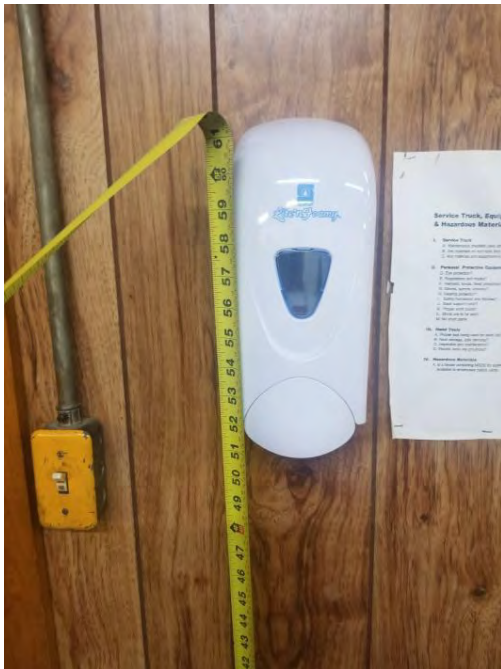
First Floor Breakroom**Finding: 9****Budget: Refer to Finding 7****Recommendation:**

The soap dispenser push button is 52" AFF. The soap dispenser is positioned too high for either a side or front approach.

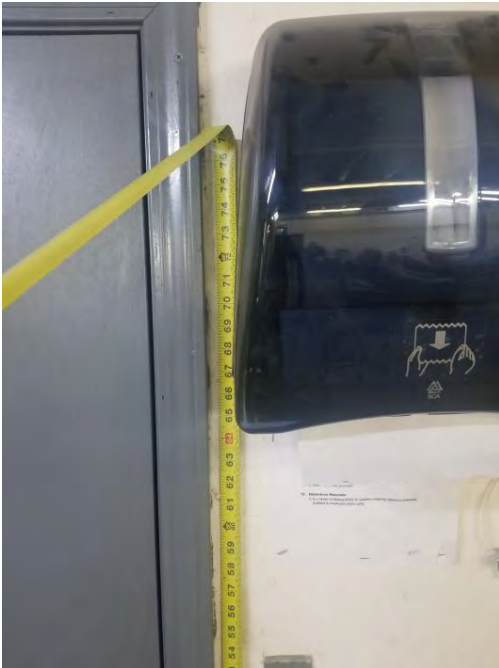
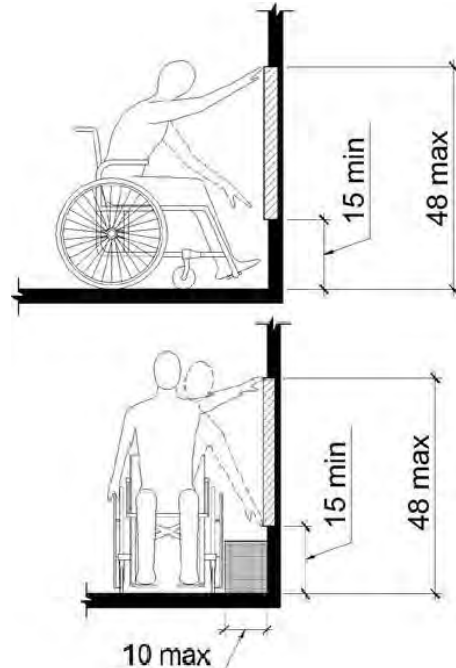
The paper towel dispenser is 64" to bottom. The paper towel dispenser is positioned too high for either a side or front approach.

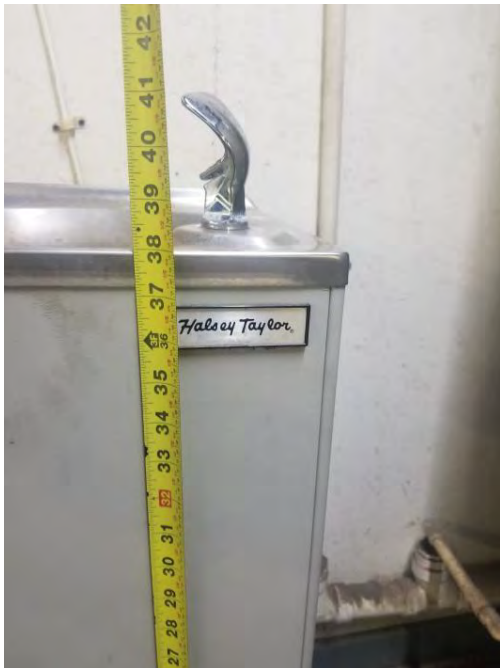
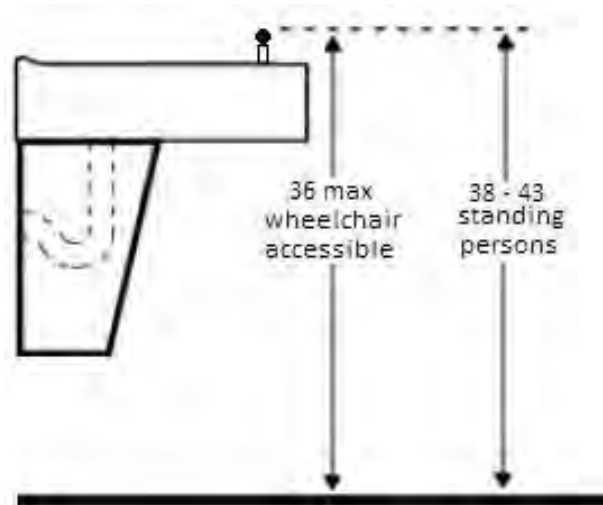
First Floor Breakroom**Finding: 11****Budget: \$2,400****Recommendation:**

There is not a wheelchair accessible drinking fountain.

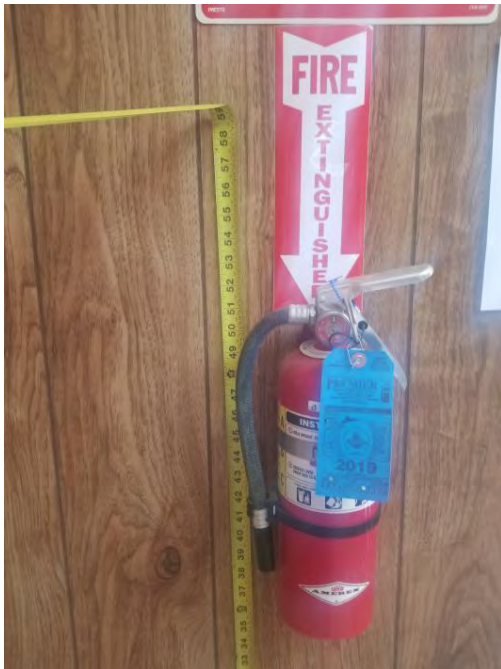
Second Floor Conference Room**Finding: 12****Budget: \$1,050****Recommendation:**

The fire extinguisher handle is at 50" AFF.

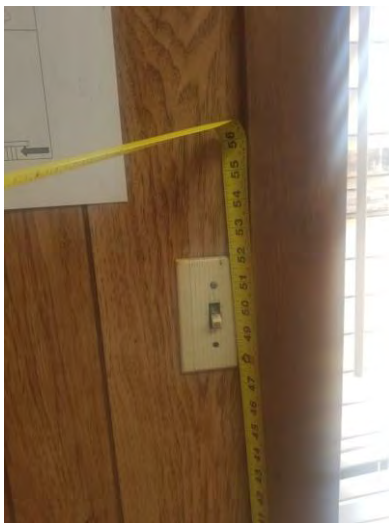
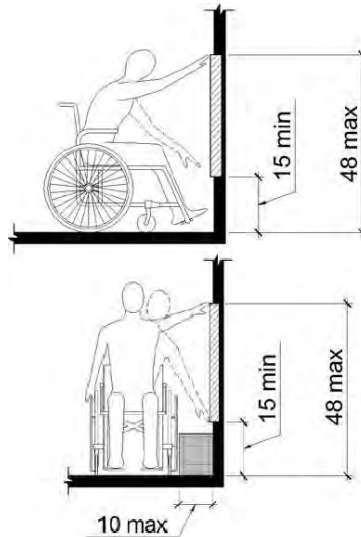
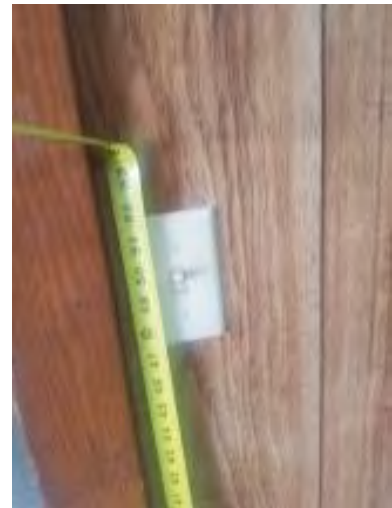
Second Floor Conference Room**Finding: 13****Budget: Refer to Finding 12****Recommendation:**

The light switch is 50" AFF. The receptacle/switch is not positioned correctly for either a side or front approach. Where a clear floor or ground space allows a parallel or front approach to a switch or receptacle and the side reach is unobstructed, the high side reach shall be 48 inches maximum above the finish floor or ground and the low side reach shall be 15 inches minimum above the finish floor or ground.

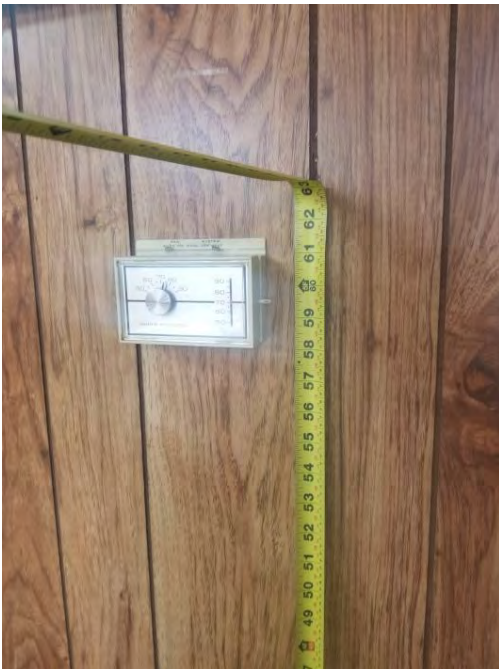
Second Floor Conference Room**Finding: 14****Budget: Refer to Finding 12****Recommendation:**

The thermostat is at 58" to bottom. The thermostat is positioned too high for either a side or front approach. Where a clear floor or ground space allows a parallel approach to an element and the side reach is unobstructed, the high side reach shall be 48 inches maximum and the low side reach shall be 15 inches minimum above the finish floor or ground.

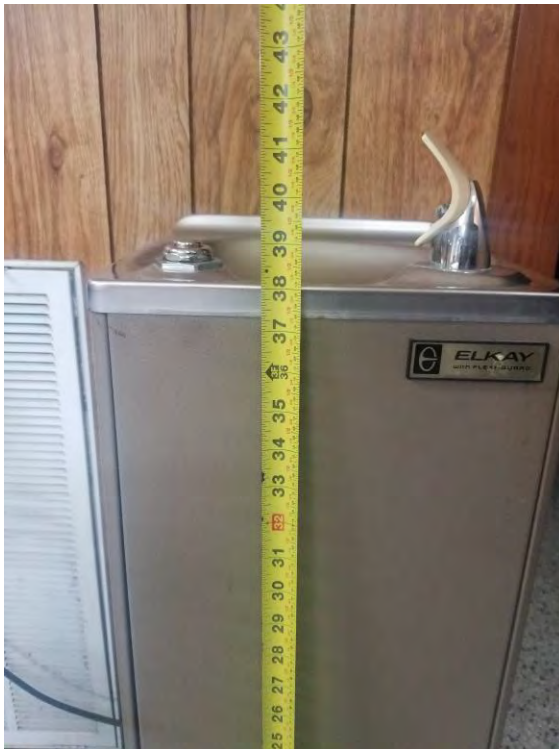
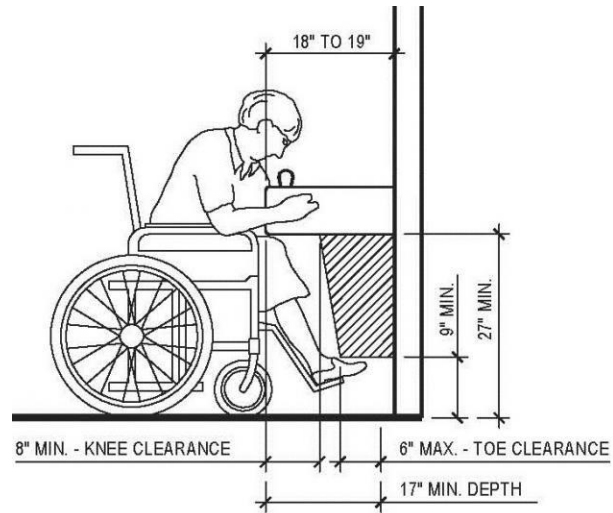
Second Floor Conference Room**Finding: 15****Budget: \$2,400****Recommendation:**

There is not enough knee clearance under the drinking fountain.

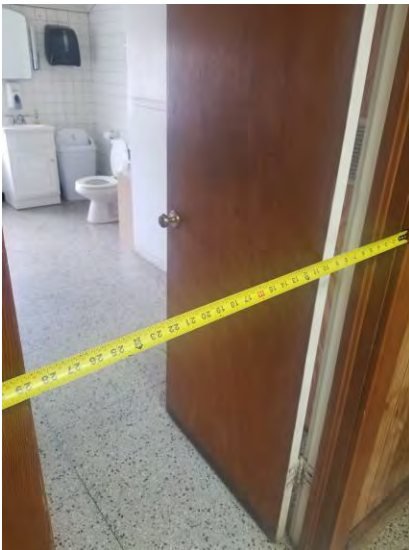
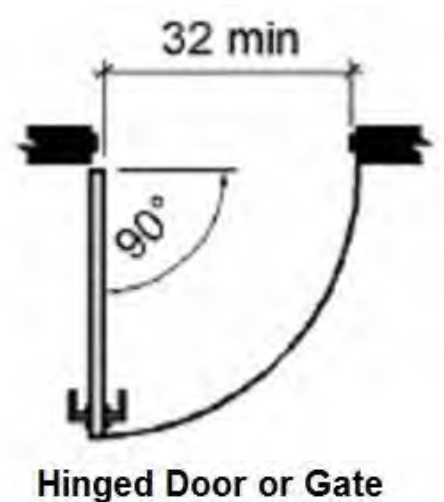
**As Built:**

The door opening is 28.5". The door opening does not provide at least 32 inches between the face of the door and the opposite stop.

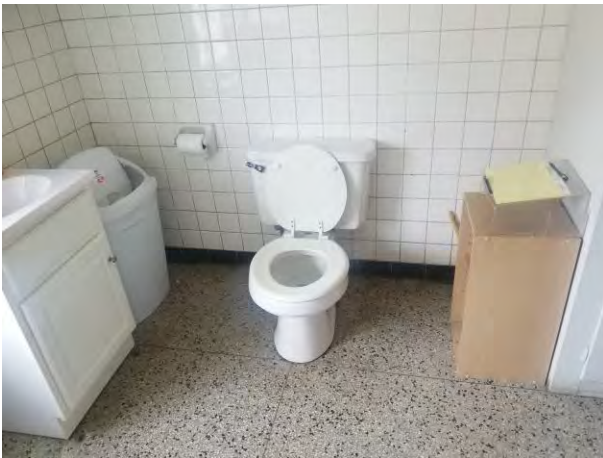
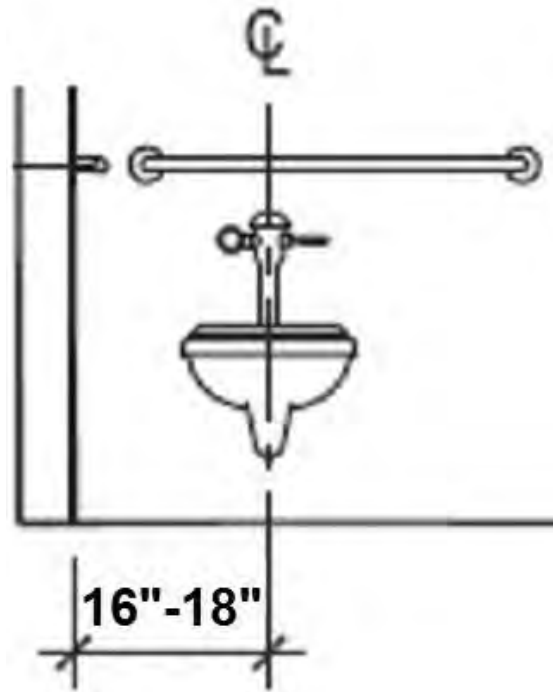
**As Built:**

The toilet is 28" from the wall. The toilet is not located within the range allowed from the side wall or partition. The centerline of the toilet must be 16 to 18 inches from the side wall.
