ADA Self-Evaluation and Transition Plan

January 2020

Opera House
RESTAURANT

Prepared by:

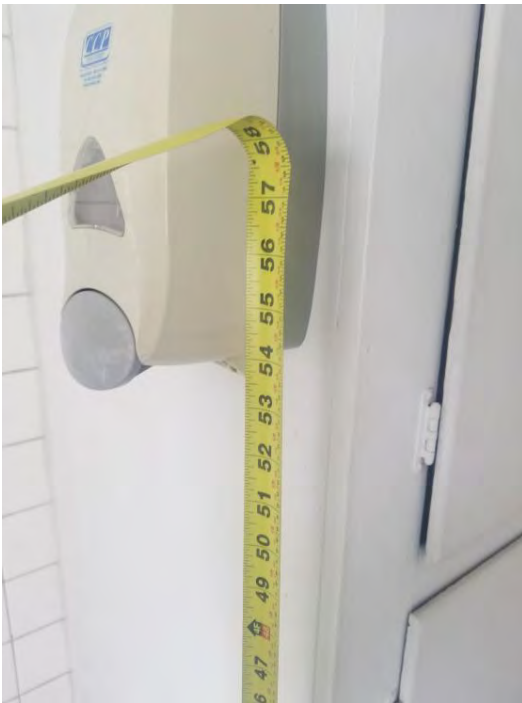
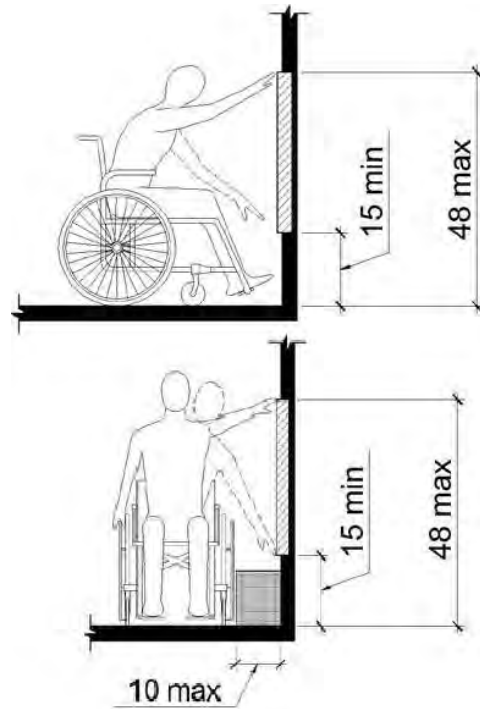
**As Built:**

The soap dispenser is 54". The soap dispenser is positioned too high for either a side or front approach. Where a clear floor or ground space allows a parallel approach to an element and the side reach is unobstructed, the high side reach shall be 48 inches maximum and the low side reach shall be 15 inches minimum above the finish floor or ground.

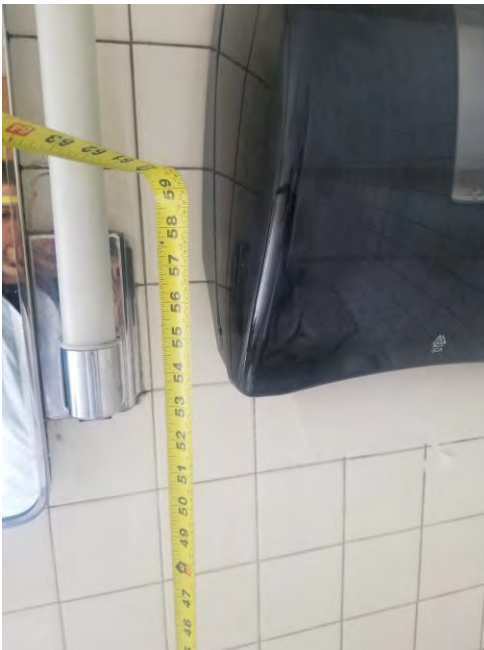
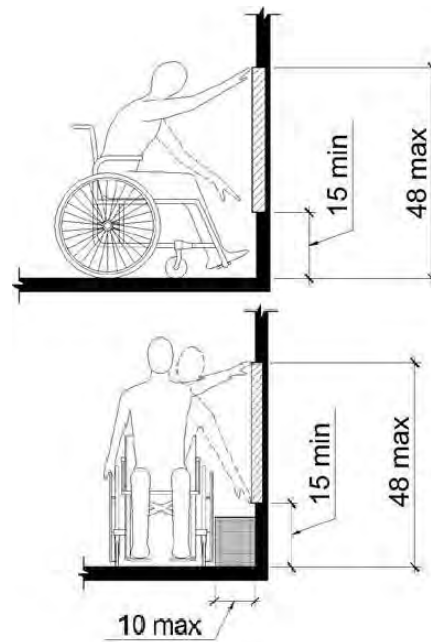
**As Built:**

The paper towel dispenser is 54" to bottom. The paper towel dispenser is positioned too high for either a side or front approach.

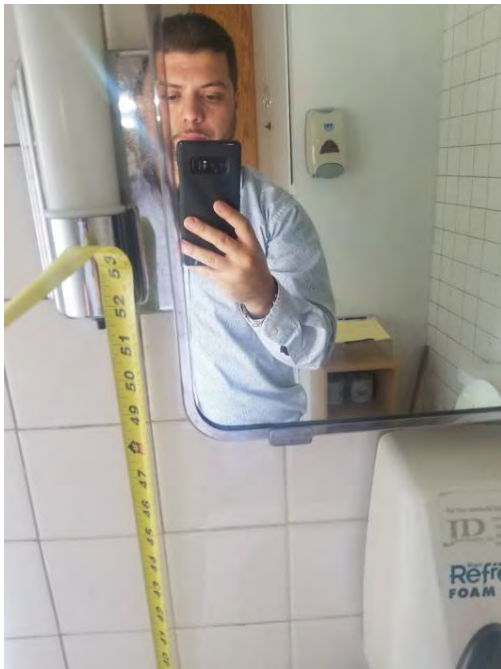
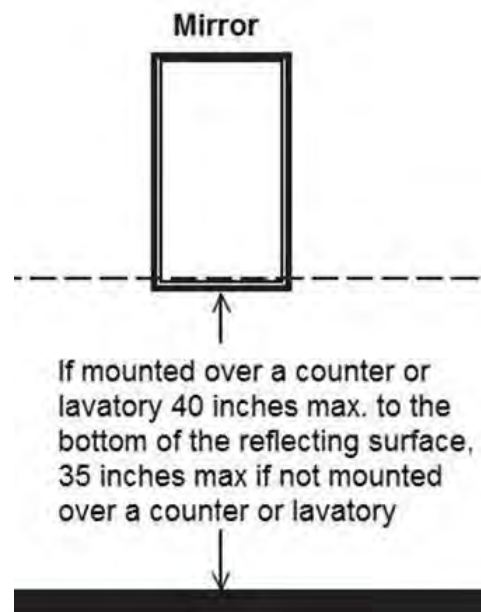
**As Built:**

There is 48" to reflecting surface. The mirror is mounted too high.

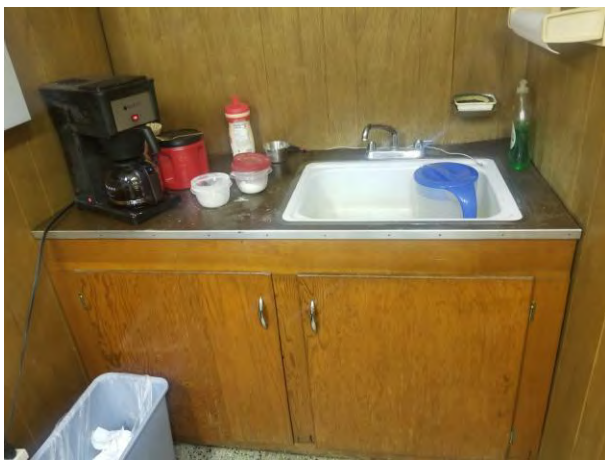
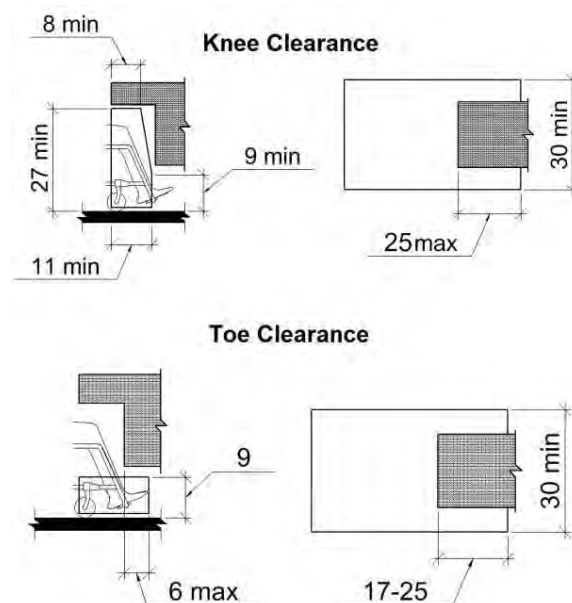
**As Built:**

There is not knee and toe clearance provided at the sink.

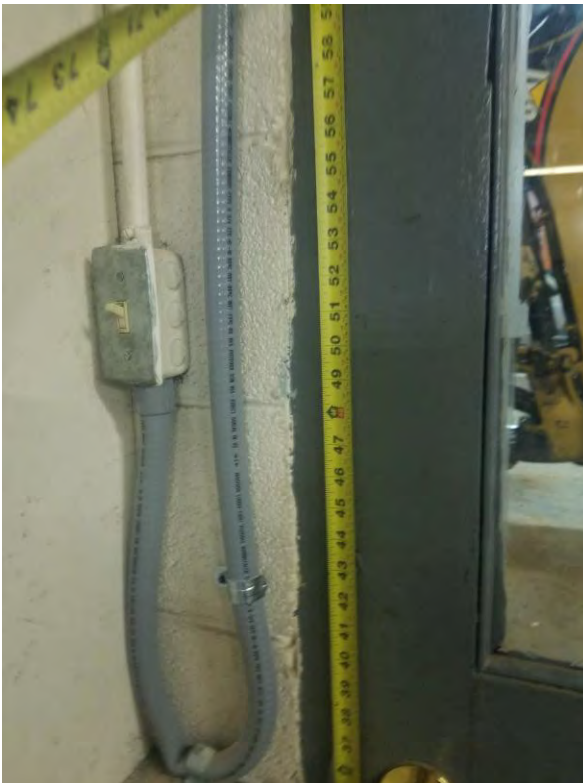
**As Built:**

The receptacle/switch is not positioned correctly for either a side or front approach.

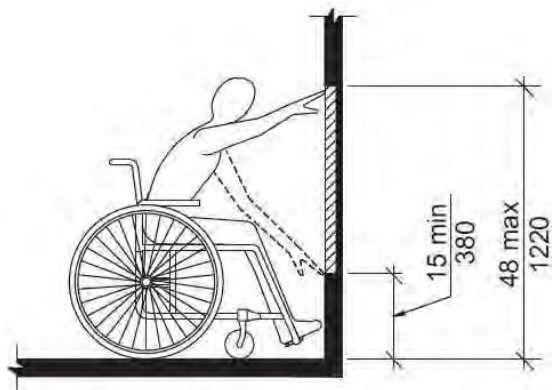
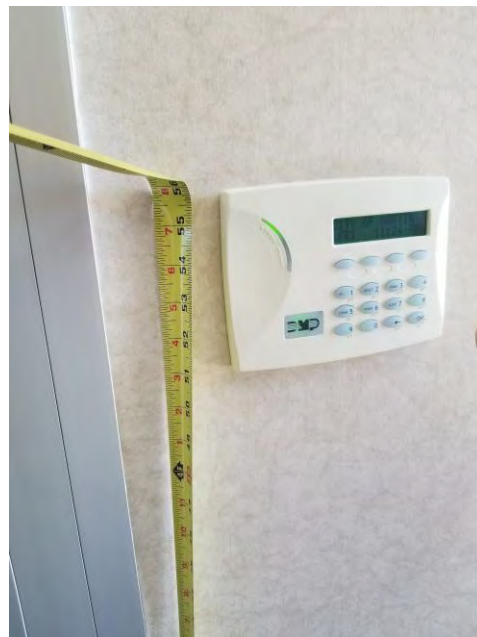
As Built:

The alarm keypad is at south entry 51" to bottom. The clear floor space only allows for a forward approach and the alarm keypad is out of reach range.

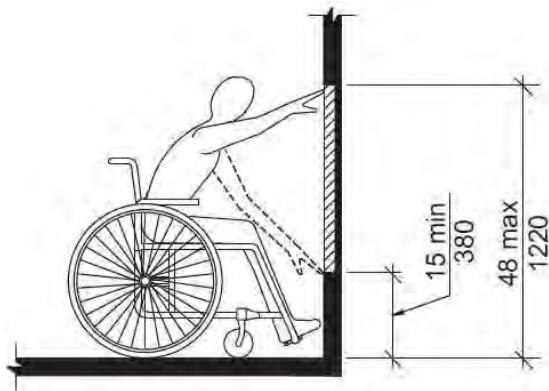
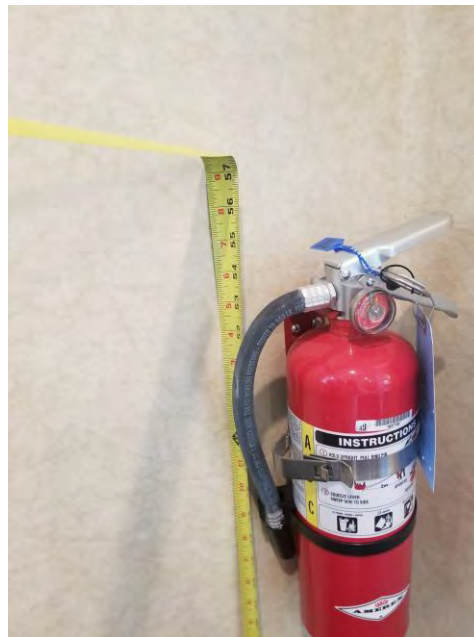
**As Built:**

The fire extinguisher handle is at 55". The clear floor space only allows for a forward approach and the Fire Extinguisher is out of reach range.

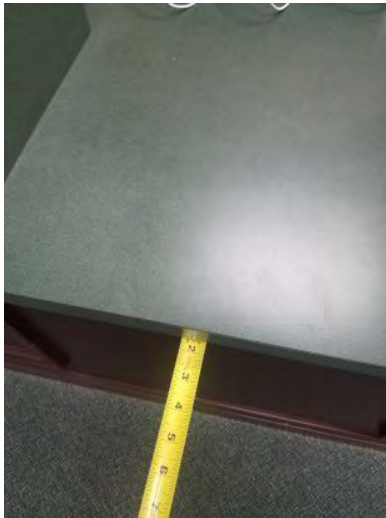
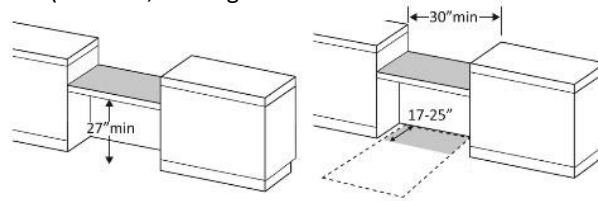
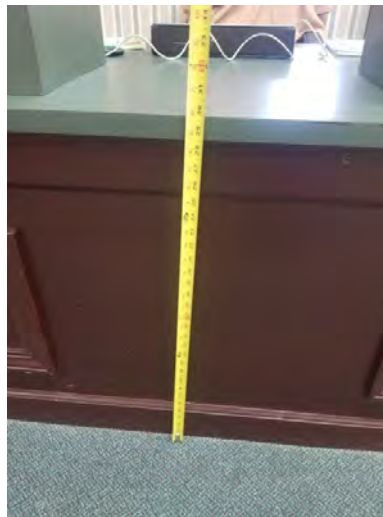
**As Built:**

There is no knee clearance provided. The transaction counter on south side of lobby provides for only a front approach.

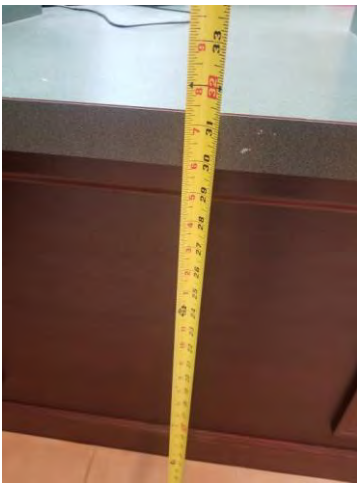
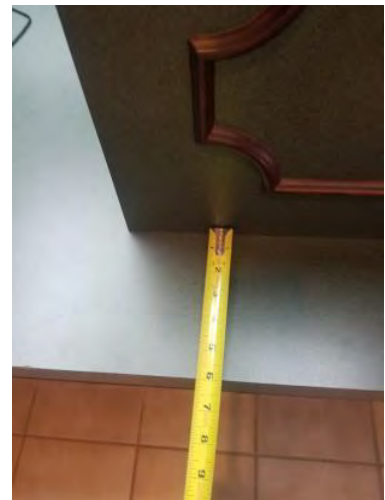
**As Built:**

There is no knee clearance provided. The transaction counter on north side provides for only a front approach. Transaction counters shall be 28 to 36 inches high and a minimum of 30 inches wide and must extend the same depth as the sales or service counter top. Knee and toe space must be a minimum of 27 inches tall, 30 inches wide, and 17 inches deep.

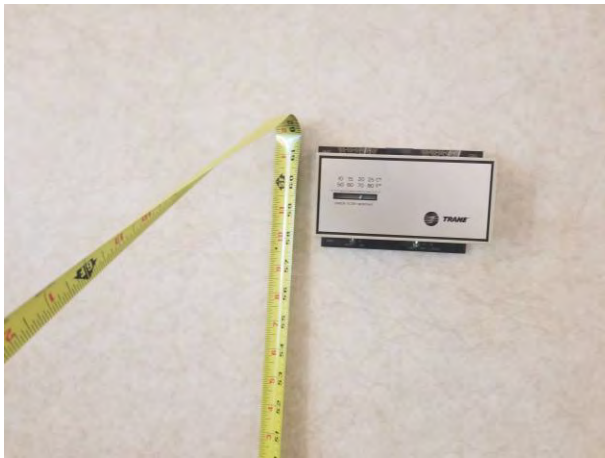
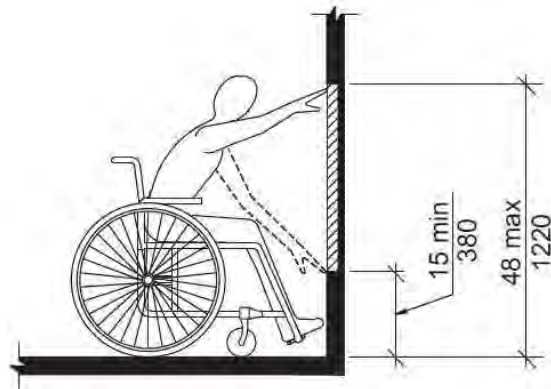
**As Built:**

The thermostat is 58" to bottom. The clear floor space only allows for a forward approach and the (XX) is out of reach range.

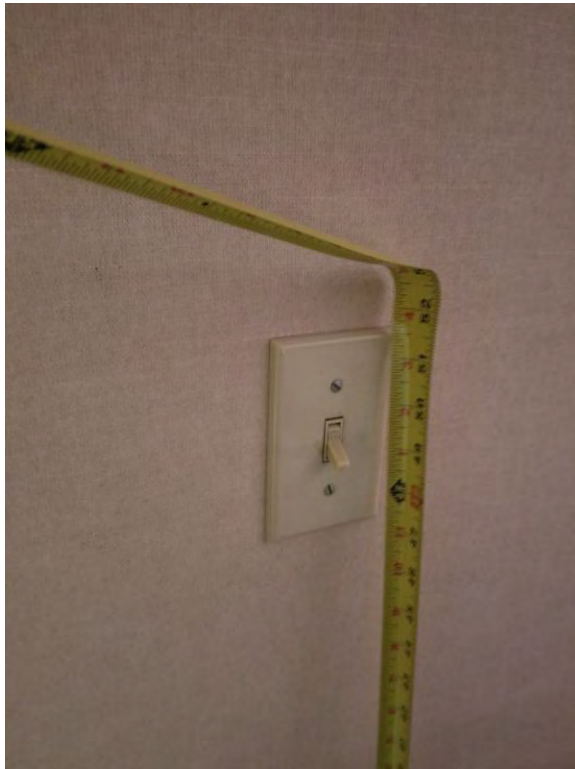
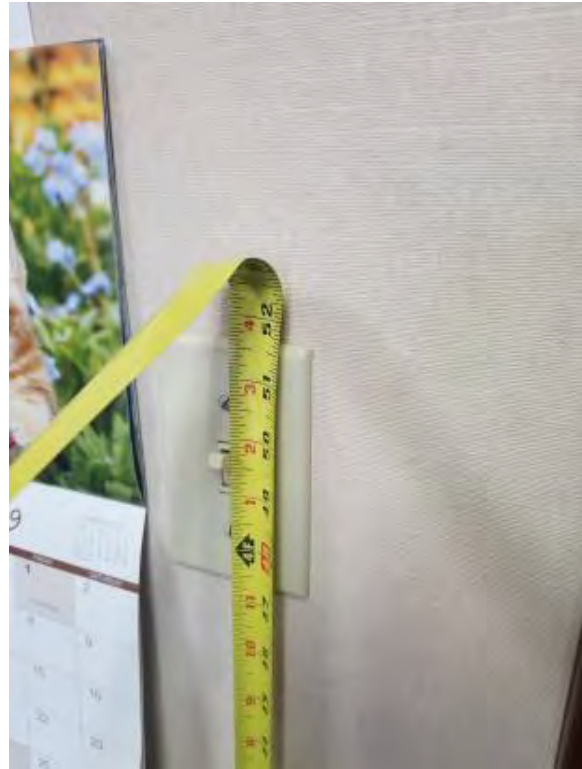
**As Built:**

The switch is over 48". The light switch receptacle is greater than 48 inches above the finish floor.

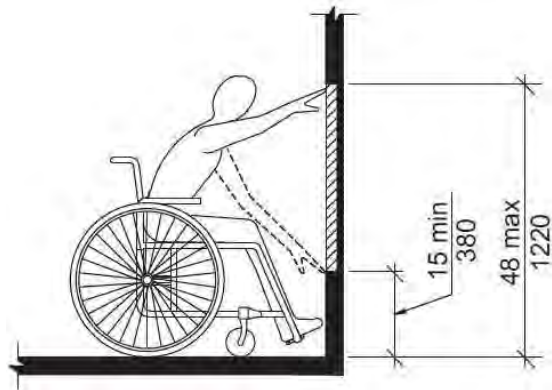
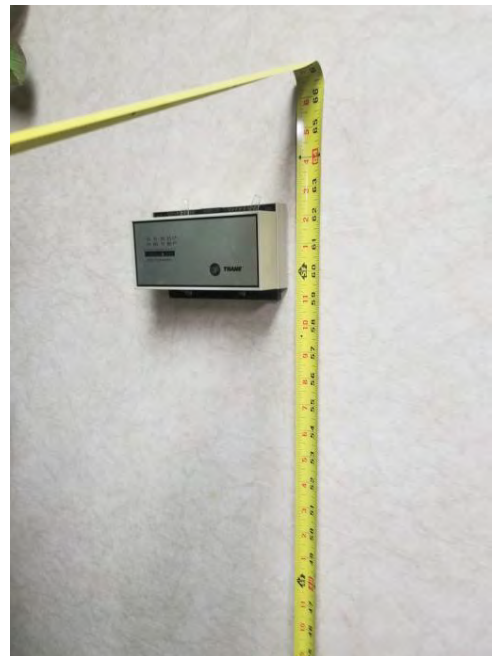
**As Built:**

The thermostat is at 60" AFF. The clear floor space only allows for a forward approach and the thermostat is out of reach range.

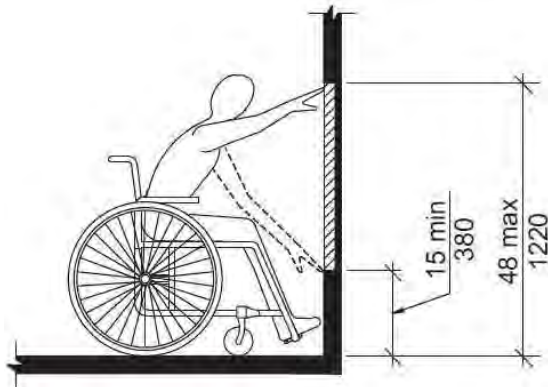
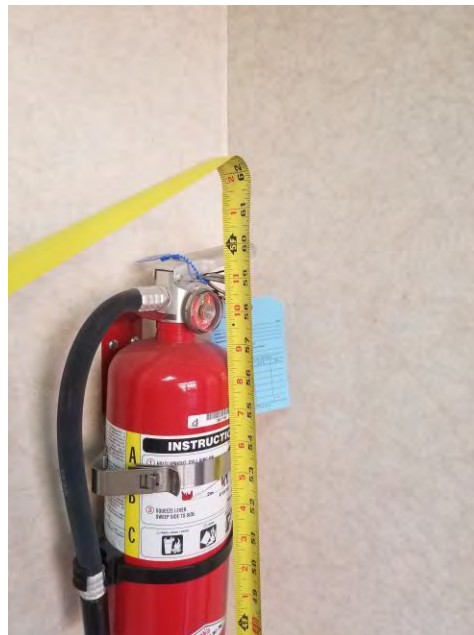
**As Built:**

The fire extinguisher handle is at 59". The clear floor space only allows for a forward approach and the Fire Extinguisher is out of reach range.

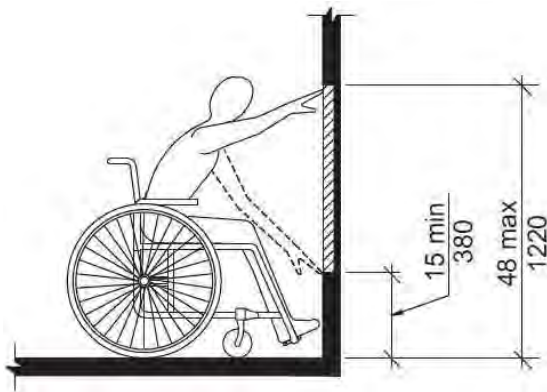
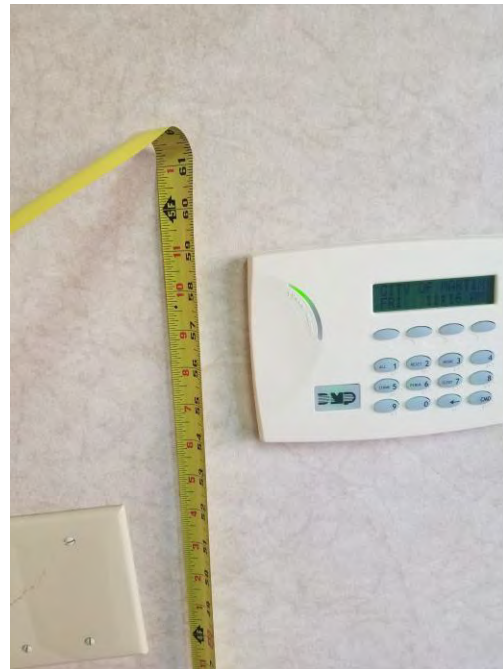
**As Built:**

The Alarm Pad is 54" to bottom. The clear floor space only allows for a forward approach and the alarm pad is out of reach range.

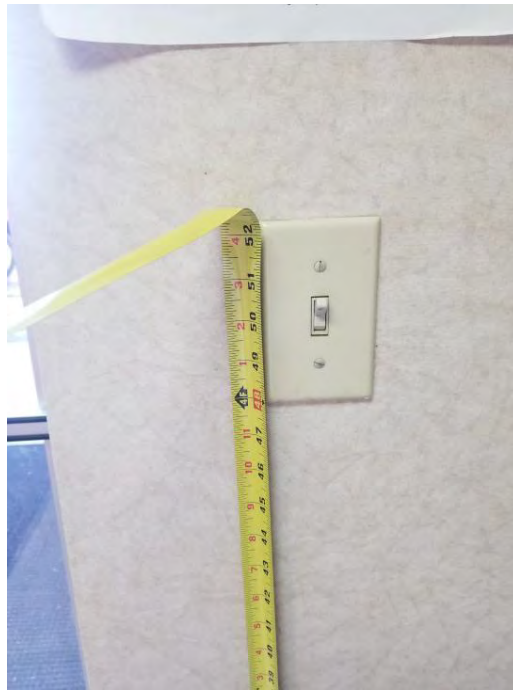
**As Built:**

The switch top is at 51". The light switch receptacle is greater than 48 inches above the finish floor.

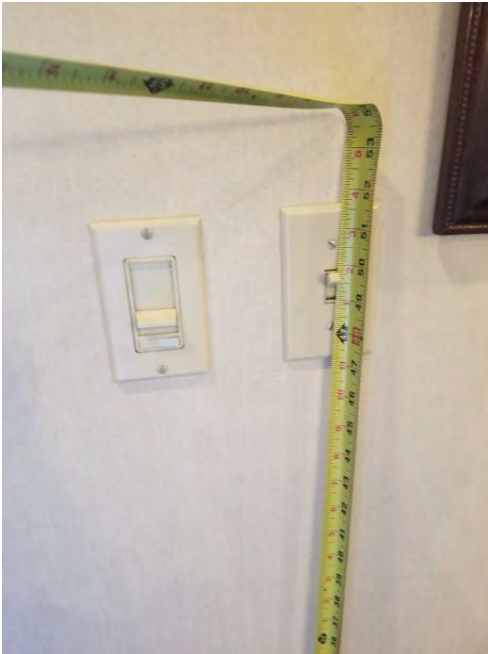
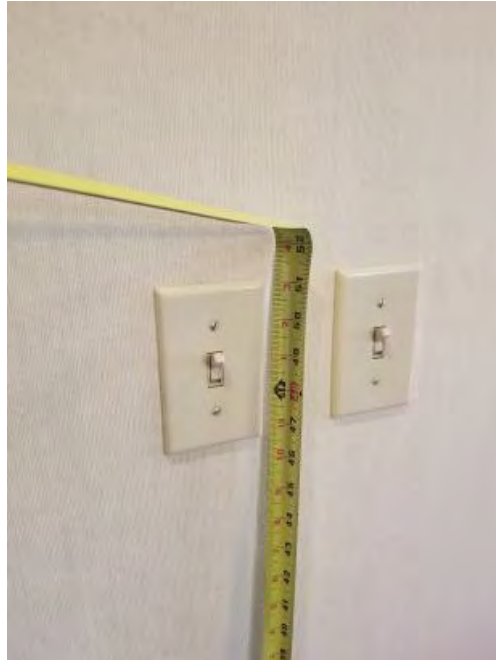
**As Built:**

There are four light switches over 48". The light switch receptacle is greater than 48 inches above the finish floor. Where a forward or side reach is unobstructed, the high reach shall be 48 inches maximum above the finished floor.

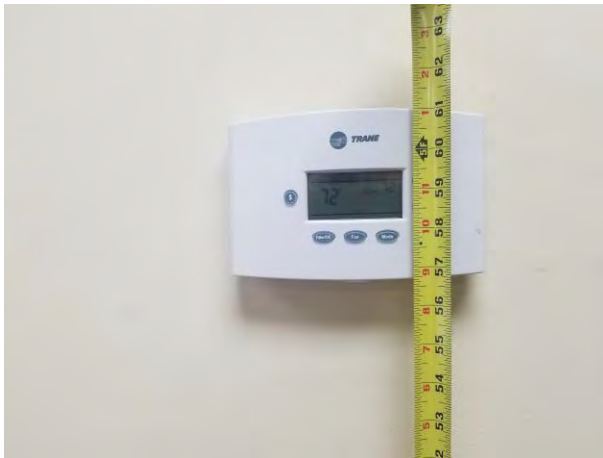
**As Built:**

The thermostat is 57" to bottom. The clear floor space only allows for a forward approach and the thermostat is out of reach range.

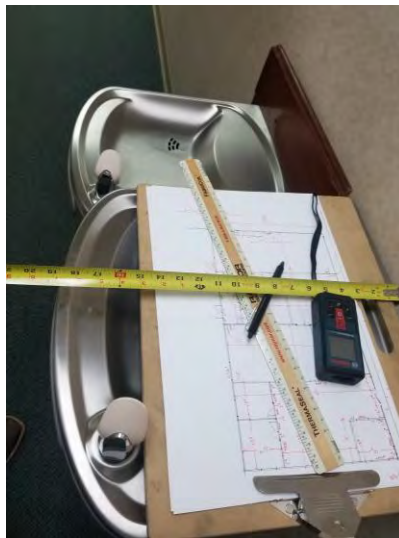
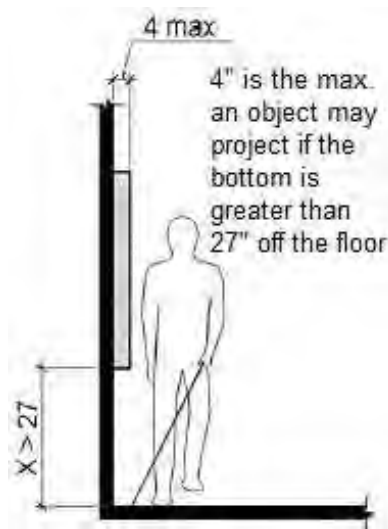
**As Built:**

The drinking fountain projects 19" from wall. The drinking fountain projects more than 4 inches into the circulation path.

Wall-mounted objects that have leading edges between 27 inches and 80 inches from the floor must not project more than 4 inches into the circulation path. Protruding objects that extend to the floor or within 27 inches of the floor are cane detectable and are therefore not hazardous. Where it is necessary or desirable to have objects protrude from the wall, a manner of cane detection must be provided.

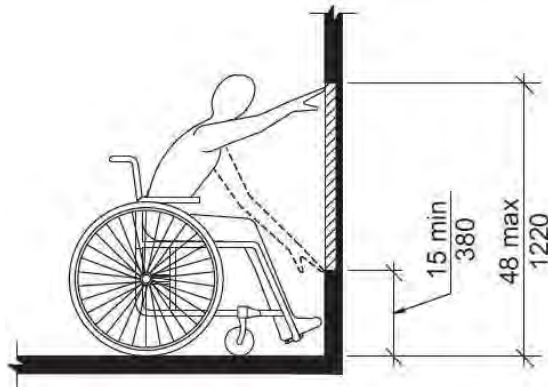
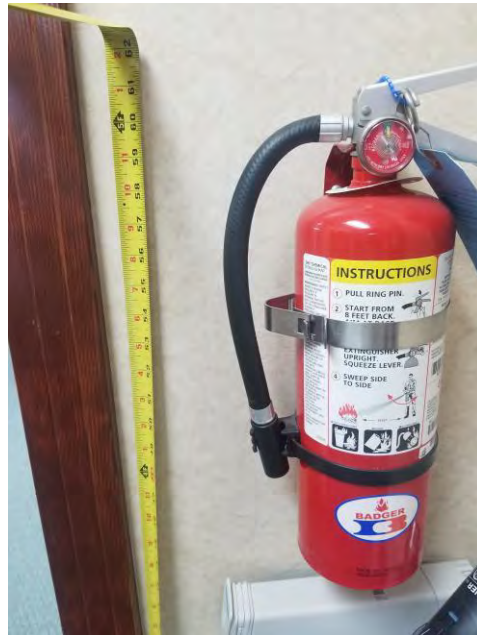
East Corridor**Finding: 14****Budget: \$75****Recommendation:**

4 (Low): Should be completed as soon as possible due to being a technical violation, but may not result in providing greater access to persons with disabilities. (Includes; Findings that are technically violations but provide a moderate to low increase in accessibility compared to the financial impact on the entity)

The fire extinguisher is 60" to handle. The clear floor space only allows for a forward approach and the fire extinguisher is out of reach range.

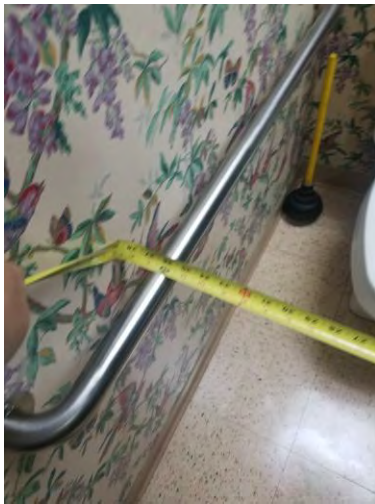
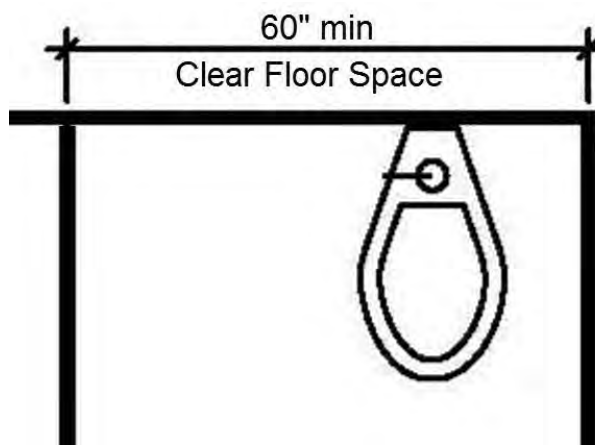
Women's Restroom**Finding: 15****Budget: \$22,250****Recommendation:**

3 (Moderate): Should be completed as soon as possible, but there may be other items that will provide greater access to persons with disabilities. (Includes; Findings that have a high financial impact on the entity in relationship to the degree of access provided)

The compartment width is 3'-2". The toilet compartment is not wide enough.

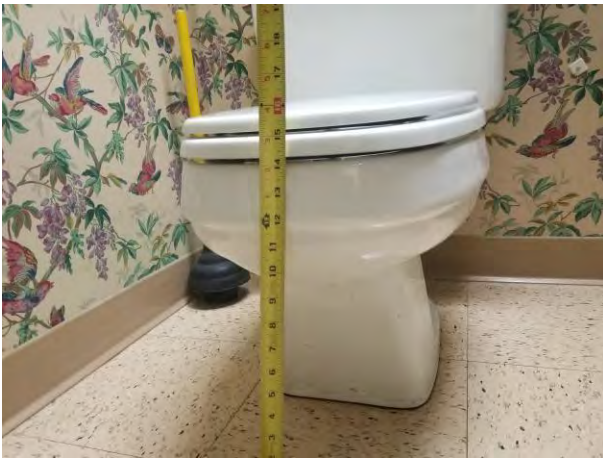
Women's Restroom**Finding: 16****Budget: Refer to Finding 15****Recommendation:**

The toilet seat is at 15". The toilet seat is not located within the range allowed off the floor.

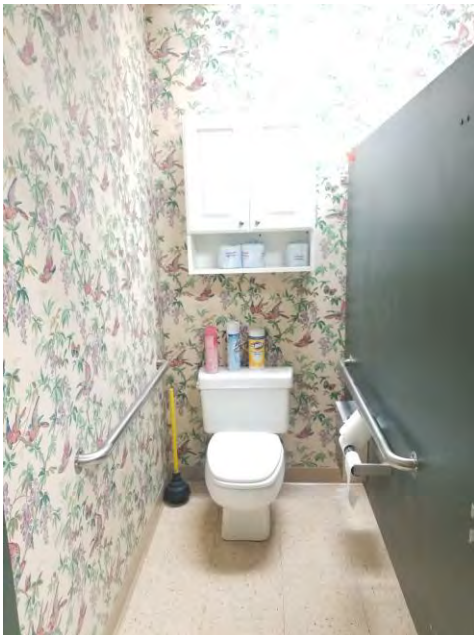
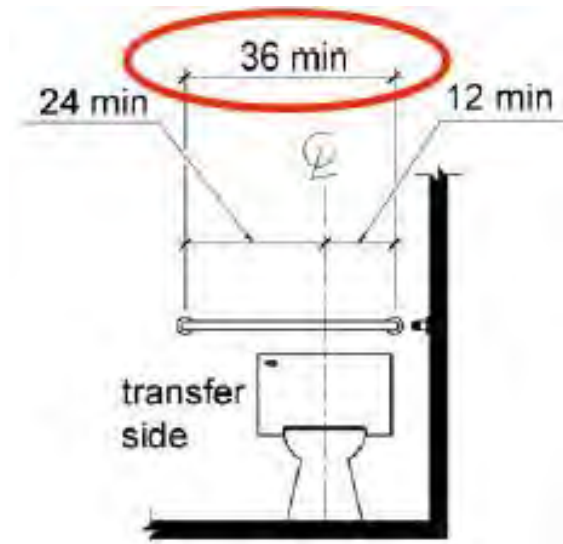
Women's Restroom**Finding: 17****Budget: Refer to Finding 15****Recommendation:**

The rear grab bar is not a minimum 36 inches in length.

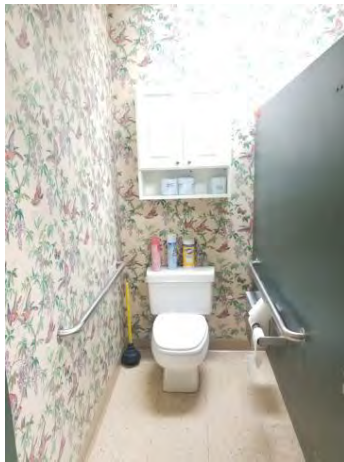
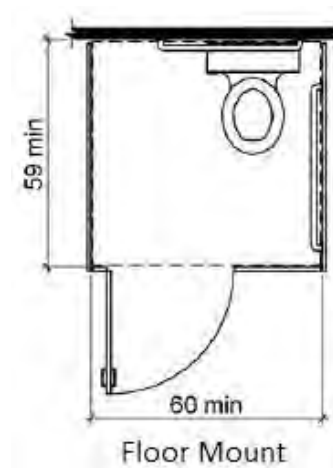
Women's Restroom**Finding: 18****Budget: Refer to Finding 15****Recommendation:**

Clear floor space is not compliant, it is 3'-2" wide. The clear floor space at the toilet is noncompliant. Wheelchair accessible compartments shall be 60 inches wide minimum measured perpendicular to the side wall, and 59 inches deep minimum for floor mounted water closets measured perpendicular to the rear wall.

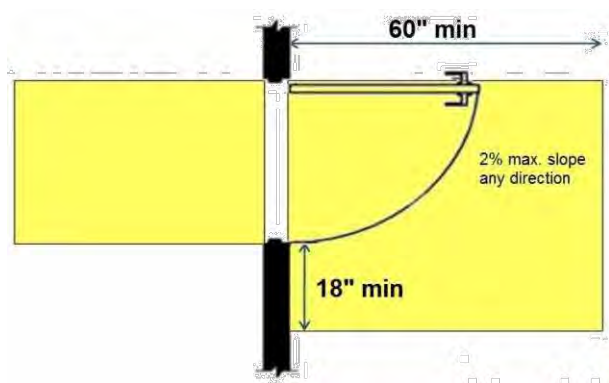
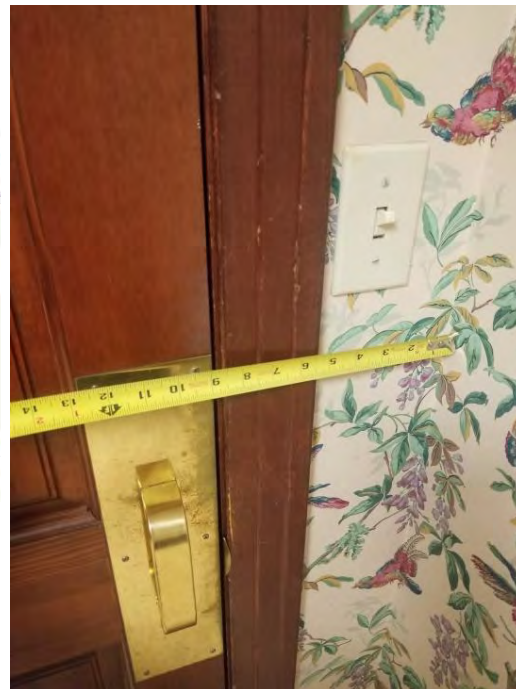
Women's Restroom**Finding: 19****Budget: Refer to Finding 15****Recommendation:**

The maneuvering space on the pull side of the door does not adequately extend beyond the latch side of the door.

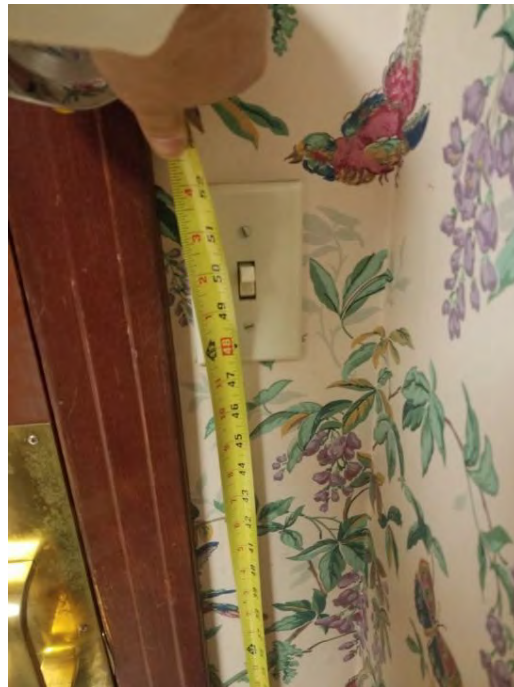
Women's Restroom**Finding: 20****Budget: Refer to Finding 15****Recommendation:**

The switch is at 50". The light switch receptacle is greater than 48 inches above the finish floor.

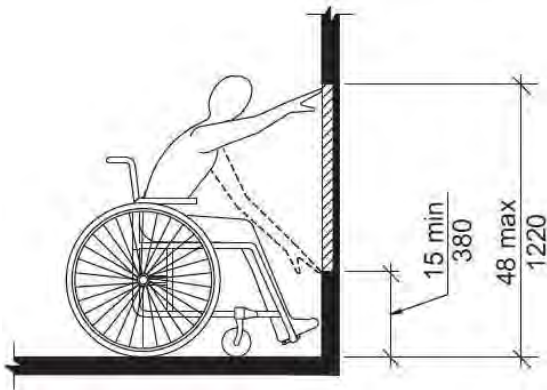
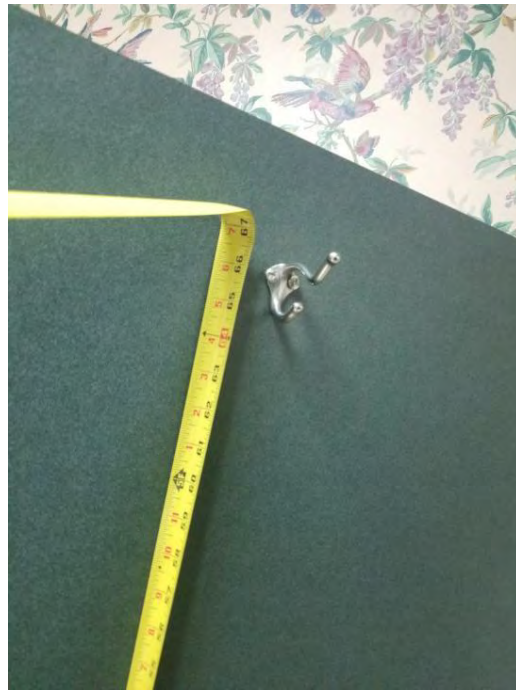
Women's Restroom**Finding: 21****Budget: Refer to Finding 15****Recommendation:**

The door hook is 66" high. The clear floor space only allows for a forward approach and the door hook is out of reach range.

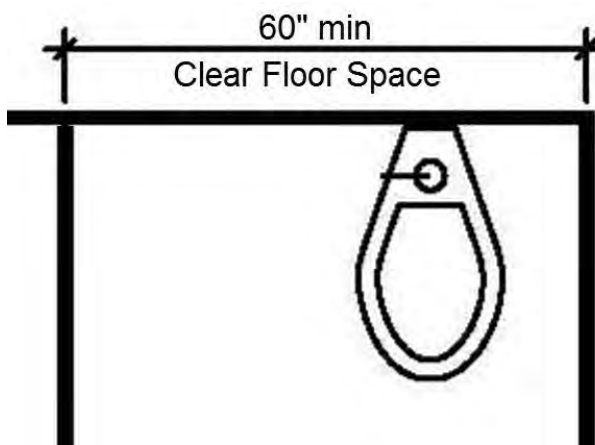
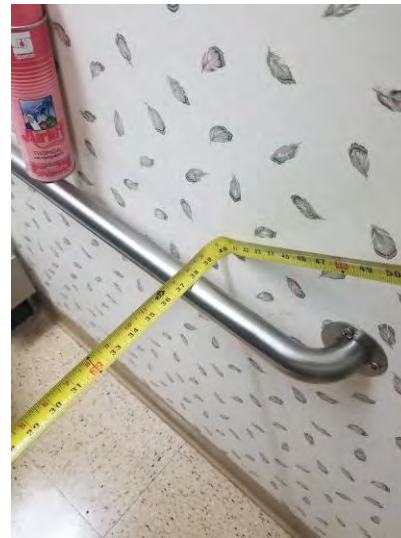
Men's Restroom**Finding: 22****Budget: \$21,500****Recommendation:**

The toilet compartment has a width of 3'-4". The toilet compartment is not wide enough.

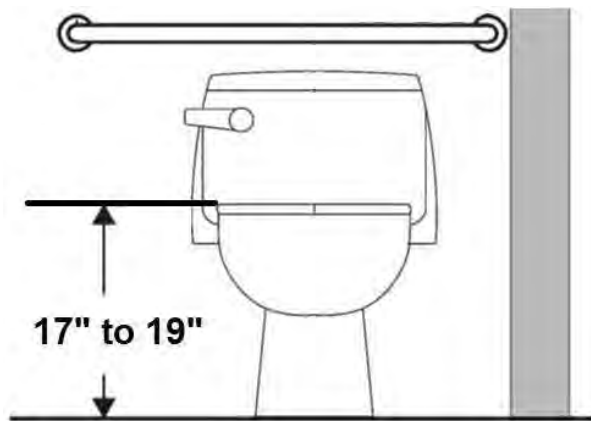
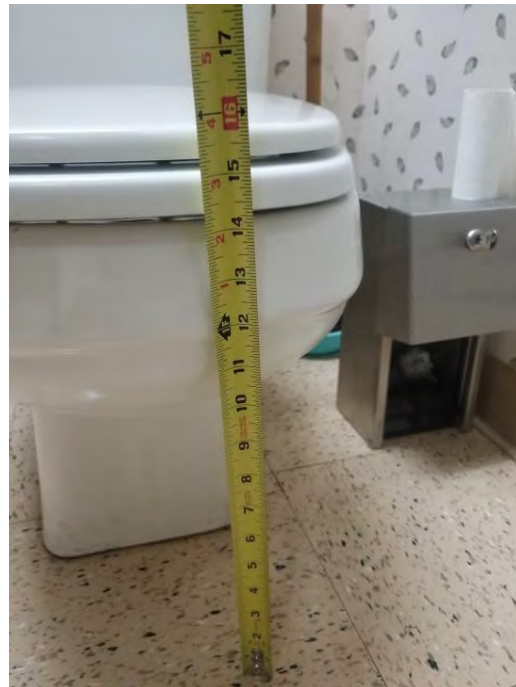
Men's Restroom**Finding: 23****Budget: Refer to Finding 22****Recommendation:**

The toilet seat height is 15". The toilet seat is not located within the range allowed off the floor.

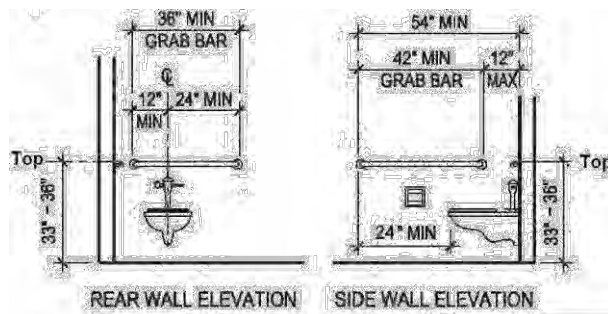
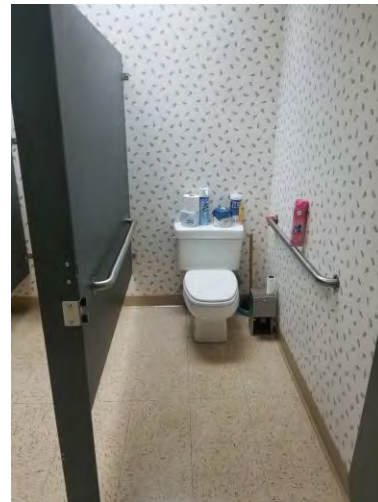
Men's Restroom**Finding: 24****Budget: Refer to Finding 22****Recommendation:**

The rear grab bar is missing.

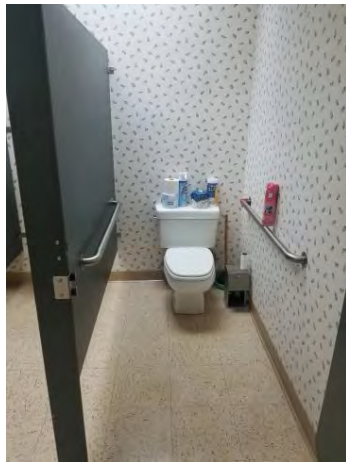
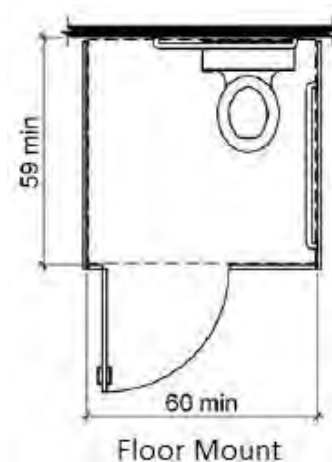
Men's Restroom**Finding: 25****Budget: Refer to Finding 22****Recommendation:**

The clear floor space has a width of 3'-4". The clear floor space at the toilet is noncompliant.

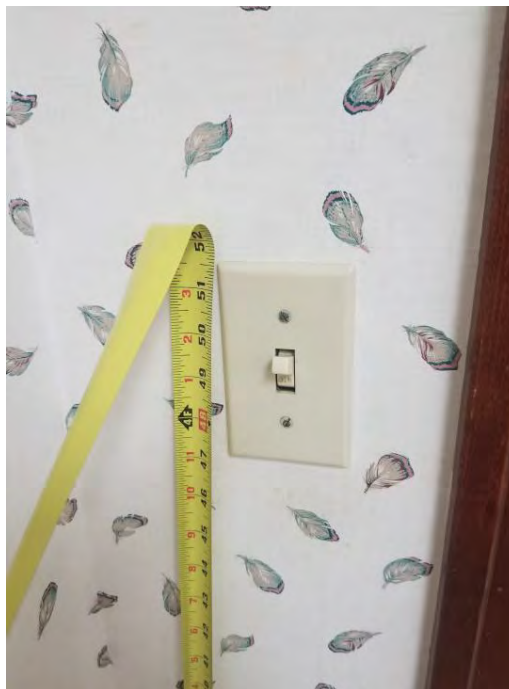
Men's Restroom**Finding: 26****Budget: Refer to Finding 22****Recommendation:**

The top of the switch is 50". The light switch receptacle is greater than 48 inches above the finish floor.

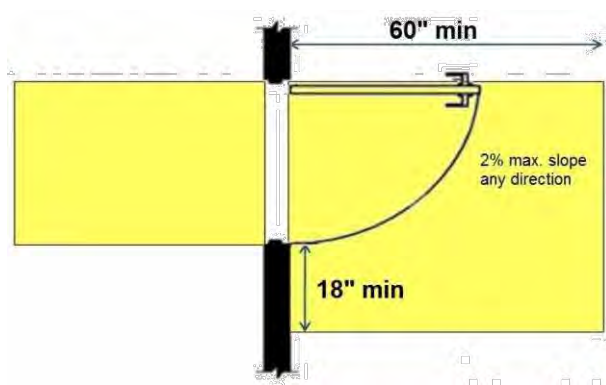
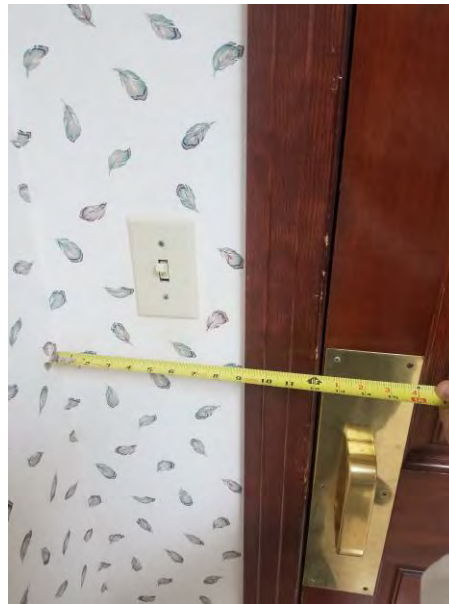
Men's Restroom**Finding: 27****Budget: Refer to Finding 22****Recommendation:**

There is 12" to the door. The maneuvering space on the pull side of the door or gate does not adequately extend beyond the latch side of the door.

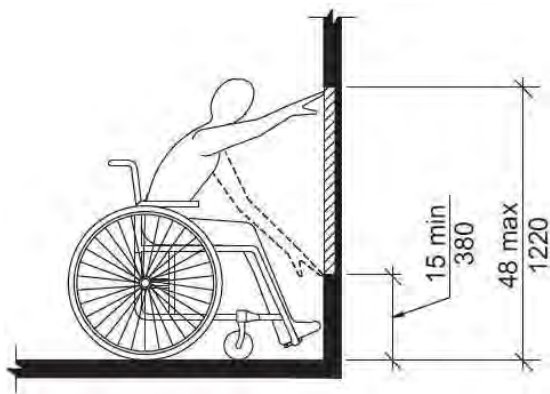
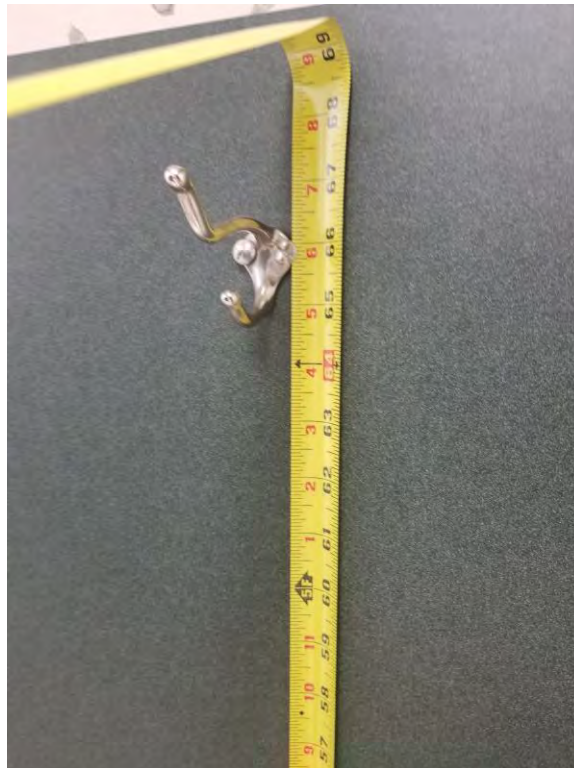
Men's Restroom**Finding: 28****Budget: Refer to Finding 22****Recommendation:**

The coat hook is at 66" AFF. The clear floor space only allows for a forward approach and the (XX) is out of reach range.

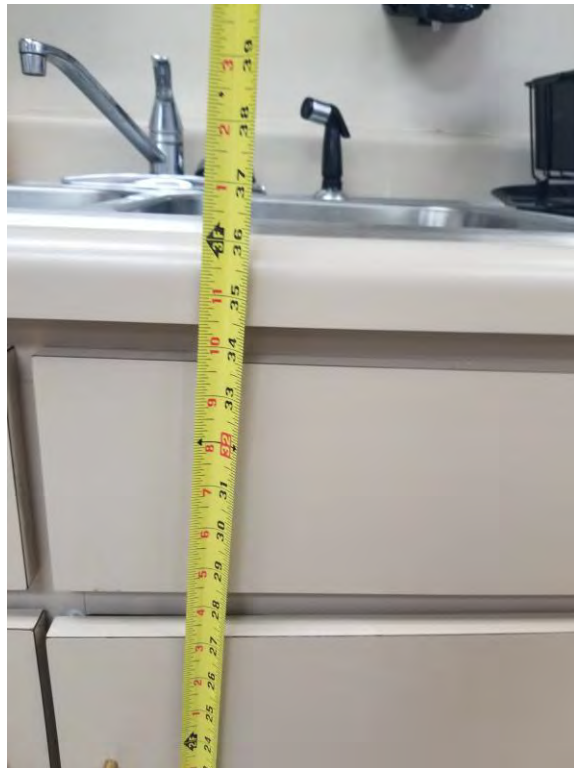
Break Room**Finding: 29****Budget: \$5,800****Recommendation:**

The sink height is 36". The top of the sink is too high.

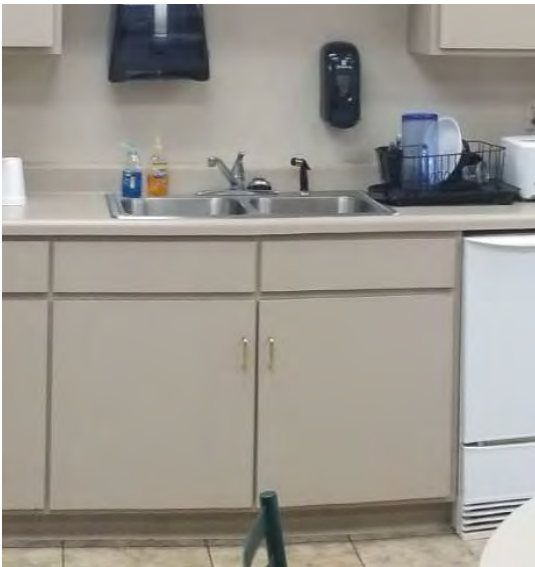
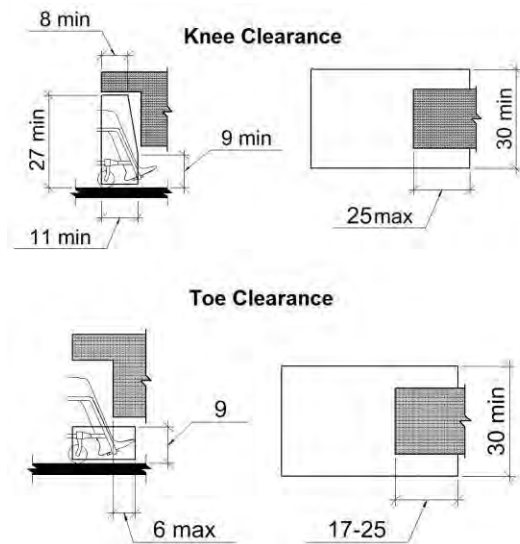
Break Room**Finding: 30****Budget: Refer to Finding 29****Recommendation:**

There is no knee or toe clearance provided at the sink.

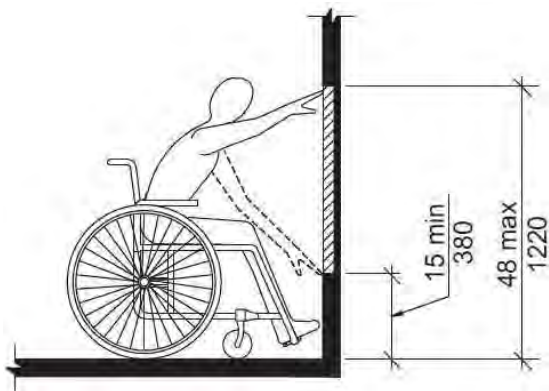
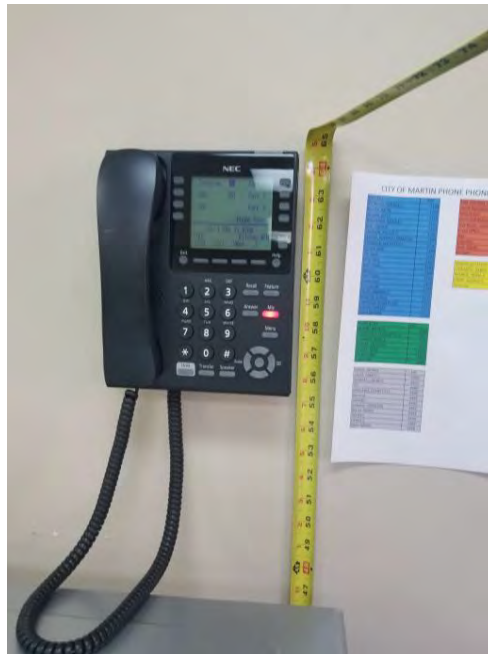
Break Room**Finding: 31****Budget: \$450****Recommendation:**

The telephone is 55" to bottom. The clear floor space only allows for a forward approach and the telephone is out of reach range.

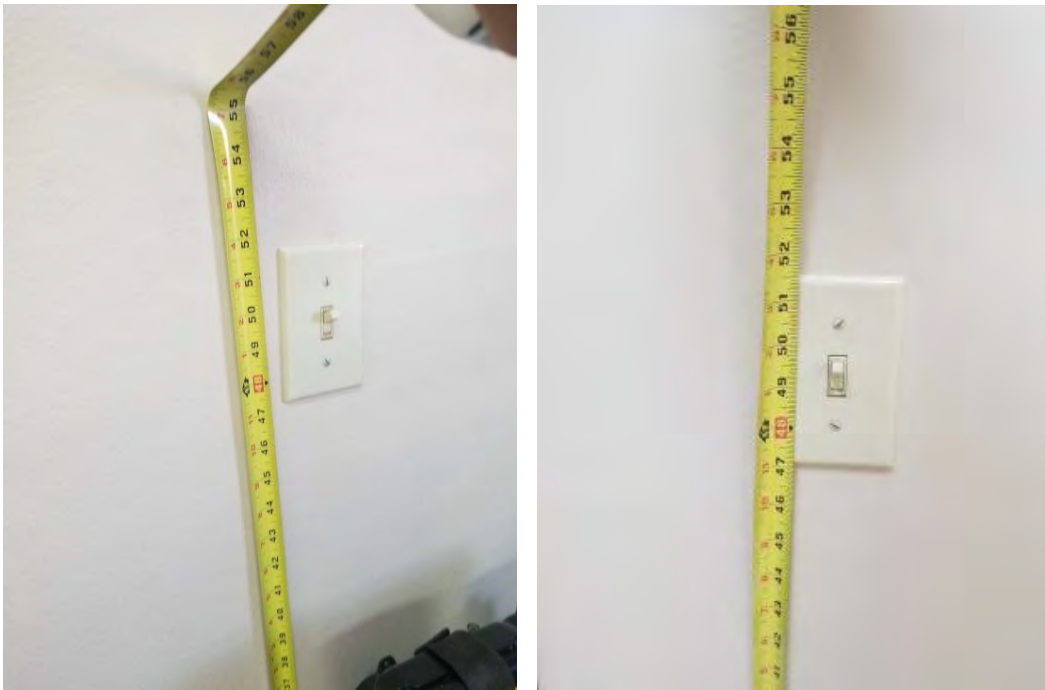
Break Room**Finding: 32****Budget: \$700****Recommendation:**

The light switch receptacle is greater than 48 inches above the finish floor.

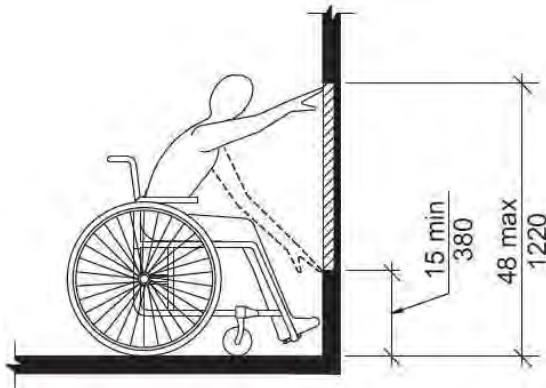
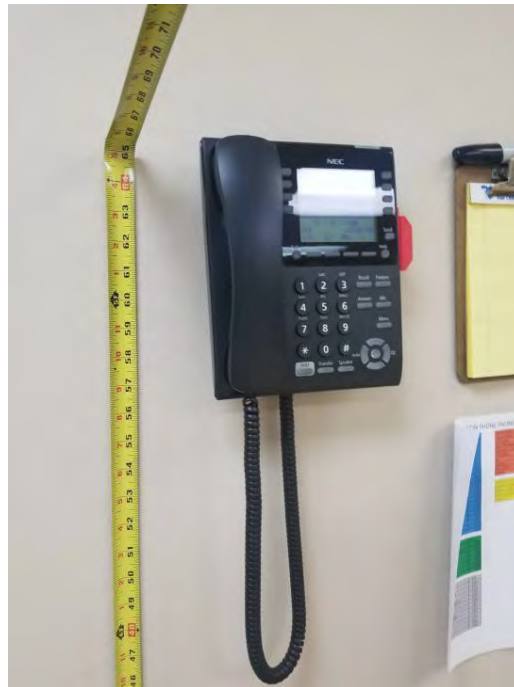
Break Room**Finding: 33****Budget: Refer to Finding 31****Recommendation:**

The clear floor space only allows for a forward approach and the Telephone is out of reach range. Where a forward reach is unobstructed, the high forward reach shall be 48 inches maximum and the low forward reach shall be 15 inches minimum above the finish floor or ground.

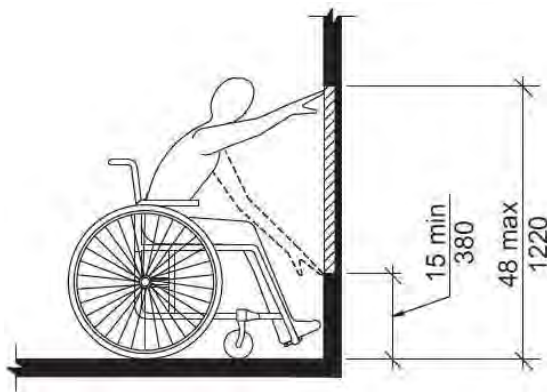
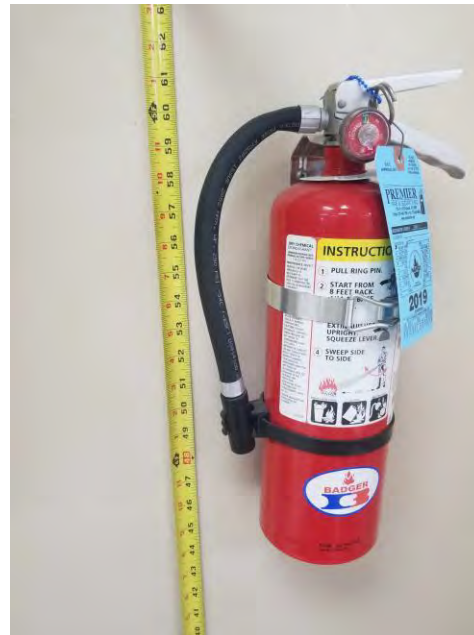
Break Room**Finding: 34****Budget: \$75****Recommendation:**

The fire extinguisher is at 60". The clear floor space only allows for a forward approach and the Fire Extinguisher is out of reach range.

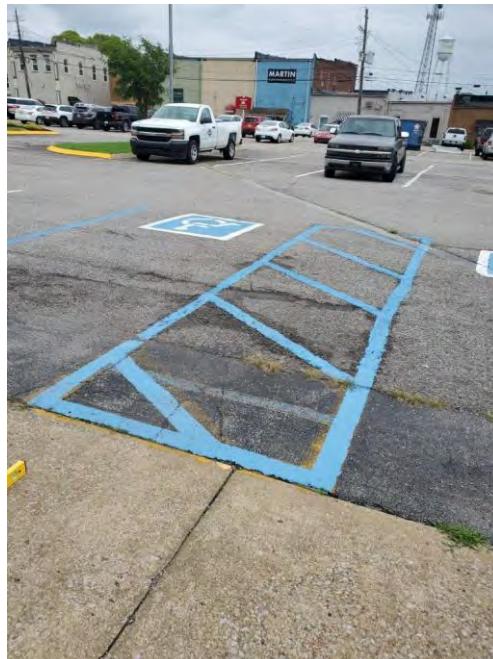
The surfaces of the accessible parking spaces and access aisles are not firm, stable, and slip resistant. Floor and ground surfaces shall be stable, firm, and slip resistant

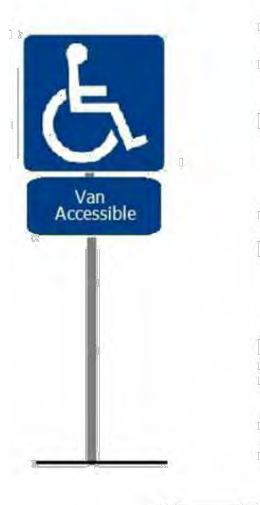
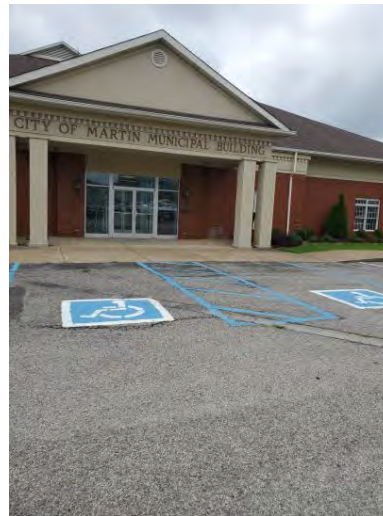
East Parking and Entrance**Finding: 2****Budget: \$250****Recommendation:**

The van stall is missing a sign identifying it as a van accessible stall.

\$250	East Parking and Entrance	2	Both spaces must have signage. One must designate van accessible.
\$3,000	East Parking and Entrance	3	Replace sidewalk to provide cross slope < 2%.
\$1,200	East Parking and Entrance	4	Replace ramp to provide smooth surface with no changes in elevation of >1/4" and slope <8.33%.
\$1,400	University Street Entrance	5	Replace 3 panels 15'x6' beginning at 3rd panel east of University Street entrance.
\$1,900	University Street Entrance	6	Replace 19'x6'.
