ADA Self-Evaluation and Transition Plan

January 2020

Opera House
RESTAURANT

Prepared by:

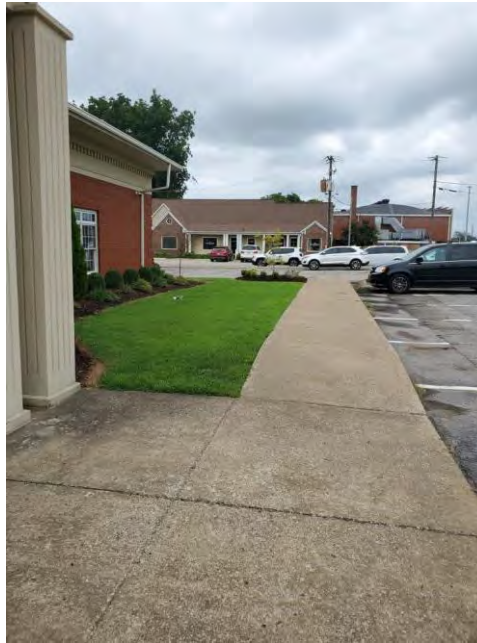
East Parking and Entrance**Finding: 3****Budget: \$3,000****Recommendation:**

The cross slope of the pedestrian access route is excessive. The cross slope of pedestrian access routes shall be 2 percent maximum.

Replace sidewalk to provide cross slope < 2%.

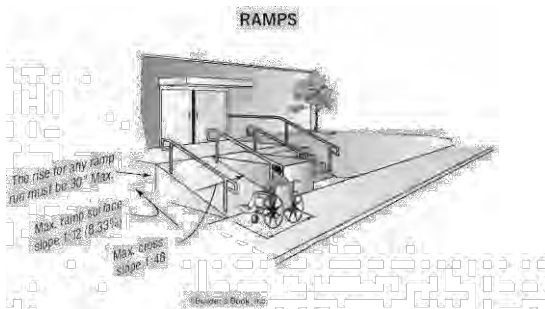
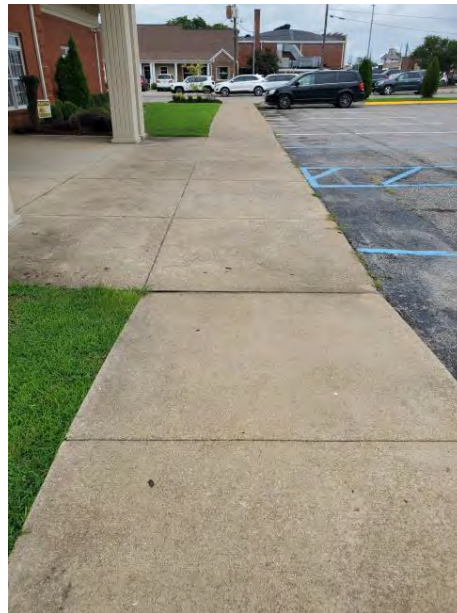
East Parking and Entrance**Finding: 4****Budget: \$1,200****Recommendation:**

The ramp south of eastern entrance at parking lot 8.5%, and it also change in elevation greater than $1/4"$. The ramps slope exceeds the maximum running slope (direction of travel) allowable of 8.33%. Ramps should have the least possible slope but in no case more than 8.3% (1:12).

Replace ramp to provide smooth surface with no changes in elevation of $>1/4"$ and slope $<8.33\%$.

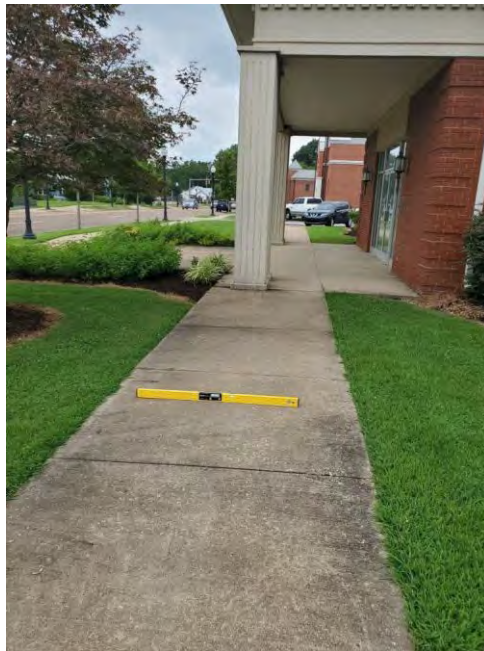
University Street Entrance**Finding: 5****Budget: \$1,400****Recommendation:**

The sidewalk approaching southern entrance and the cross slope of the pedestrian access route is excessive. Three panels exceed 2%, up to 3%. The cross slope of pedestrian access routes shall be 2 percent maximum.

Replace 3 panels 15'x6' beginning at 3rd panel east of University Street entrance.

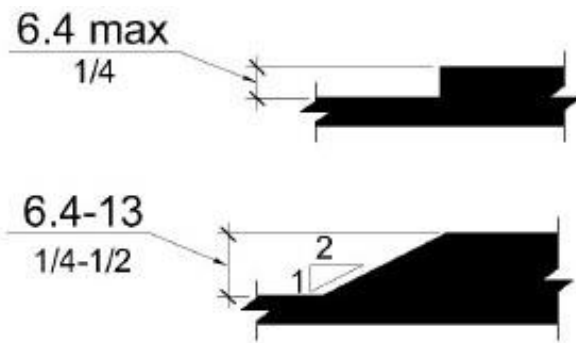
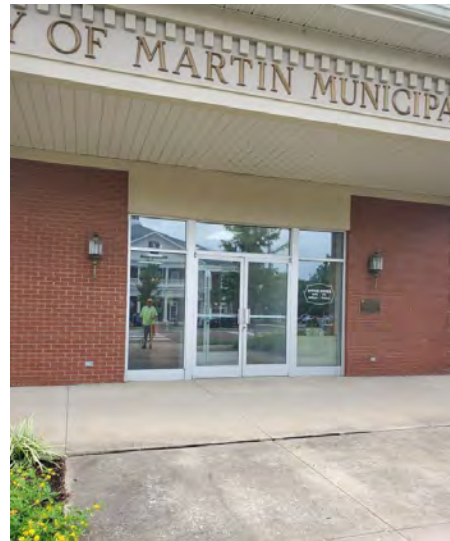
University Street Entrance**Finding: 6****Budget: \$1,900****Recommendation:**

The surface of the pedestrian access route has vertical discontinuities greater than 1/2 inch or between 1/4 inch and 1/2 inch that are not beveled.

Replace 19'x6'. Note- Could replace 19x6 for compliance or all for aesthetics (19'x18')

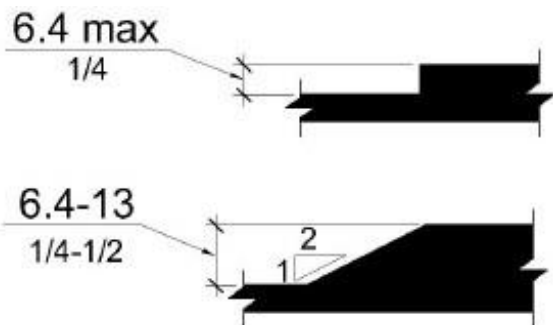
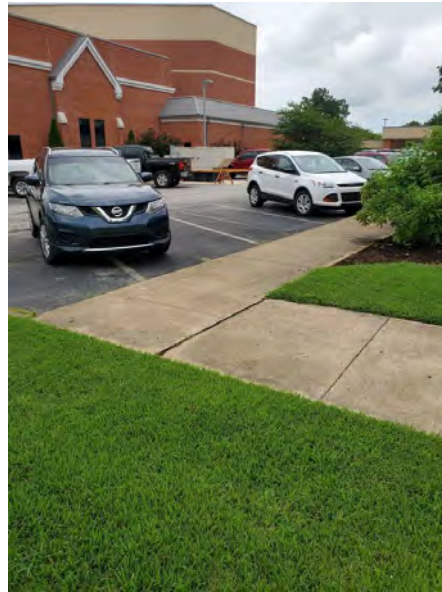
University Street Entrance**Finding: 7****Budget: \$500****Recommendation:**

The panel settled creating $> 1/4"$ of discontinuity.

Replace 5'x6' panel.

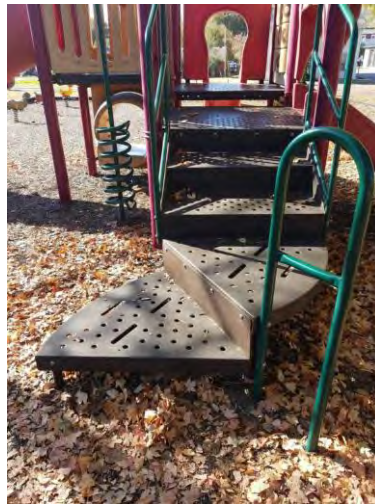
An unobstructed transfer space to the platform has not been provided.

A transfer space complying with 305.2 and 305.3 shall be provided adjacent to the transfer platform. The 48 inch (1220 mm) long minimum dimension of the transfer space shall be centered on and parallel to the 24 inch (610 mm) long minimum side of the transfer platform. The side of the transfer platform serving the transfer space shall be unobstructed.

Play structure is not accessible. Missing accessible route to structure. Does not have required transfer platform or ramp to play components. To bring structure into compliance, provide these two deficient items.

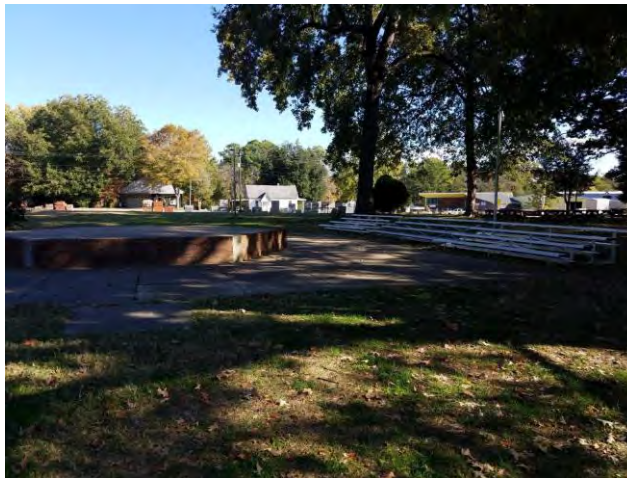
Stage**Lat:** 36.3409200000, **Long:** -88.8502200000**Finding:** 2**Budget:** \$8,000**Recommendation:** Provide accessible route and ADA compliant bleachers or tables.**Barrier Priority:** 1 (High): Should be completed immediately. (Includes; Findings that have little or no cost, were in violation of the codes at the time of construction, or pose an imminent safety threat)

There is no accessible route to stage seating. The adjacent concrete is non-compliant.

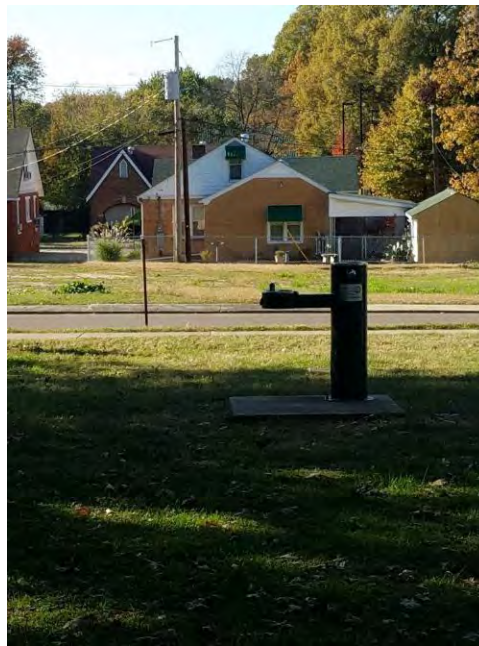
Parking Green Space**Lat: 36.3409600000, Long: -88.8506200000****Finding: 4****Budget: \$800****Recommendation:**

The drinking fountain is not on an accessible route of travel.

Provide accessible route to fountain.

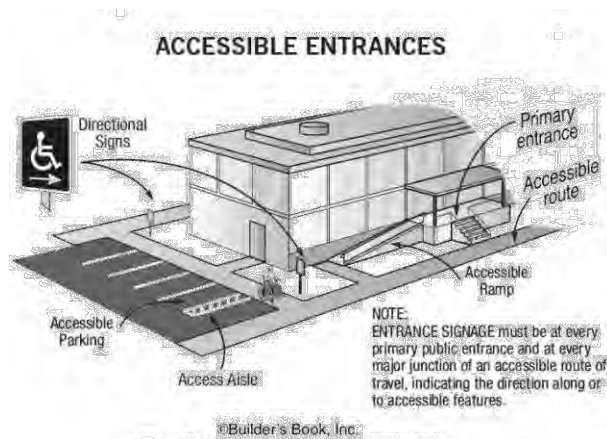
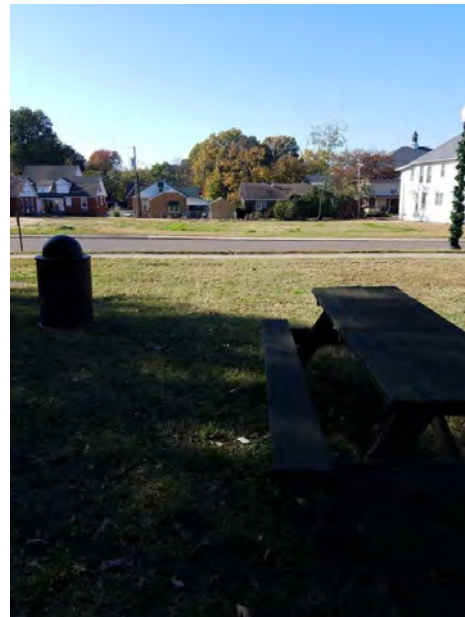
Parking Space Green**Lat: 36.3410900000, Long: -88.8507500000****Finding: 5****Budget: \$6,000****Recommendation:**

There is no accessible route to the picnic elements.

Provide accessible route and ADA compliant table and amenities.

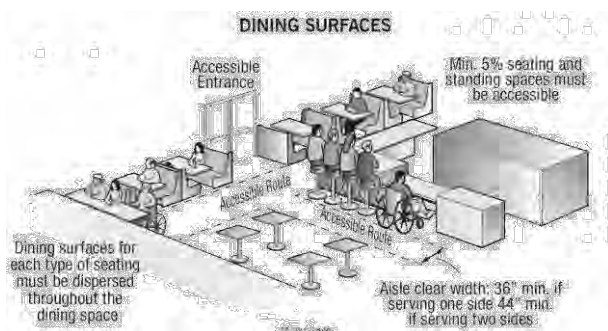
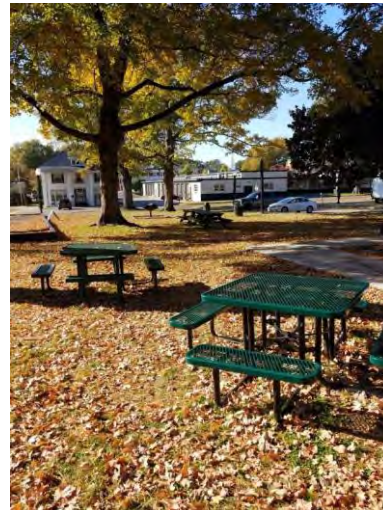
Parking Green Space**Lat: 36.3412400000, Long: -88.8503900000****Finding: 6****Budget: \$5,000****Recommendation:**

There are no accessible dining surfaces.

Provide accessible route and ADA compliant table and amenities.

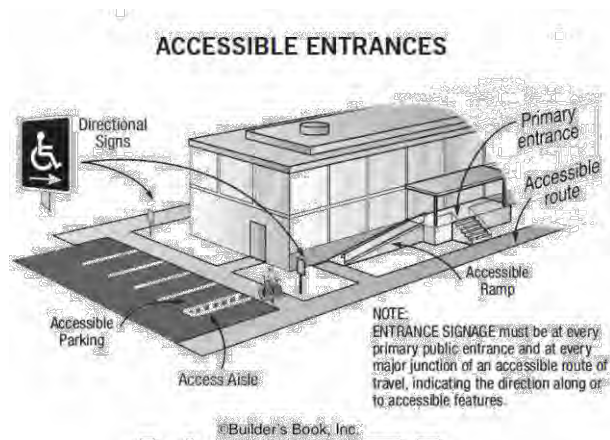
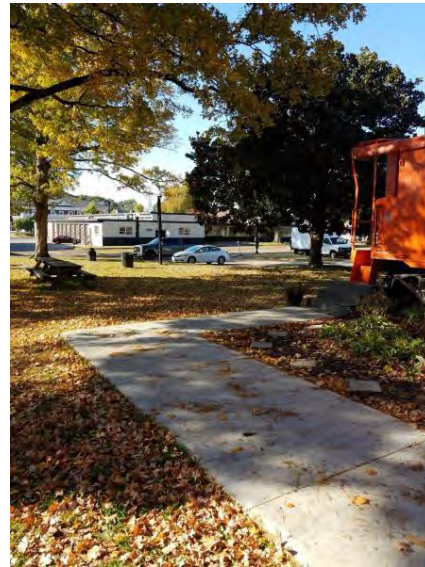
No area description**Lat: 36.3411700000, Long: -88.8503600000****Finding: 7****Budget: \$3,000****Recommendation:**

There is no accessible route to the caboose.

Provide accessible route from parking or public way.

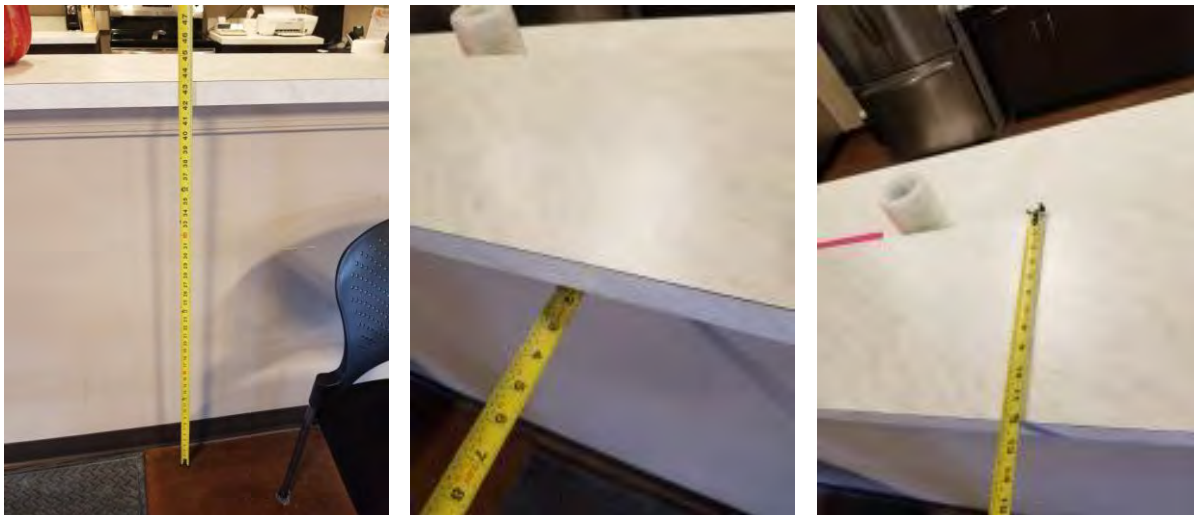
The countertop is at 43.5". The kitchen countertop is too high.

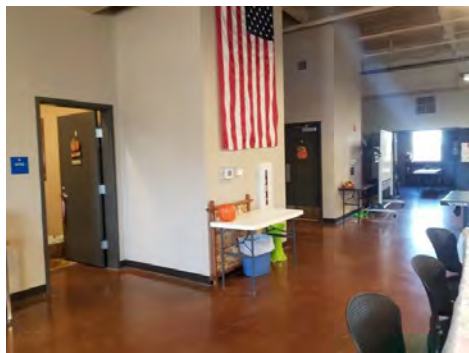
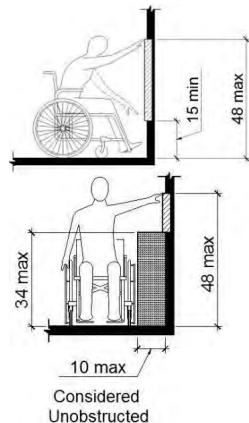
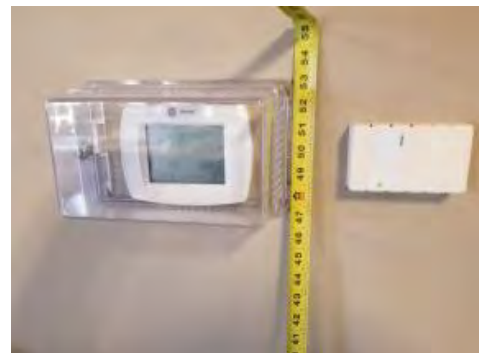
Multipurpose Room**Finding: 2****Budget: \$300****Recommendation:**

The bottom of the thermostat is at 48". The thermostat is not positioned correctly for either a side or front approach.

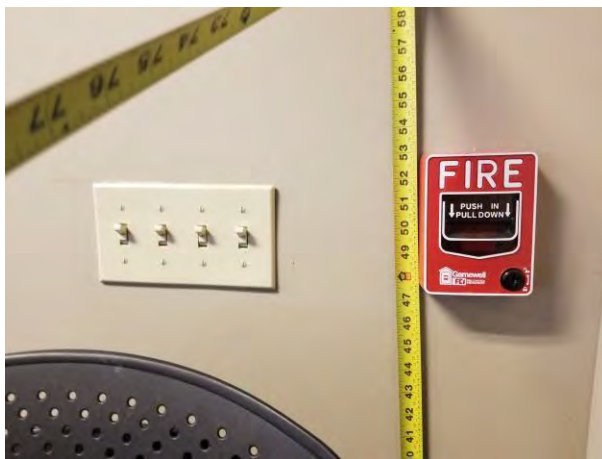
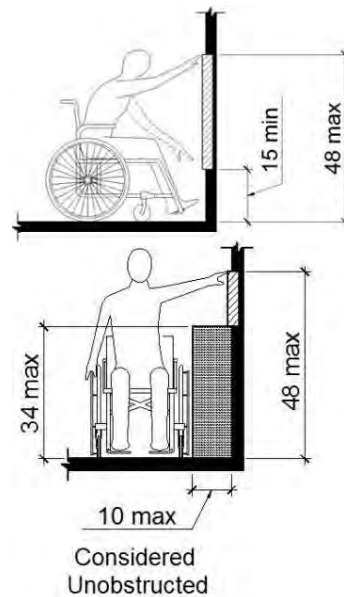
Multipurpose Room**Finding: 3****Budget: \$2,050****Recommendation:**

The fire alarm "pull down" is at 50" AFF is not positioned correctly for either a side or front approach.

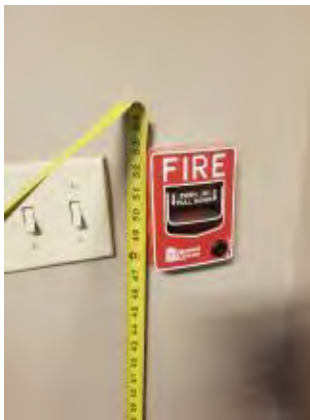
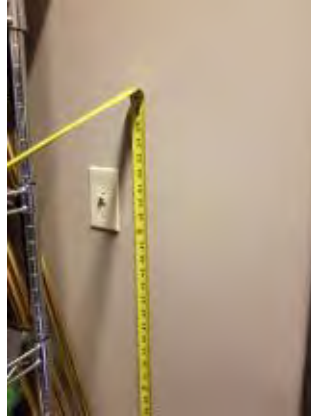
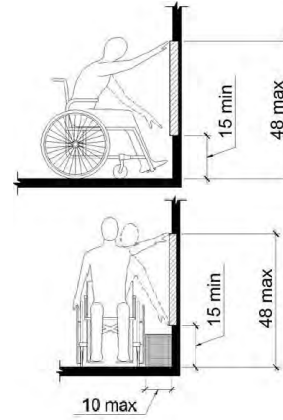
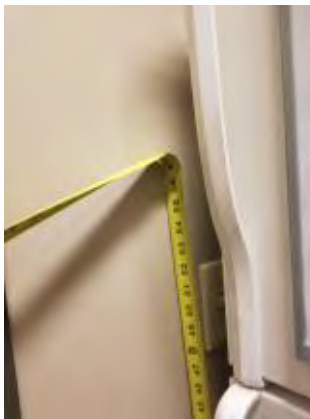
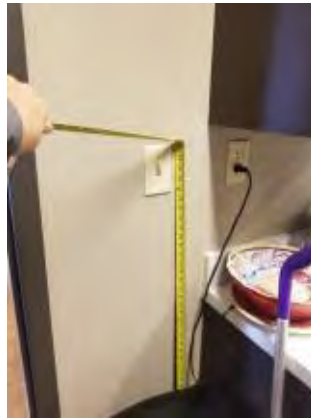
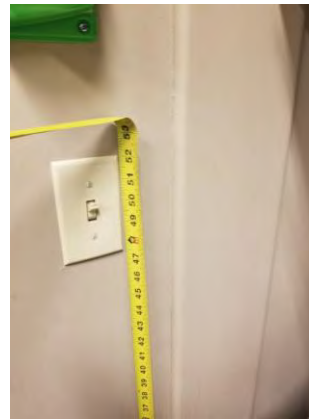
Throughout**Finding: 4****Budget: \$****Recommendation:**

All switches are at 50" AFF.

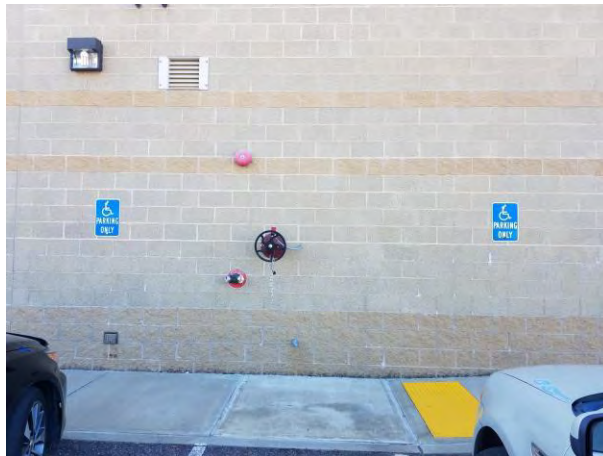
The van stall is missing a sign identifying it as a van accessible stall.

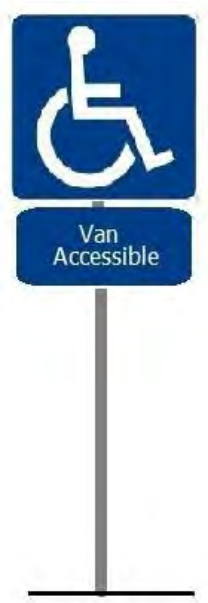
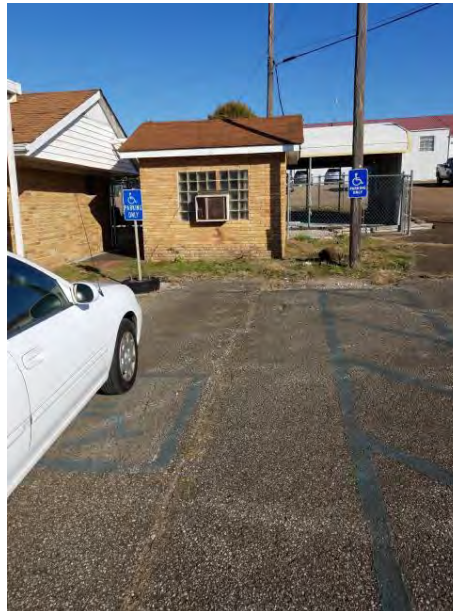
Senior Center Parking**Finding: 2****Budget: \$600****Recommendation:**

The van stall is missing a sign identifying it as a van accessible stall.

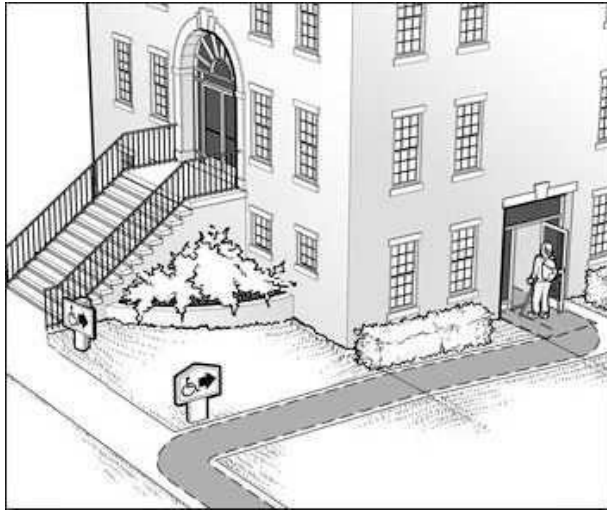
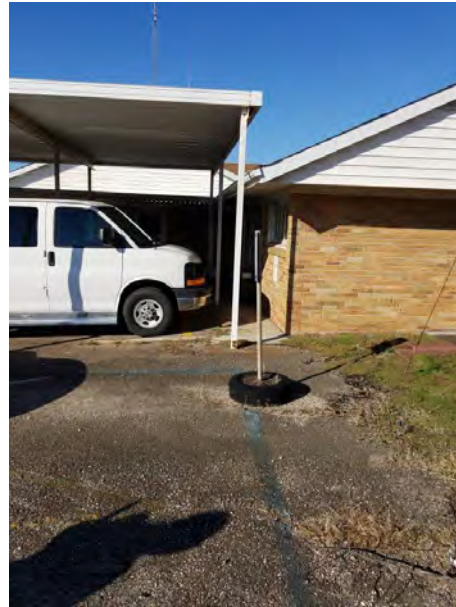
Senior Center Parking**Finding: 3****Budget: \$3,000****Recommendation:**

The building entrance is not located on an accessible route. The ramp provided is not accessible from parking space. When a building, or portion of a building, is required to be accessible, an accessible route of travel shall be provided to all portions of the building, to accessible building entrances and between the building and the public way. All walks, halls, corridors, aisles, skywalks, tunnels, and other spaces that are part of an accessible route must comply. An accessible route of travel must not pass through kitchens, storage rooms, restrooms, closets or other spaces used for similar purposes. At least one accessible route within the boundary of the site must be provided from public transportation stops, accessible parking and accessible passenger loading zones and public streets or sidewalks to the accessible building entrance they serve. The accessible route shall, to the maximum extent feasible, coincide with the route for the general public. At least one accessible route shall connect accessible buildings, facilities, elements and spaces that are on the same site. At least one accessible route shall connect accessible building or facility entrances with all accessible spaces and elements.

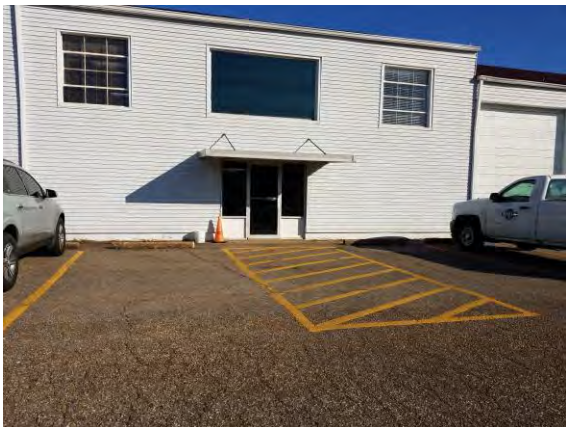
There are no accessible parking stalls.

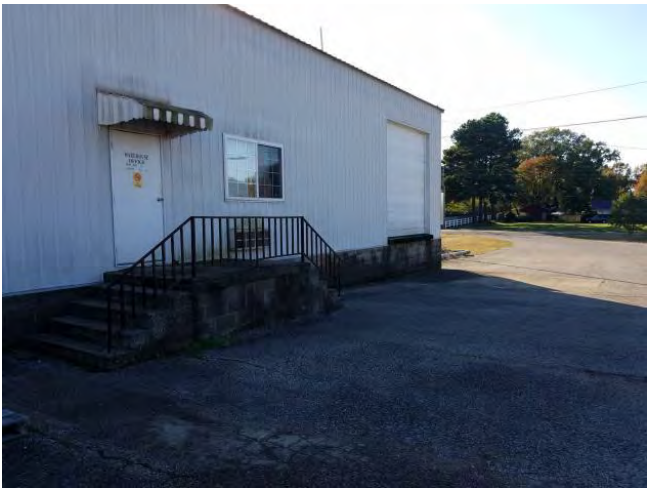
There are no accessible parking stalls or signage provided. No level pavement.

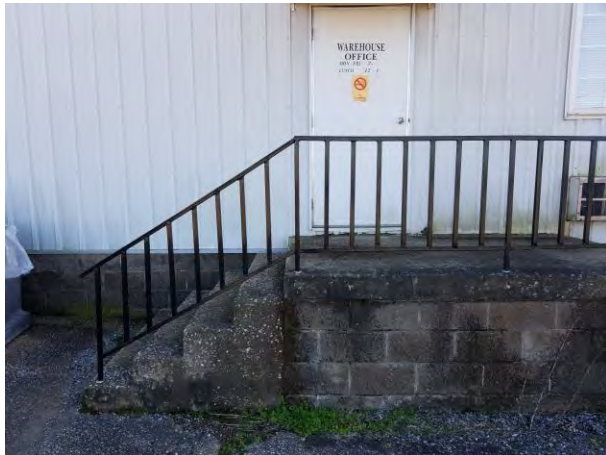
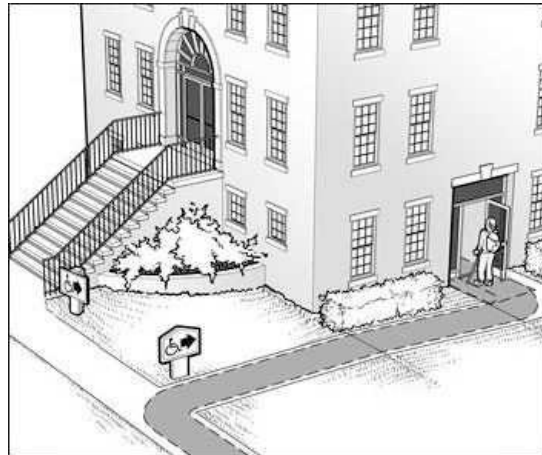
The building entrance is not located on an accessible route. 5 steps at door entrance. 2" threshold.

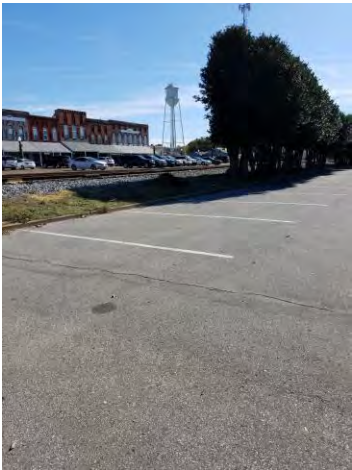
There are no accessible parking stalls.

PRIORITY 3 (Moderate)			
Estimated Cost	Location	Finding	Distress/ Description/ Recommendation
\$1,500	Total		
\$1,500	Parking	1	Van accessible space (striping and signage) can be added with access aisle in first two spaces near farmers market adjacent to railroad tracks.

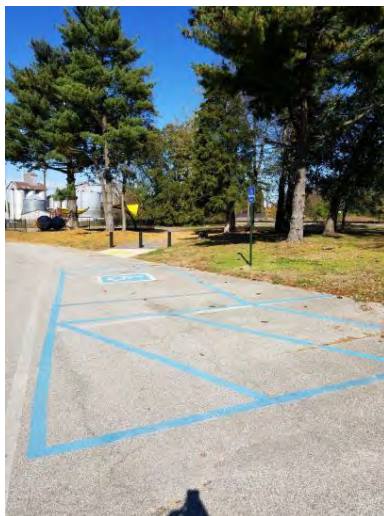
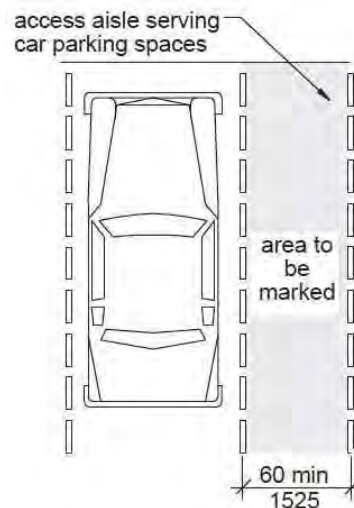
The access aisle is missing at the accessible parking stall.

PRIORITY 3 (Moderate)			
Estimated Cost	Location	Finding	Distress/ Description/ Recommendation
\$9,000	Total		
\$1,000	Frederick Street Parking	1	Restripe to provide compliant parking and access aisle for van accessible space.
\$3,000	Frederick Street Parking	3	Parking should be resurfaced and restriped to provide <2% slope in all directions with proper width parking and access aisle.
\$5,000	Trail	5	Remove and replace trail to lengthen sloped section and reduce slope to under 5%.

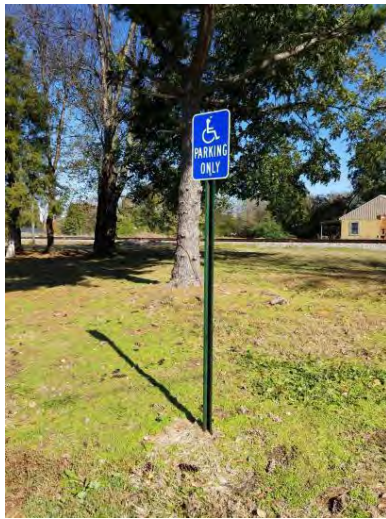
Frederick Street Parking**Finding: 2****Budget: \$150****Recommendation:**

There are 15 spaces with only 1 being striped, and no van sign. The van stall is missing a sign identifying it as a van accessible stall.

PRIORITY 4 (Low)			
Estimated Cost	Location	Finding	Distress/ Description/ Recommendation
\$9,700	Total		
\$150	Frederick Street Parking	2	Provide van sign at accessible space.
\$750	Trail	4	Concrete pad should be expanded to minimum size required to allow wheelchair parking next to bench
\$100	Trail	8	Provide concrete path to fountain.
\$7,000	Trail	9	Slope exceeds 2% in multiple sections west of Campus Road. The area that is over 2% is also experiencing cracking. Replace trail sections exceeding 2%.
\$300	Carter Street Parking	10	Restripe 1 van accessible space.
\$400	University Street Parking	11	Restripe and ensure compliant widths.
\$1,000	Play Area	12	Bring mulch to sidewalk grade or ramp concrete down to meet current mulch grade.

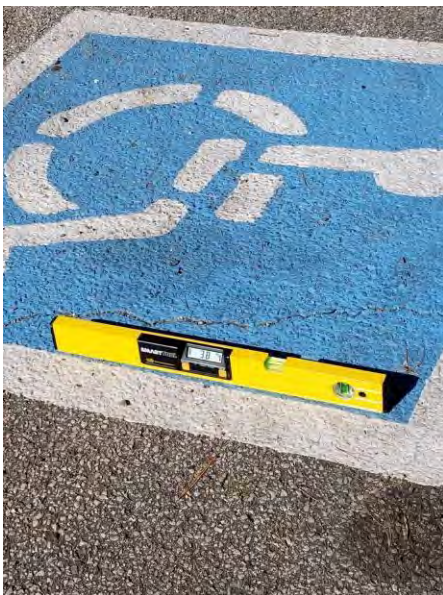
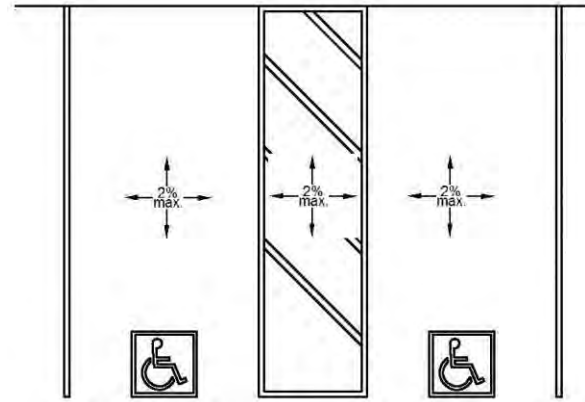
Frederick Street Planning**Finding: 3****Budget: \$3,000****Recommendation:**

The van slot varies up to 3.8% The cross slopes (narrow dimension) and/or running slopes (long dimension) of the accessible stall exceeds 2%.

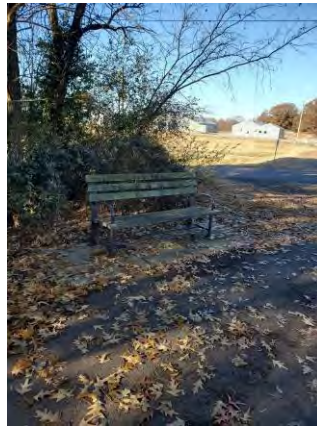
Trail**Finding: 4****Budget: \$750****Recommendation:**

The benches are on a concrete pad, which is typical in multiple locations. The outdoor seating area is not on an accessible route.

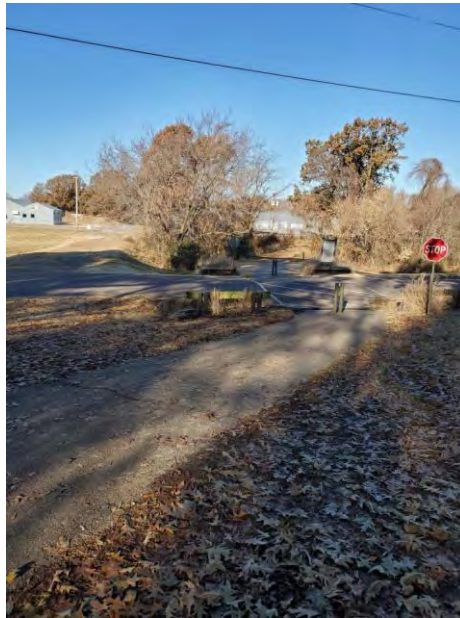
Trail**Finding: 5****Budget: \$5,000****Recommendation:**

The slope exceeds 5% directly into street crossing with no landing. The grade of the pedestrian access route is too steep.

Remove and replace trail to lengthen sloped section and reduce slope to under 5%.

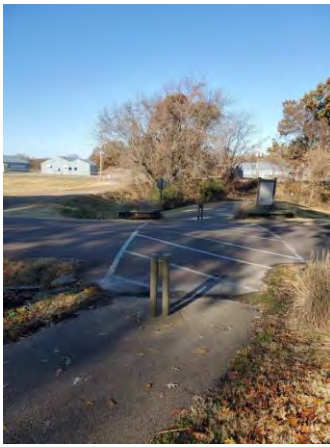
Trail**Finding: 6****Budget: \$350****Recommendation:**

The detectable warning is missing at the curb ramp.

PRIORITY 2 (Important)			
Estimated Cost	Location	Finding	Distress/ Description/ Recommendation
\$1,350	Total		
\$350	Trail	6	Install detectable warning at Campus Road crossing.
\$1,000	Trail	7	When installing detectable warnings, repair asphalt trail to bring flush with the road.

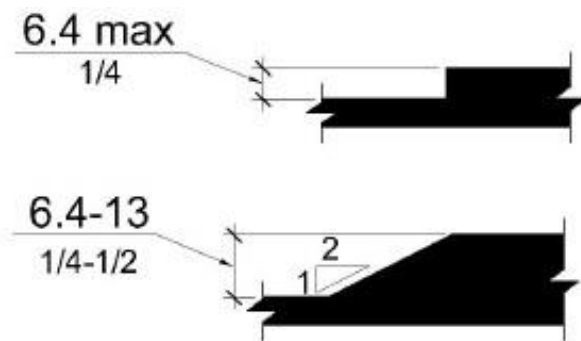
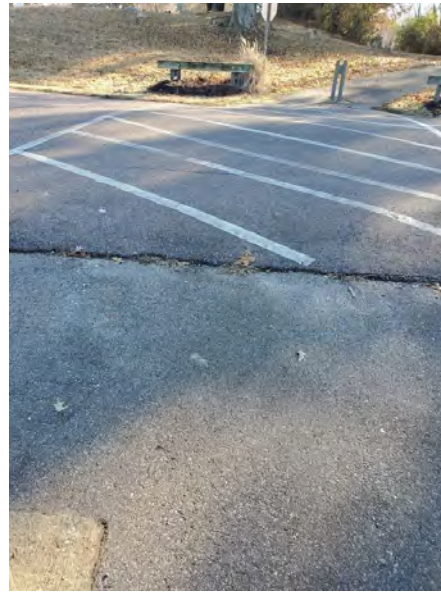
Trail**Finding: 7****Budget: \$1,000****Recommendation:**

The Campus Road paving overlay creates 1" lip over trail at crossing. The surface of the pedestrian access route has vertical discontinuities greater than 1/2 inch or between 1/4 inch and 1/2 inch that are not beveled. Vertical surface discontinuities shall be 0.5 inch maximum. Vertical surface discontinuities between 0.25 inch and 0.5 inch shall be beveled with a slope not steeper than 50 percent. The bevel shall be applied across the entire vertical surface discontinuity.

When installing detectable warnings, repair asphalt trail to bring flush with road.

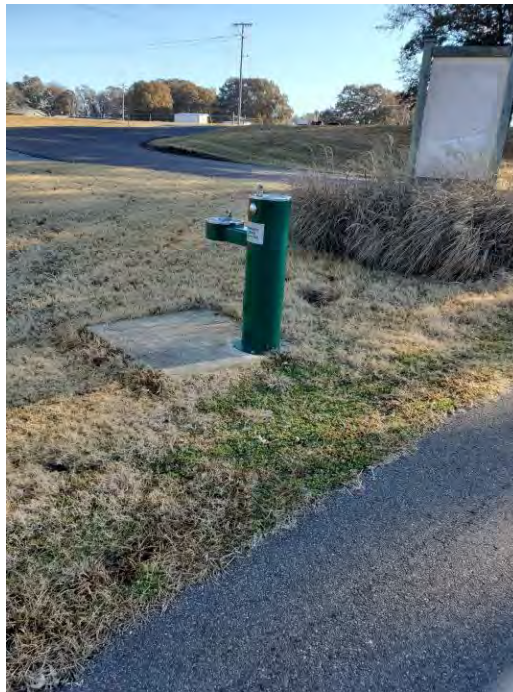
Trail**Finding: 8****Budget: \$100****Recommendation:**

The drinking fountain is not on an accessible route of travel.

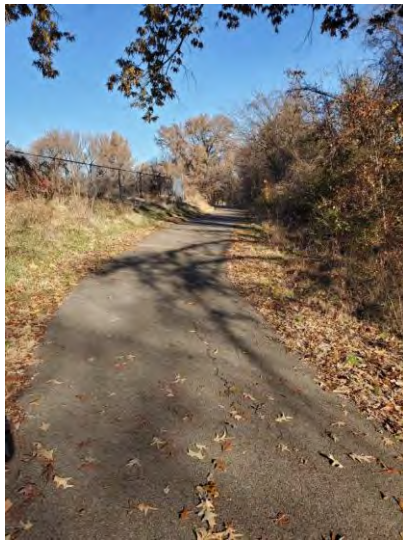
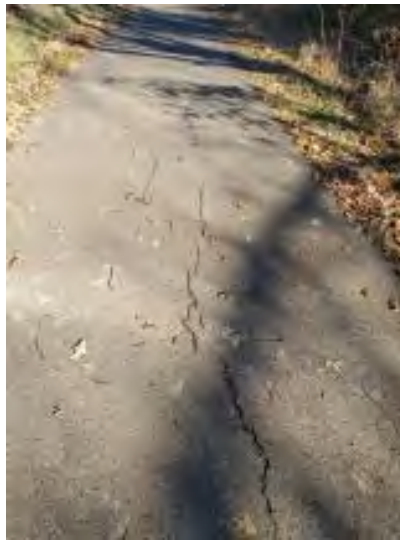
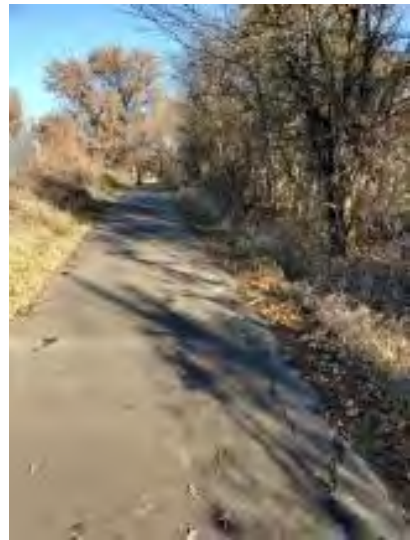
Trail**Finding: 9****Budget: \$7,000****Recommendation:**

The cross slope of the pedestrian access route is excessive.

Slope exceeds 2% in multiple sections west of Campus Road. The area that is over 2% is also experiencing cracking. Replace trail sections exceeding 2%.

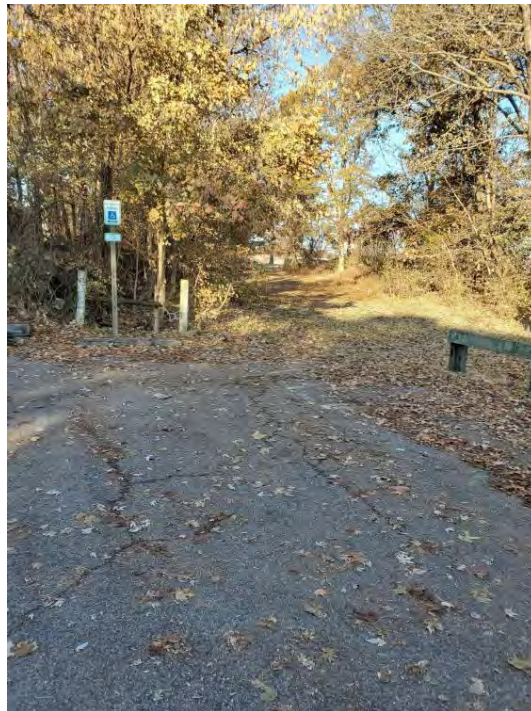
Carter Street Parking**Finding: 10****Budget: \$****Recommendation:**

The striping and markings for the accessible parking stall, loading/unloading access aisle are dilapidated and in need of repair and/or maintenance.

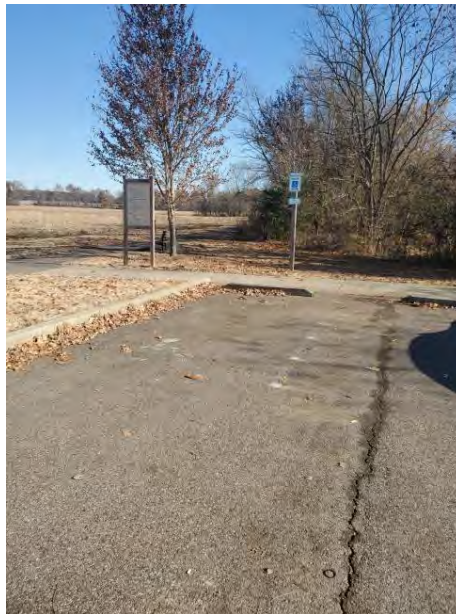
University Street Parking**Finding: 11****Budget: \$400****Recommendation:**

The striping and markings for the accessible parking stall, loading/unloading access aisle are dilapidated and in need of repair and/or maintenance.
